CSB-1190-3
 Country : UK
 Date : 2/2/2007
 APC : G26
 Repair Level : 3

Title M702iGM702iSMOTORAZR V3xx - 3G - Atlas_Switcher
 Model Effected Izar_Japan, Izar_Global, Izar_Global i-mode and Scorpius

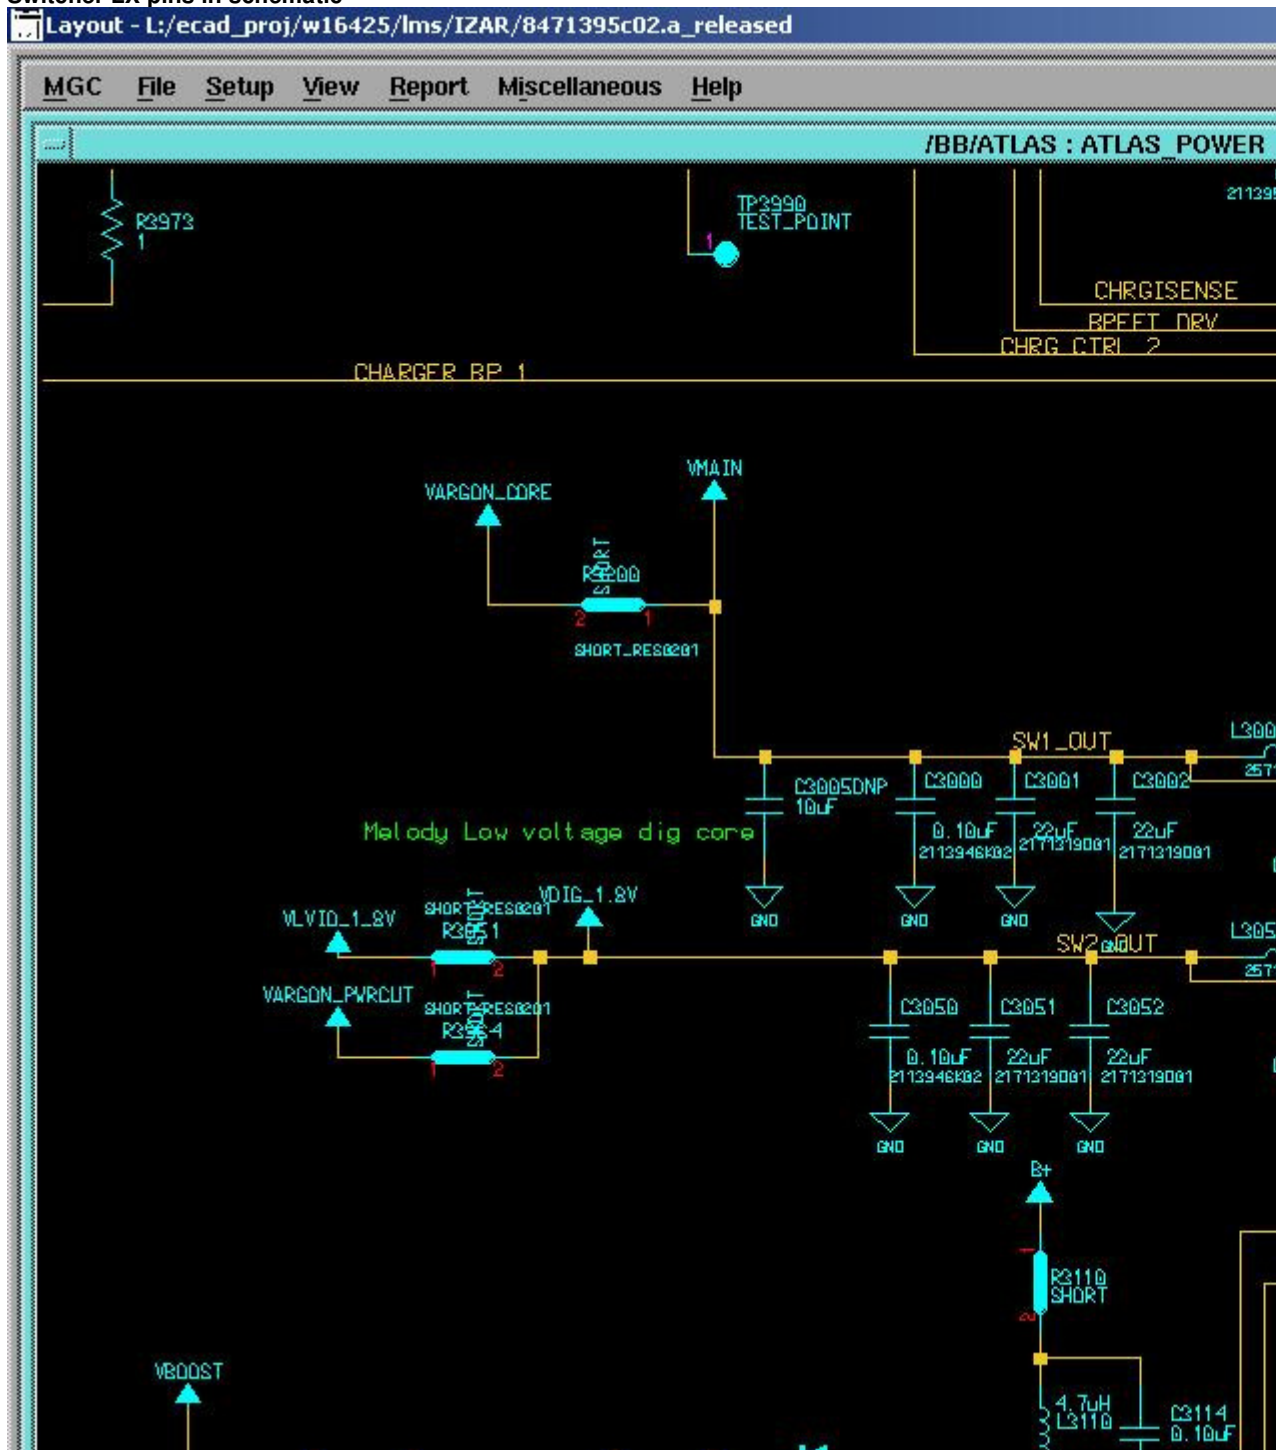
Switcher LX pins in schematic

1. Confirm phone panics with white screen after it goes into DSM.
2. Confirm phone does not panic when USB cable is plugged in.
3. Monitor switcher LX pins to confirm SW1 or SW2 or both fail in PFM mode, and record Atlas date code.
4. Determine if the device is functional or if it needs to be replaced.

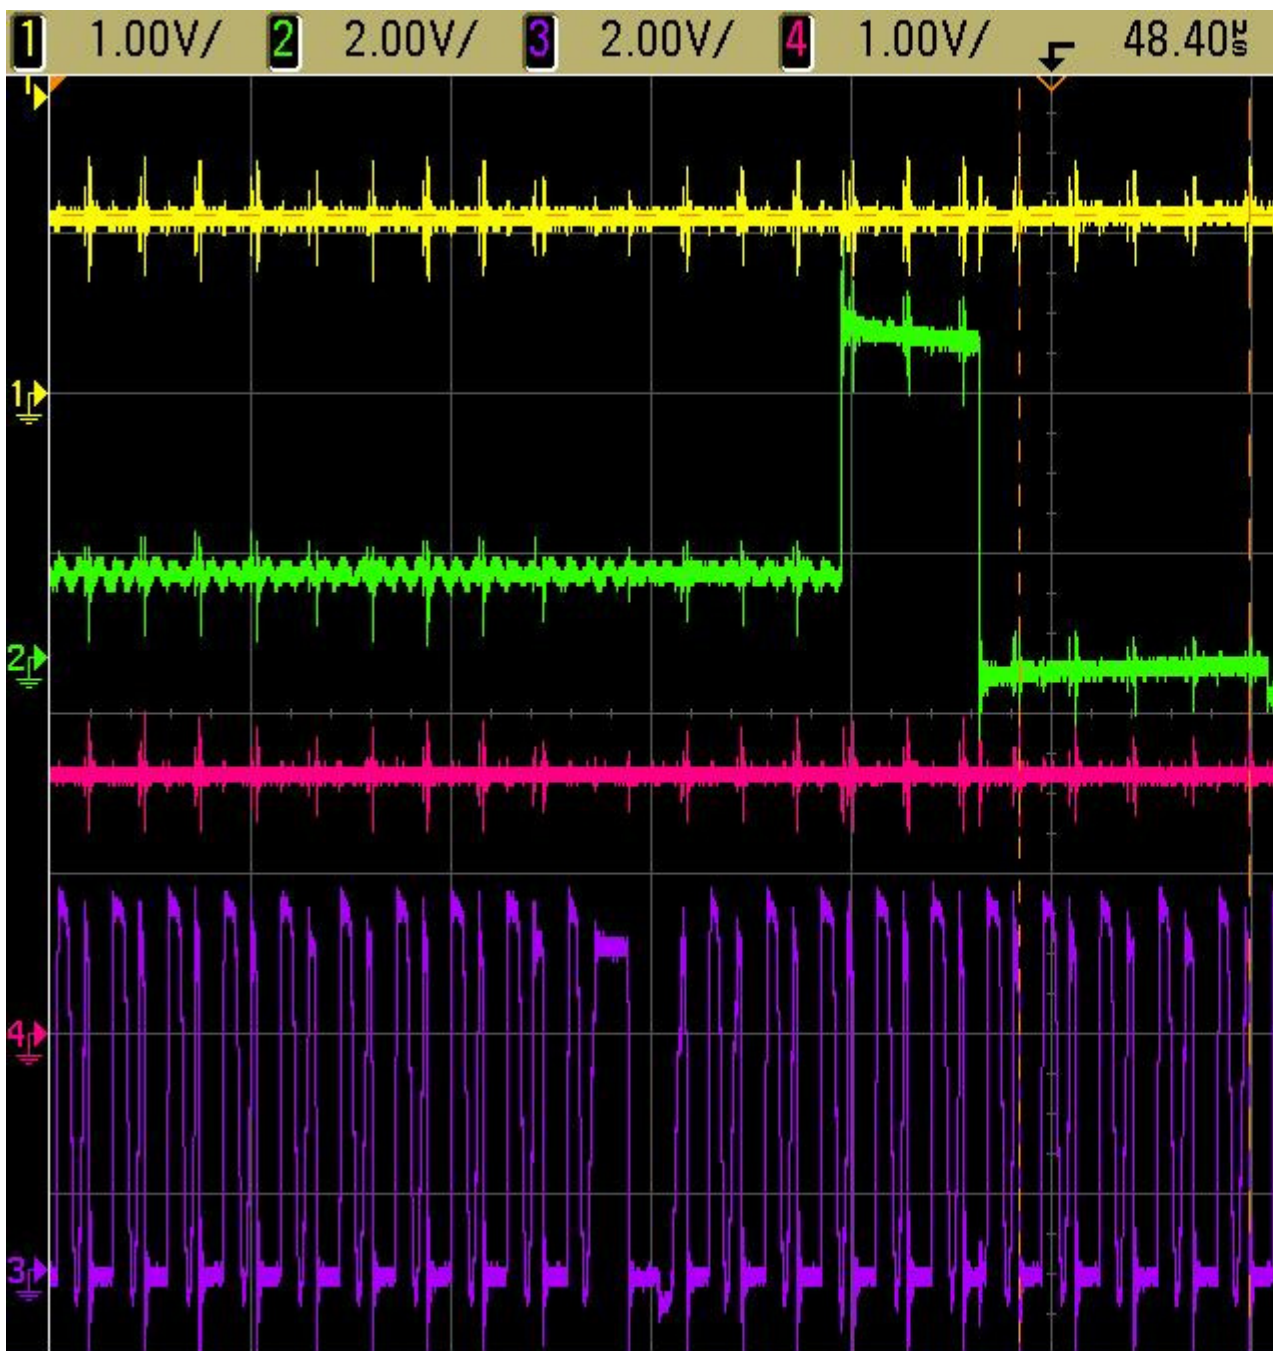
Bad Unit

When phone goes into DSM, Atlas SW1 LX pin switches normally at KHz range and SW2 LX pin switches abnormally at MH PFM mode.
