# FIELD SERVICE BULLETIN

FSB Number	FLCCFSB2007 - 310/Rev2
Author	Oke Christiansen
Date	Tuesday, January 15, 2008
Subject	<b>CDMA GSM - MOTORAZR2 V9m MOTORAZR<sup>2</sup> V8 - Missing Battery Insulator Tape</b>
Model Affected	All
Level Of Repairs	2

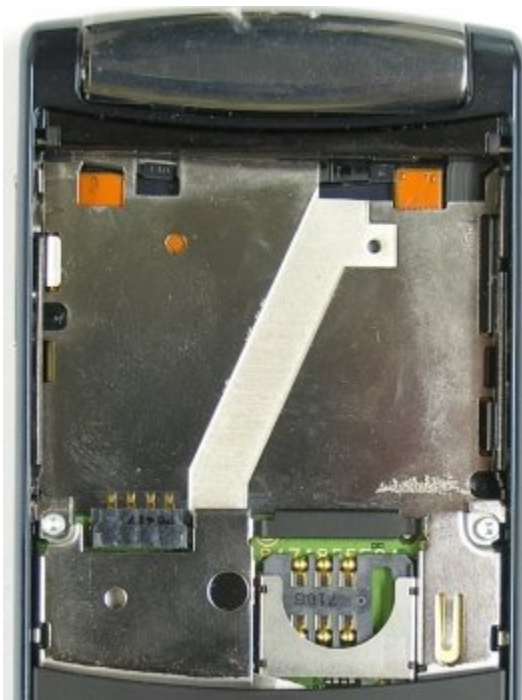
Service is aware of an issue identified in the NPI Analysis of the CDMA MOTORAZR<sup>2</sup> V9m, alongside GSM MOTORAZR<sup>2</sup> V8. Some units, returned with several customer complaints, showed a missing or damaged Battery Insulator Tape.

The root cause of the missing or damaged label seems to be that Customers did not understand the use of the latch at the Battery Insulator Tape. After inserting the battery and assembling the battery door, the latch is looking out of the housing. So they decide to rip the latch off. In some cases they ripped the whole tape of the phone which will also cause that the IMEI/ESN and factory labels are missing.

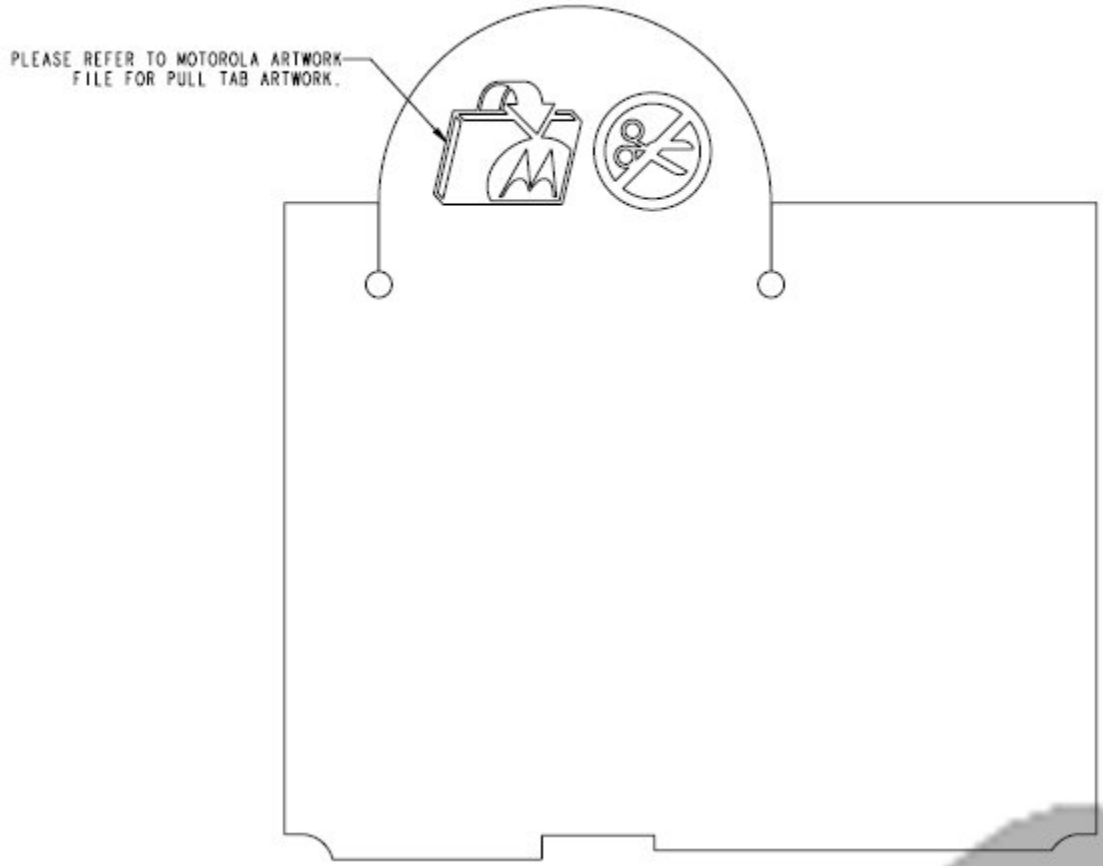
Graphics will be added to the Battery Insulator Label to make the use of the latch visible to the end users.

The additional artwork to the label has been approved and all current label production has switched over to it. This CA will not prevent that the consumer rip of the label, but it will advise him the purpose of the foil latch.

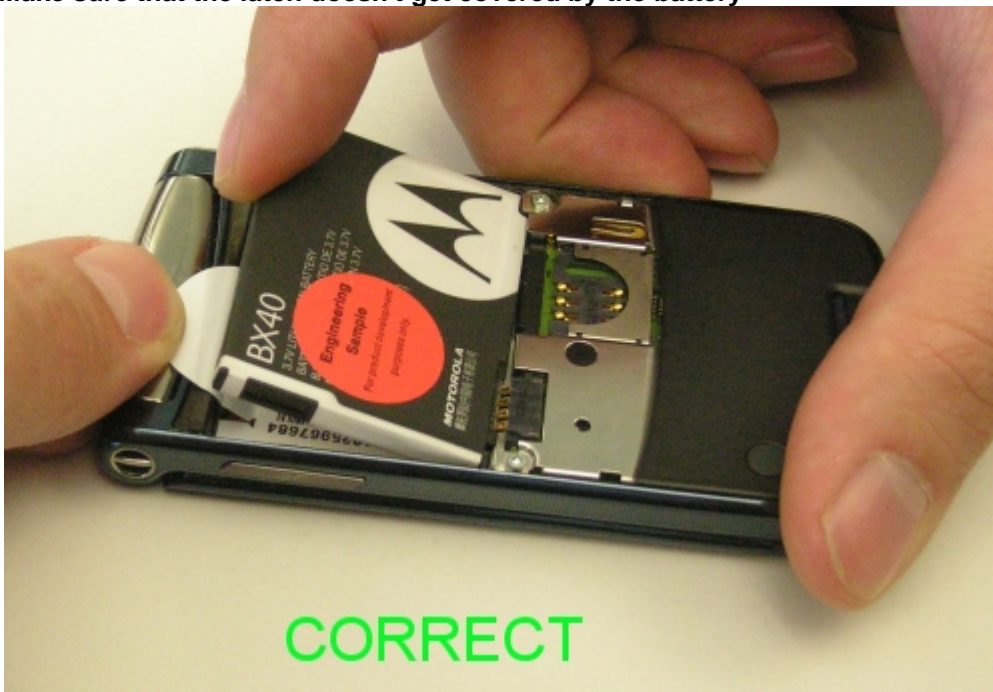
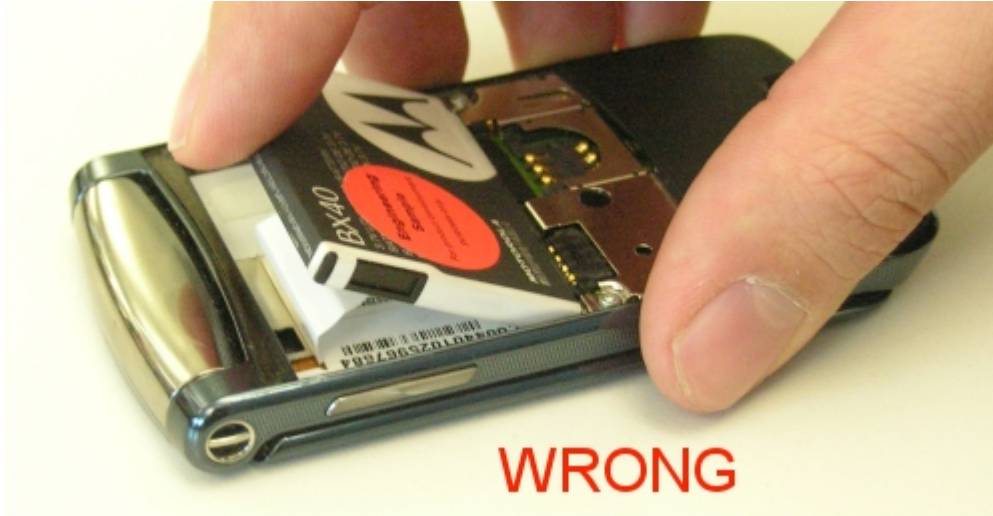
1. Make sure that the latch doesn't get covered by the battery

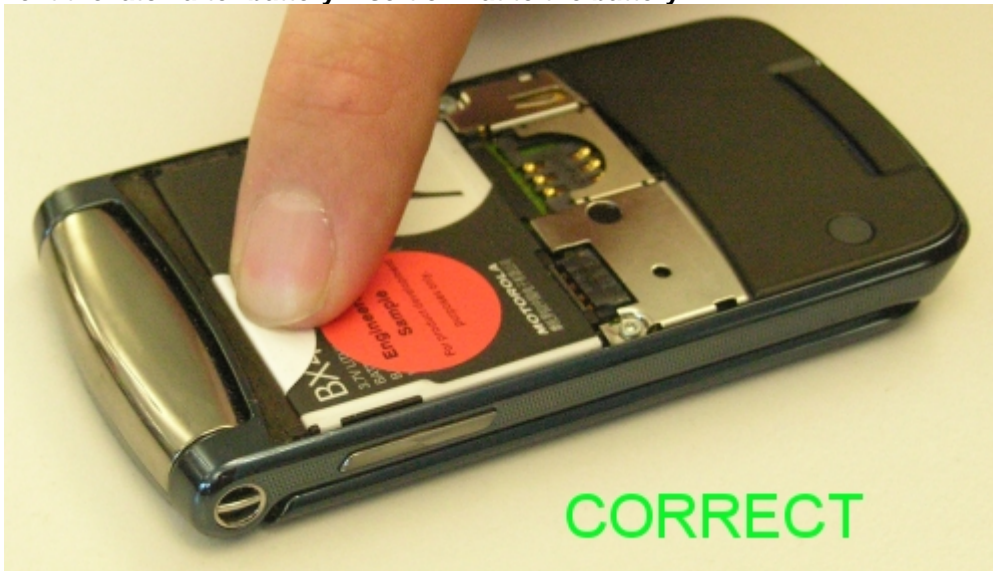
**2. Bent the latch after battery insertion flat to the battery**

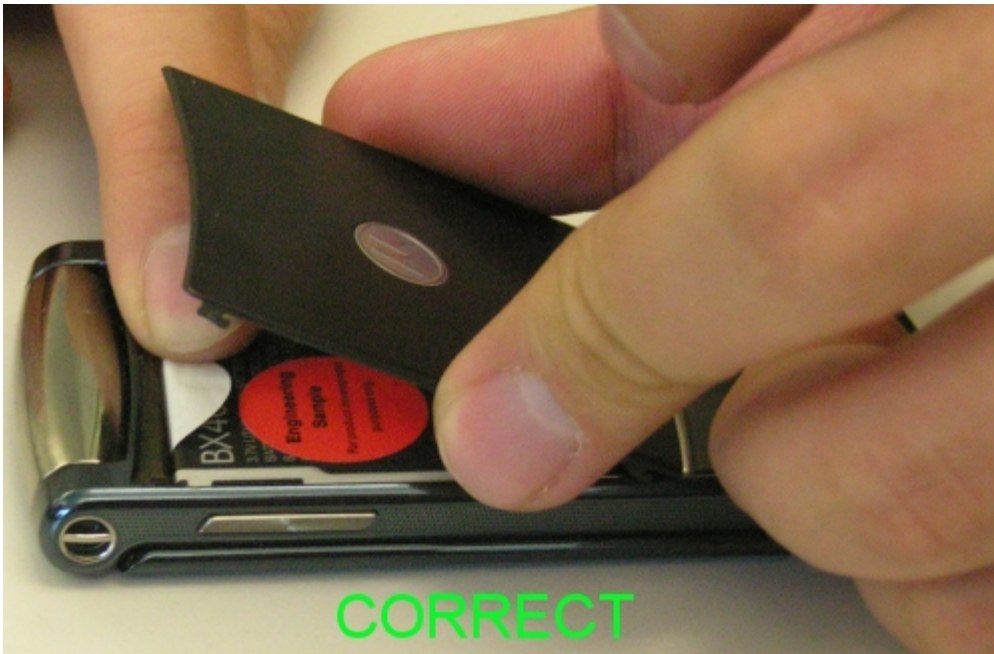
**3. Make sure that the latch is hidden under the battery door**
