FIELD SERVICE BULLETIN

FSB Number	FLCCFSB2008 - 4/Rev3
Author	Oke Christiansen
Date	Monday, January 28, 2008
Subject	3G CDMA GSM - MOTORAZR2 V9 MOTORAZR2 V9m MOTORAZR2 V8 - No Display / Keypad / Camera issues due to FM on Flex connectors
Model Affected	All
Level Of Repairs	2

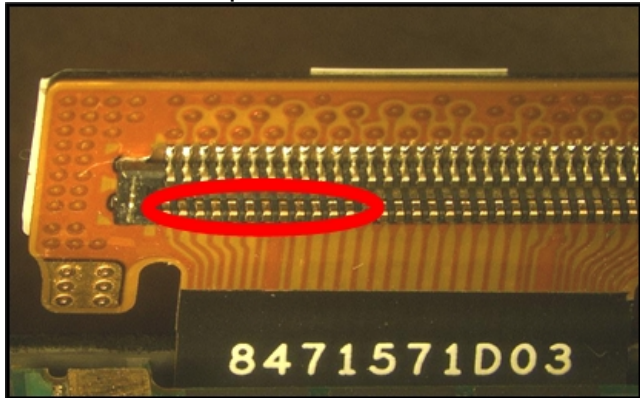
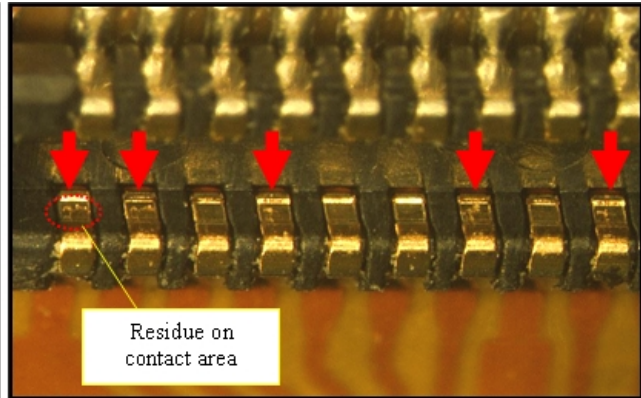
2. Very carefully remove the rear housing
3. Open and close the 70-pin connector 3-4 times and check to see if the failure mode is still present after each insertion. If the failure mode disappears, it is very likely the cause is flux or EGC residue contamination.
4. Inspect the 70-pin connector contact pins using a stereo microscope with at the very least 30X magnification. The flux residue contamination is clear and can be very difficult to see. Try tilting the connector as you watch through the microscope, it will help to differentiate the flux residue. Inspect both the PCB and the k-flex sides of the connector.
