FIELD SERVICE BULLETIN

FSB Number: LVCCFSB2005-287 (Rev. A)
Author: Tony Bryan
Date: November 10, 2005
Total No. of Pages: 6
Subject: GSM ROKR E1 – iTunes Activates Incorrectly
Phone Models: GSM ROKR E1
Level of Repair: 2

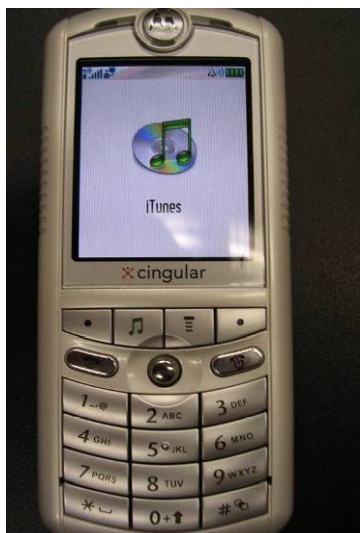
Scenario #1 – Misaligned, Undetected, Unformatted, or Non-Functioning TF-Card
Observed Phone Symptom: Press iTunes Key (Green Music Key) and the phone never proceeds beyond this screen.

1. Try Re-seating Trans-Flash Card, if this fails to address the issue, proceed to the following steps.

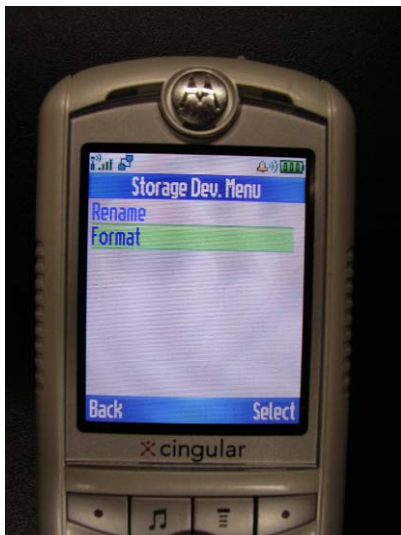
Action:
7. If “Unformatted” or “Damaged” the message will appear.

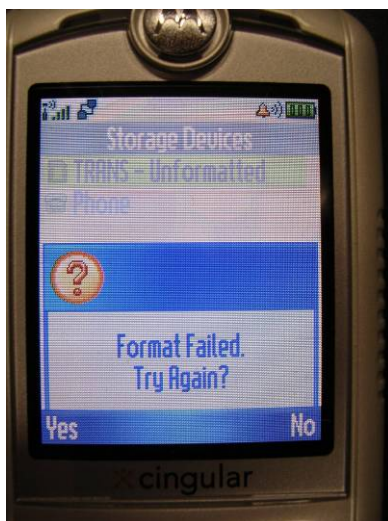
Action:
10. "Format Failed. Try Again" select "Yes"
11. If Formatting does not work, the Customer has a damaged Trans-Flash Card.

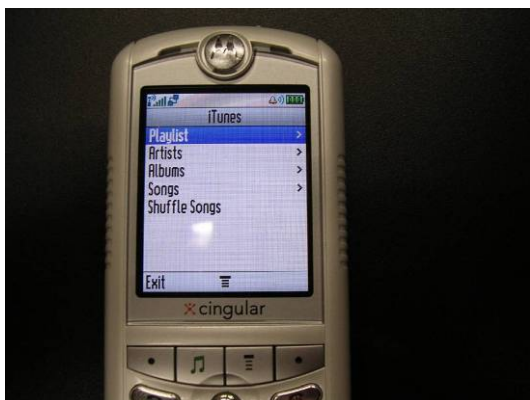
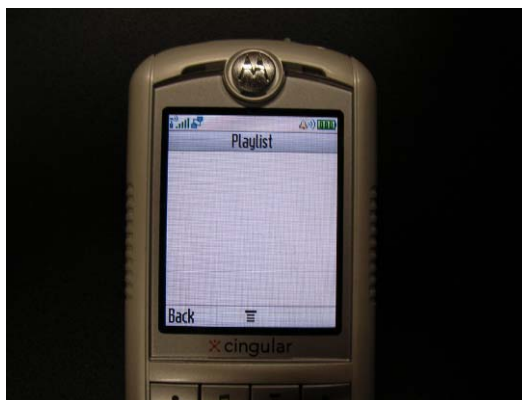
Observed Phone Symptom: Press iTunes Key (Green Music Key) and the iTunes application on the phone opens but one of the following are true

- When “Playlist” is selected on the phone, none of your music appears
- When connected to PC/Apple Computer, the phone does not appear in the iTunes window and will not automatically download music.
- Trans-Flash Card does not show up in phone menu: “Menu>Settings>Phone Status>Storage Device”

Action:
1. Re-seating the Trans-Flash Card

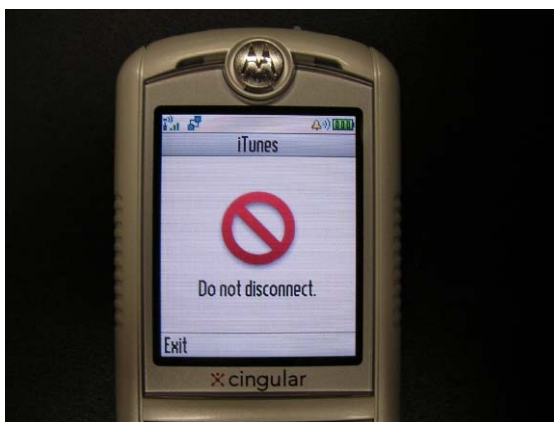
Observed Phone Symptom: Press iTunes Key (Green Music Key) and the and the following occurs without the phone being connected to a PC/Apple Computer.

Action:
1. Re-seating the Trans-Flash Card
