FIELD SERVICE BULLETIN

FSB Number: LVCCFSB2005-318
Author: Tony Bryan
Date: November 14, 2005
Total No. of Pages: 2
Subject: GSM ROKR E1 – Browser Bookmarks (Left/Right Soft-Keys)
Phone Models: GSM ROKR E1
Level of Repair: 2

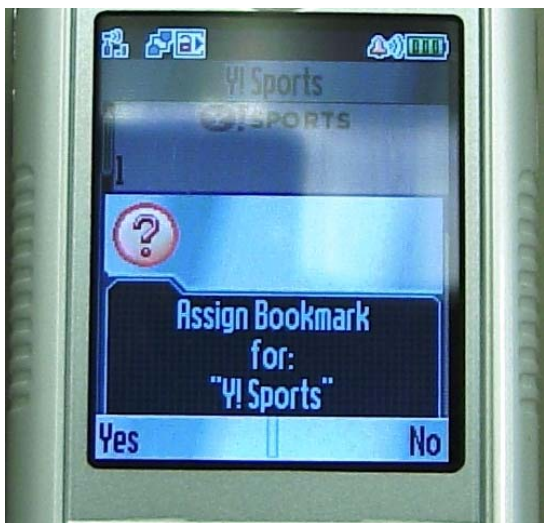
Fig. 1.0 – Correct Operation

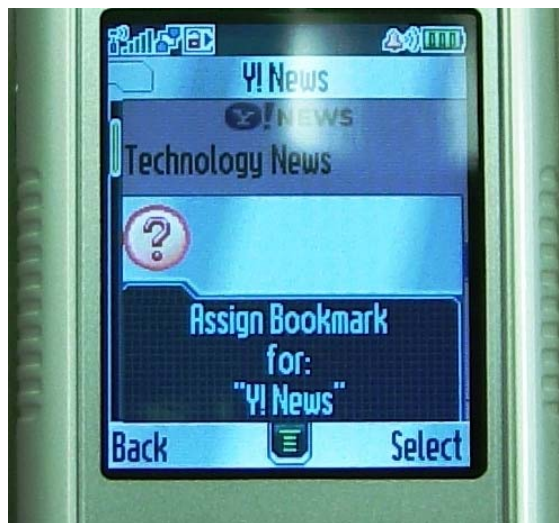
Service is aware of an issue, identified during the NPI Analysis of the GSM ROKR E1 product. Some units were returned with customer complaints of “Operation – Menu Navigation” where the complaint detail pointed to an issue while using the phone’s browser. These units were confirmed to be caused by a software issue that resulted in the incorrect labeling of the Left and Right Soft-Keys while attempting to store a Browser Bookmark. The root cause of this issue is that the browser title is not scrolling to match the browser content. The actual function of the Left and Right Soft-Keys is not affected when this issue is present but the keys are not labeled correctly. See images below.

Fig. 2.0 – Incorrect Operation

A software solution has been integrated into software versions R373_G_0E.30.44R and later.

1. Confirm the customer complaint is related to this issue then, per the normal Service Procedure, re-flash the unit with the latest approved software for your region equal or later than R373_G_03.30.44R.
 - a. If the customer complaint is determined not to be related to this issue, then follow normal troubleshooting techniques per the customer complaint.
