FIELD SERVICE BULLETIN

FSB Number: LVCCFSB2006-86
Author: Rajesh Verma
Date: March 6, 2006
Total No. of Pages: 2
Subject: **GSM L7 No Camera**
Model Affected: L7
Level of Repair: 2

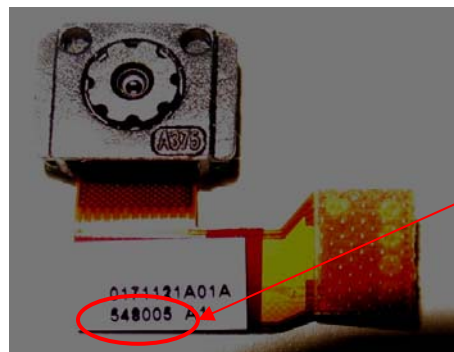
Fig: 3

The supplier Altus has corrected this problem with use of new substrate. Camera module P/N 0171121A01A has started using new substrate from week 02, 2006 or later. See Figure 3 below to identify date code information of Camera module.

Example of
548005: year
2005; week
48; lot # 005

1. If the customer complaint is confirmed, then:
 - a) Replace Camera module with date code week 02, 2006, or later
 - b) Retest the unit to verify proper operation.
2. If the unit still exhibits failure symptoms, then proceed with normal troubleshooting techniques per the customer complaint.

Purge current inventory of camera module 0171334A01 of date code before week 02, 2006, and replace with date code week 02, 2006 or later.
