FIELD SERVICE BULLETIN

FSB Number: LVCCFSB2003-100
Author: Tony Bryan
Date: October 17, 2003
Total No. of Pages: 3
Subject: **Triplets Desense Improvement**
Model Affected: V300, V303, V400, V500, V525
Level of Repair: 2

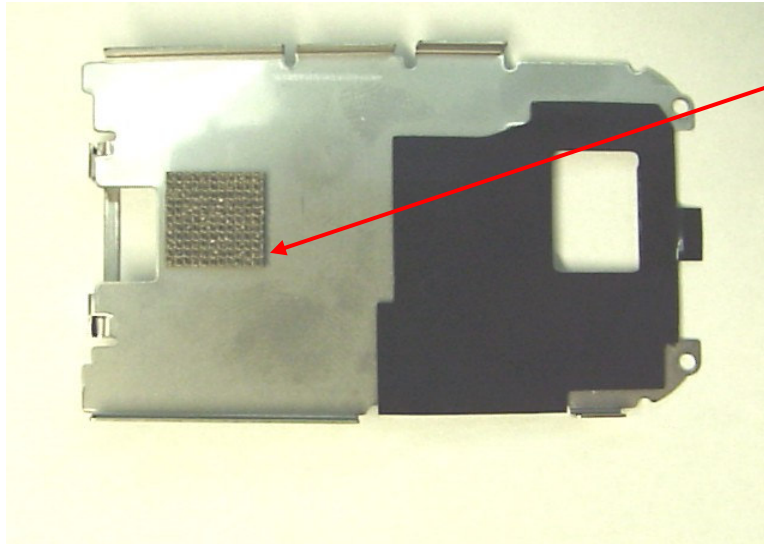
Diagram 1.0 Moon Pad Placement

Service is aware of an issue with Desense on GSM Triplets Products. Factory and ALT Testing has seen some fallout for poor RF Performance related to Desense.

Manufacturing has implemented the placement of a conductive 2mm Moon Pad (3289229N02) centered on the SIM Chassis. The added conductive Moon Pad makes contact with the PCB Shielding and grounds the SIM Chassis to improve Desense performance. Please see Diagram 1.0 below for proper placement of the Moon Pad (3289229N02).

Special Note:
Place grounding pad as shown on Base Chassis, approx. 2 mm from the lower part of the battery contact opening; approx. centered between the sides.

When servicing any GSM Triplets Product customer return with a customer complaint relating to Call Performance or Dropped Calls, check to make sure the Moon Pad is properly placed and is making direct contact with the PCB Shielding.

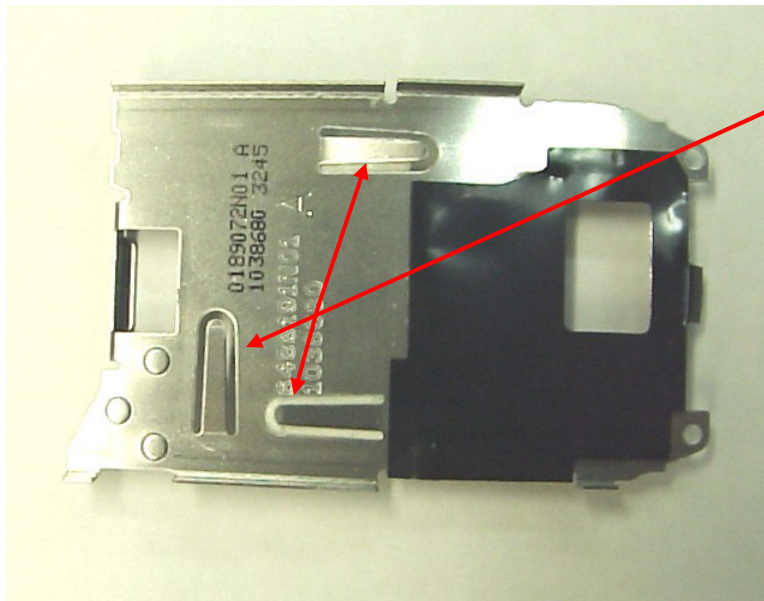
Diagram 2.0 New SIM Chassis Design

NOTE: Image shown is a V600 SIM Chassis and the Part Number is not valid!!

A re-design of the original metal SIM Chassis (0188940N01) has been requested by Hardware Development and will be implemented in manufacturing as soon as material with the new design is available. The new design will include three metal fingers that extend into the housing and make contact with the PCB Shielding adequately grounding the SIM Chassis. Diagram 2.0 below shows a sample of the SIM Chassis with the improved design.

Special Note:
New Design with Three Metal Fingers to GND Chassis

When servicing any GSM Triplets Product customer return with a customer complaint relating Call Performance or Dropped Calls, check and replace the SIM Chassis with a part with the improved design.
