FIELD SERVICE BULLETIN

FSB Number: LVCCFSB2003-102
Author: Tony Bryan
Date: October 24, 2003
Total No. of Pages: 3
Subject: **GSM Triplets - Side Key Flex Connectivity**
Model Affected: V300
Level of Repair: 2

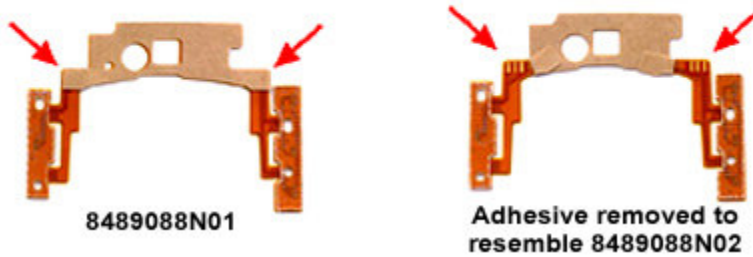
Diagram 1.0 Adhesive Removal

Service is aware of a connectivity issue with the (8489088N01) Side Key Flex on GSM V300. Electrical failures for Side Key-No Function, seen in Factory and ALT Testing, have been linked to a connectivity issue between the Side Key Flex and the contacts on the PCB. The majority of the failures were contributed to the adhesive backed flex.

STEP 1: Manufacturing will be switching over from the current (8489088N01) part to a no-adhesive part (8489088N02) and will modify existing (8489088N01) stock by removing the adhesive at the contacts.

Peel back the tab of the wing to remove the adhesive from the the flex.
Do not cut the tab as this may damage the flex.

1. Modify the adhesive on the side flexes by removing a portion of it.
2. To remove the portion of adhesive from the side flex, peel back the wing of the backing paper and use a black stick to scrape away the adhesive from the area in the picture below.
** DO NOT CUT THE BACKING PAPER OR USE A KNIFE TO REMOVE THE ADHESIVE AS THIS MAY DAMAGE THE FLEX.
3. Afterwards, use an alcohol wipes to thoroughly clean the area of adhesive and debris.
** THIS MODIFICATION SHOULD MAKE THE N01 SIDE FLEX NOW RESEMBLE THE N02 SIDE FLEX.
