FIELD SERVICE BULLETIN

FSB Number: LVCCFSB2003-112
Author: Rajesh Verma
Date: Nov.11, 2003
Total No. of Pages: 2
Subject: Camera Automated Time Capture Failure
Model Affected: Triplets V300
Level of Repair: 3, 4

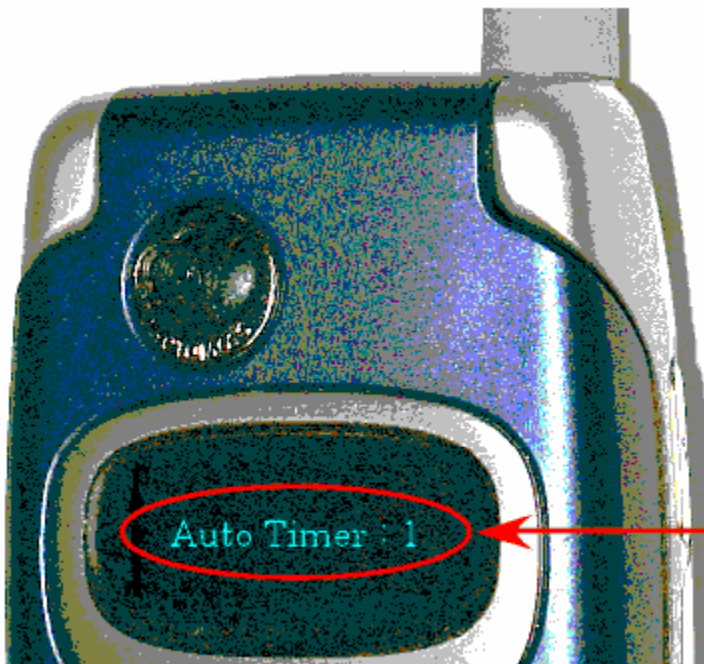
It has been brought to the attention of the Service Organization during the 1st NPI analysis of EMEA V300 with software version OB.08.76R. Some units have been returned with customer complaint of Phone freezes during Automated Time Capture. This is an issue with the camera feature when attempting to use the Automated Time Capture option. When selecting this option, the unit will begin to count down, but will occasionally freeze and "Auto-Timer: 1" will be shown on the CLI display and the Main display will go blank. The root cause has been traced to software- whenever the capture is completed, the ATI stops for the capture and waits for the status of the hardware to become idle but sometimes the hardware state never becomes idle and thus the phone will be in one loop indefinitely.

**Display Frozen
at 1 second**

The problem has been corrected in software version TRIPLETS_G_0B.08.8F5R and later.

1. Please verify failure symptom.
2. Re-flash/Reflex to software version TRIPLETS_G_0B.08.8F5R or latest approved software version for region.
3. Verify unit does not display failure symptom.
