**FIELD SERVICE BULLETIN**

FSB Number: LVCCFSB2003-129  
Author: Tony Bryan  
Date: December 05, 2003  
Total No. of Pages: 4  
Subject: **GSM V300 Flip Assembly (C56-CLI Chassis Short)**  
Model Affected: V300  
Level of Repair: 3

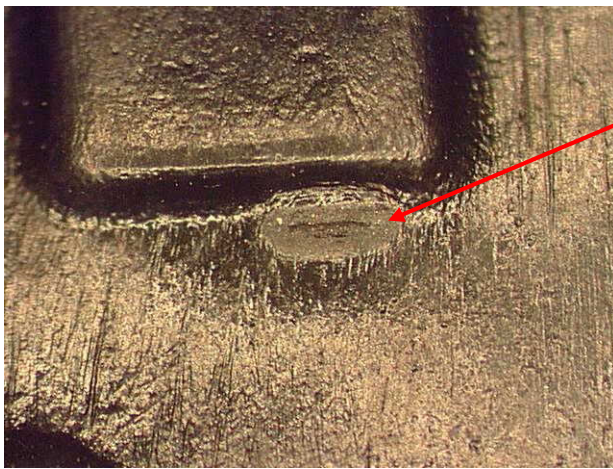
Figure 1.0 - CLI Snubber damaged by C56

Service is aware of an issue identified during the 1<sup>st</sup> 200 NPI Analysis on V300. Some units, returned with a customer complaint of “Can’t Switch Phone On”, “No Display Backlights”, or “Will not Charge Battery, were found to draw excessive current (1.25mA) when plugged into an external power supply. Analysis revealed a short, internal to the Flip Assembly, on the B+ Line to be the cause. The short occurs as a result of the CLI Chassis (0788807N01) design not allowing the proper amount of clearance for C56, a filter cap on the B+ Line. After assembly, torque on the Flip Assembly causes the CLI Snubber to be pierced by C56, which allows the capacitor to short to the CLI Chassis (0788807N01). This results in the radio drawing 1.25 amps, as well as shorting out the backlights for both the Main and CLI Displays. See Figure 1.0 below.

**Damaged CLI Snubber at the point of the short C56**

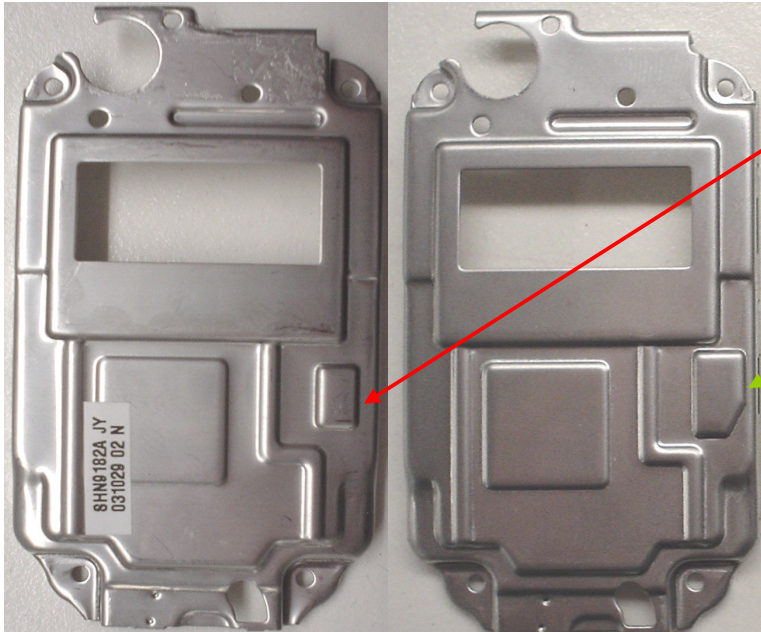
Figure 3.0 - Redesign of CLI Chassis

Current Rev. D Chassis

**Capacitor interferes with chassis.**

Redesign of CLI Chassis (0788807N01) Rev. E to allow additional clearance for C56. See Figure 3.0 below. Tooling for Rev. E chassis is in place at the suppliers and pilot builds have been completed of the Rev. E chassis as of 11/14/03. Production is scheduled to cut over to the Rev. E Chassis by the 1<sup>st</sup> week in January.

NEW Rev. E Chassis

**Additional clearance for capacitor added to chassis.**
