FIELD SERVICE BULLETIN

FSB Number: LVCCFSB2003-130
Author: Tony Bryan/Rajesh Verma
Date: December 10th, 2003
Total No. of Pages: 4
Subject: **GSM Triplets – Antenna Issue**
Model Affected: V300, V500, V525
Level of Repair: 3

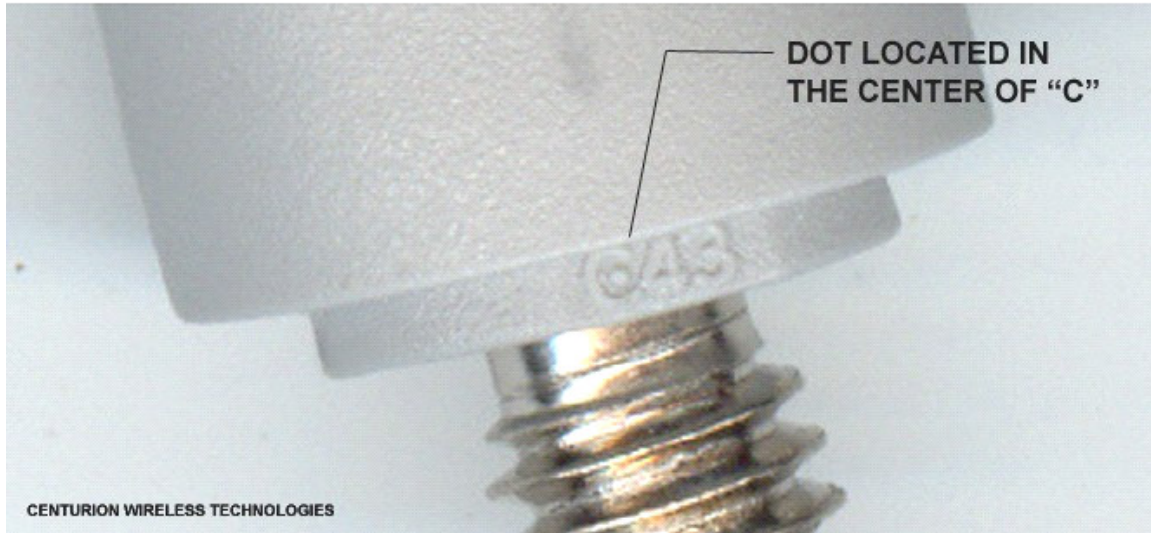
**IDENTIFICATION METHOD FOR ALL V300 & V500
ANTENNAS MANUFACTURED STARTING NOVEMBER 20th.**

Centurion has replaced inventories with antennas processed after Nov.20th when all process improvements and screening was in place. New parts, built after Nov. 20th, are uniquely marked with a “Dot” inside the “C” at base of plastic. Screened parts will be marked with a “Red Dot” at the metal tip. See Figure 1.0 below.

Please quarantine all existing stock of the 8588912N01 V300 and 8589122N01 V500/V525 antenna and replace with new parts built after November 20, 2003. See Figure 1.0 for identification markings on new parts.
