### **FIELD SERVICE BULLETIN**

FSB Number: LVCCFSB2003-97  
Author: Rajesh Verma  
Date: October 14th, 2003  
Total No. of Pages: 3  
Subject: **GSM V300 Flip Cover Dent**  
Model Affected: V300,  
Level of Repair: 2

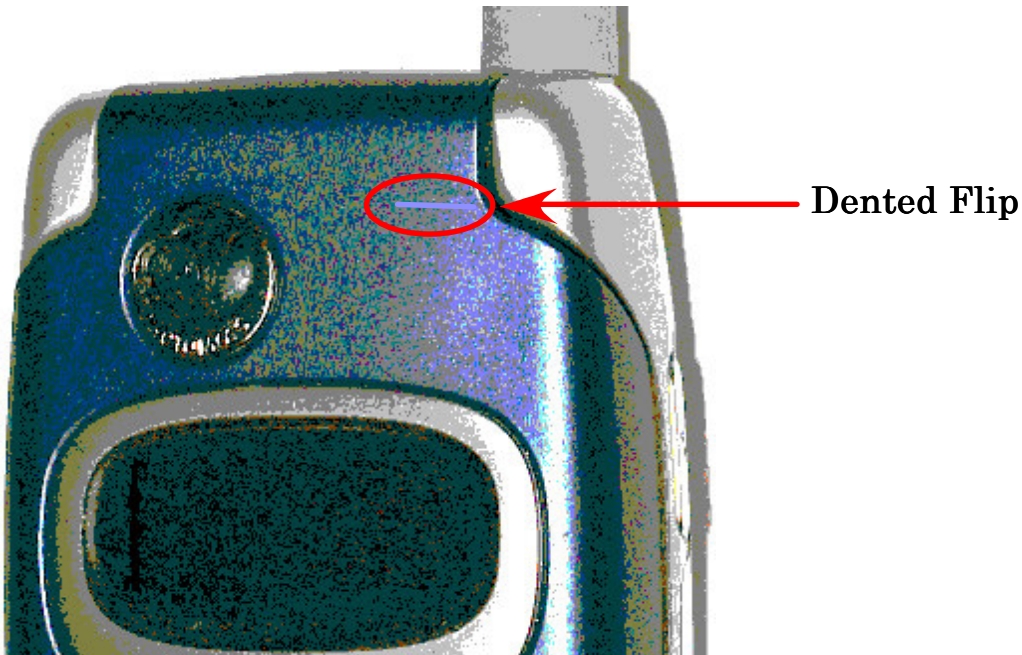
Service has been made of an issue identified in ALT testing. Flip hyper extension testing has resulted in dents in the soft touch paint starting around 800 cycles against a 3500 cycle requirements. Specifically, test to failure information resulted in small dents forming at 800 cycles with further degradation to 3500 cycles. The dents are caused by the Flip Stop on the front housing.

The dent in the flip cover is caused by Flip Stop deterioration in the front housing.

Development has redesigned Flip Stop with new material Santoprene, which is more durable than existing material Silicon. Existing stock will be used to support launch and once the improved parts are available the remaining older parts will be scrapped. It's a running change and cutover to new front housing with Santoprene Flip Stop is Nov 22, 2003.

Any GSM V300 customer returns with complaint of dented flip should be replaced with new flip cover P/N 0188931N01 and front housing P/N 0189211N01. Use front housing P/N 0189211N01 made from existing material Silicon until front housing with new material Santoprene are available. Front housing manufactured on or prior to week 4 of Nov.2003 may cause this issue. Cutover to new material is target Nov 22, 2003. Picture below describe how to identify date code on front housing.

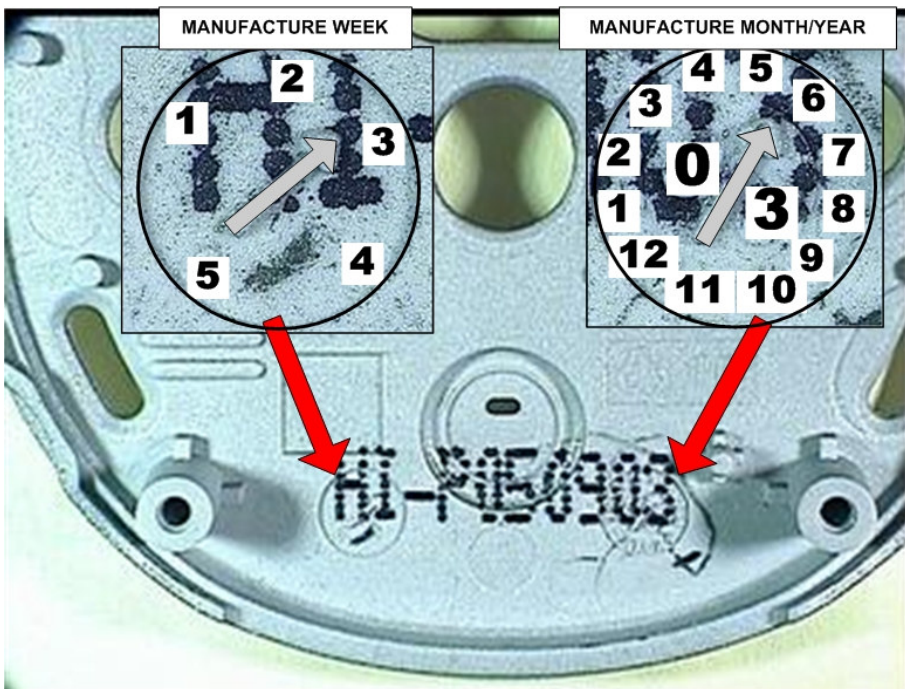
**Front Housing manufacturer date week 3, month 6 and year 03.**
