Author: Henrik Sondell, Technical Support
Date: 2003-01-22
Subject: GSM Triplets – Integrated Camera Module
Rating: Level 1&2 Authorized

Products: V300/V500/V525

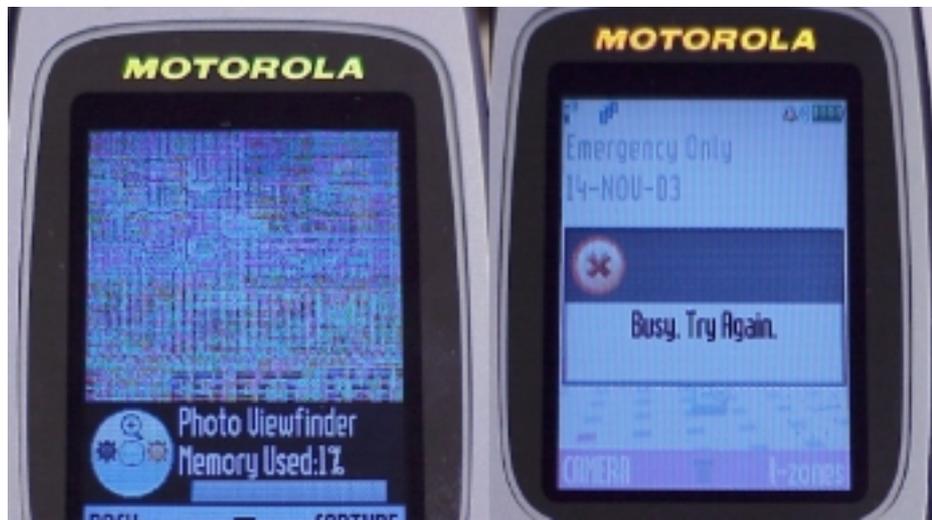
Problem: Service is aware of an issue identified during the 1st 200 NPI Analysis on V300/V500/V525. Some units, returned with a customer complaint of “Camera–No Operation” or “Error Display-Shows Busy”, were found to have cracked solder joints on the integrated camera module between the imager and flex. The images below show examples of the failure symptoms, visible to the user when attempting to activate the camera, that are a result of these broken solder connections.

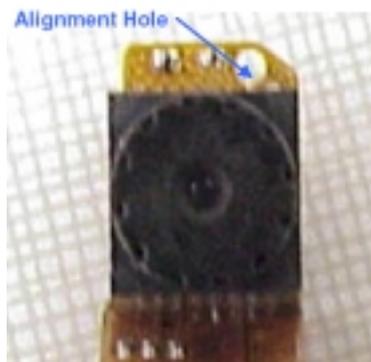
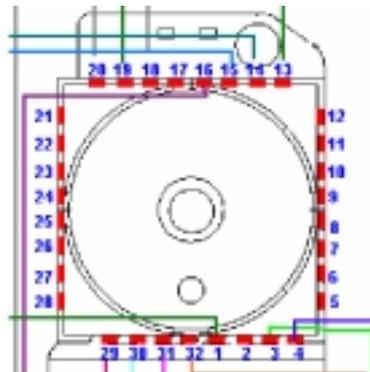
The root cause of the defect is stress to the solder joints of the imager, at both the bend and alignments sides, during the assembly of the camera module into the flip. Pins 13, 14, and 15 are the most susceptible to opens. See images below.

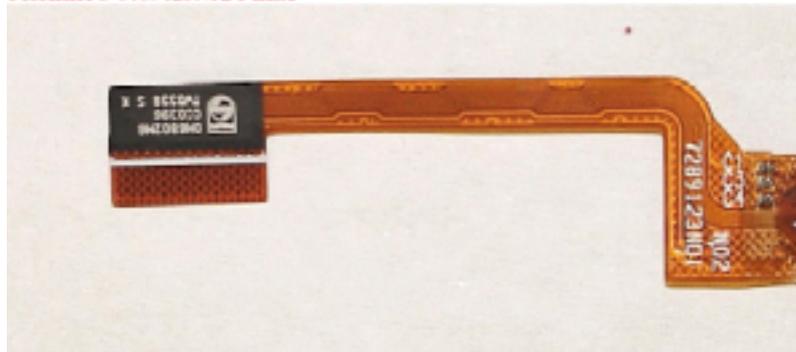
PHILLIPS 8489420N02 FLEX

This issue affects the 7289123N01, N02, N06, and N07 Phillips Camera Modules that were built with the original Phillips 8489420N02 Flex.

Quarantine all existing stock of 7289123N01, N02, N06, and N07 Phillips Camera Modules. Affected modules should be sorted, using the images shown above, to identify modules built with the original Phillips 8489420N02 Flex. All modules confirmed to have been built with the Phillips 8489420N02 Flex should be removed from inventory.

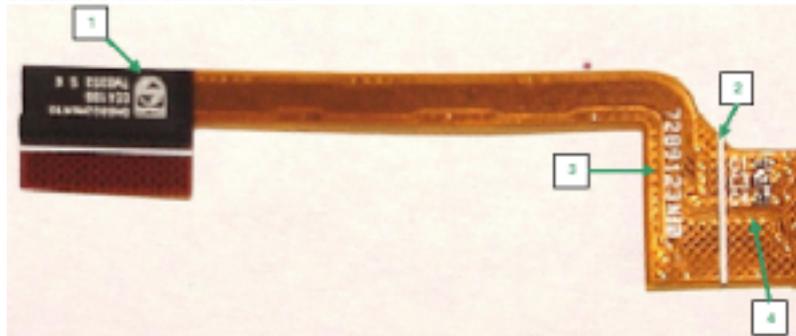
PHILLIPS 8489420N03 FLEX

1. Phillips Marking at connector
2. White line above imager part number and below components.
3. Part number printed on the flex will read 7289123N10 or 8489420N03
4. Smaller number of traces visible on surface layer

1. Phillips has changed the design of the flex from the original 8489420N02 Part to a new 8489420N03 Part with some of the surface layer traces rerouted to the bottom layer to increase the overall flexibility of the flex and reduce the amount of stress applied to the solder connections during the assembly process.
2. UV Glue will be added, by the factory, to the alignment side of the imager on all remaining Phillips Cameras built with the original N02 Flex. The UV Glue will add additional support to the affected solder connections.
3. Phillips will optimize the plating and hot bar processes to improve the overall robustness of their design.
4. Steps will be taken to optimize the assembly process of the Camera Module in the Flip Assembly to limit stress put on the imager's solder connections.

2. Disassemble the unit and flip assembly to replace the camera module, with a Phillips camera built with the improved 8489420N03 flex. See Images Above.
