FIELD SERVICE BULLETIN

FSB Number: BJCCFSB2004 - 129
Author: Xu Changhong
Date: 8 Jun 2004
Total No. Of Pages: 3
Subject: **Citizen Polyphonic Speaker Issue**
Model Affected: **EZX A768**
Triplet GSM V300, V303, V500,V600, V400,V525
GSM C650 , GSM V80
Level of Repair: 3

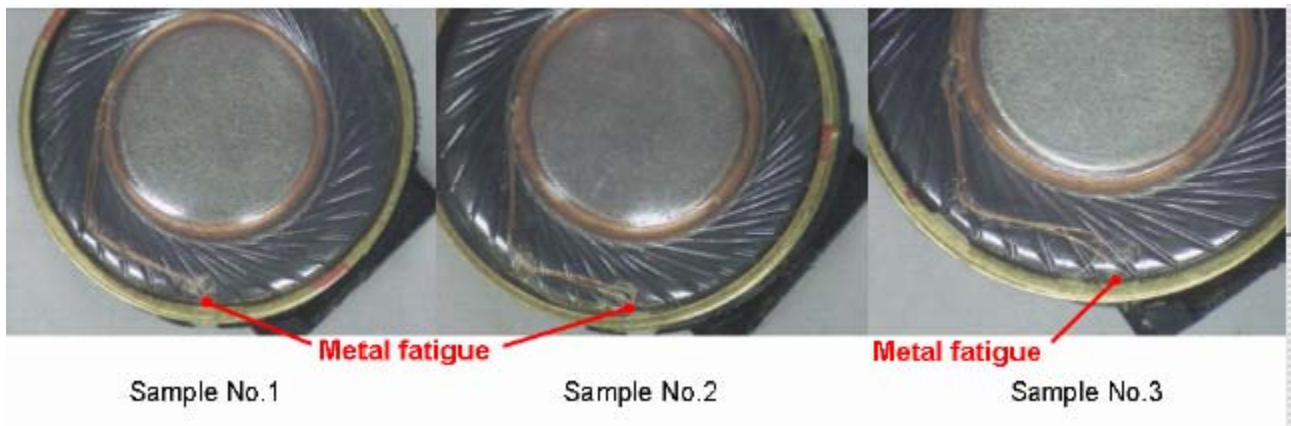
Fig. 1

During EZX (A768) MOL analysis no ring tone is highlighted as Top 2 issue in filed return of Apr and May, Most of these failures were found that Loudspeaker damaged with failure mode of open circuit. Supplier (Citizen) F/A report show root cause is the **failed forming shape** of the coil wire allows a strain concentration result in metal fatigue fracture. Figure 1 illustrate detailed failure mode.

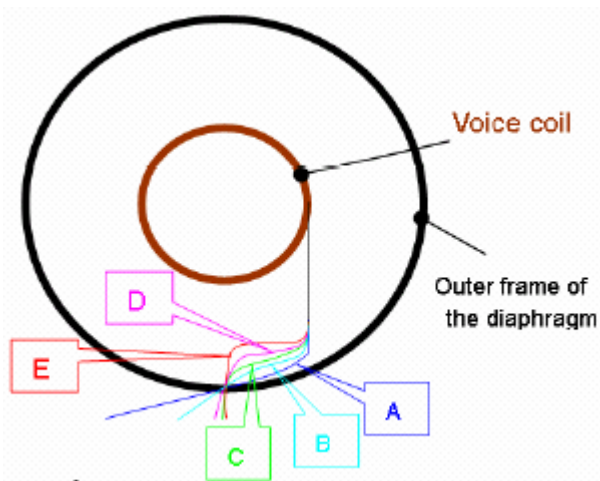
Fig. 3

The sample B will be accepted as boundary sample of the corrected forming shape.

2. Define the boundary sample of corrected coil forming shape as illustrated in Figure 3
