FIELD SERVICE BULLETIN

FSB Number: BJCCFSB2004-142
Author: Jianfeng Ma
Date: July 7, 2004
Total No. Of Pages: 3
Subject: **GSM Triplets – Navigation key falsing**
Model Affected: GSM V300, V303, V400, V500, V525, V600
Level of Repair: 1 & 2

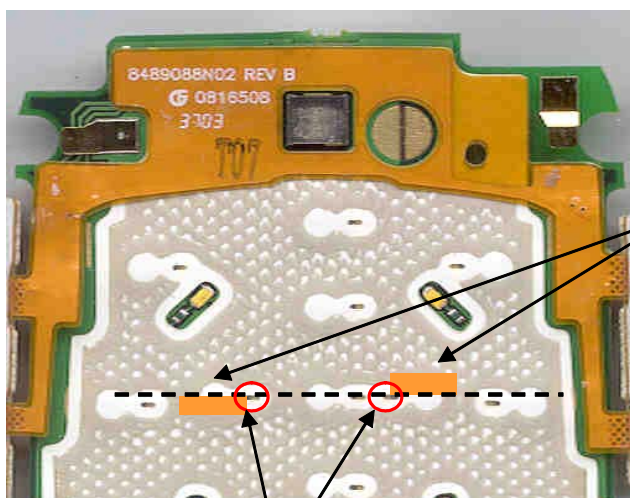
Diagram 1

Service is aware of an issue, identified in the 2nd 200 NPI Analysis of GSM Triplets, affecting the operation of left or right navigation key. Some units, returned with a customer complaint of “Main Keypad, No function/ hangs”, were found with left or right navigation key intermittent . Analysis has revealed the key falsing mainly occurs on Rev D PCB, caused by the two keys(left & right) with contact area smaller than others during keypad dome collapsing.

Short Term: Paste two Kapton tapes (3x5mm) beneath left & right navigation key plungers shown as Diagram 1. This short term solution had been implemented in factory from Jan 10,2004. (P/N changed from 4089226N01 to **4089226N02**, available since April, 2004.)

Paste 2 Kapton tapes
(3x5mm) on left and
right navigation key

- 1.The edge of tapes should be pasted in parallel with the broken line connecting the two air holes of left and right navigation key.
- 2.The top right corner/down left corner of the tapes should be near the air holes but NOT overlay the air holes.
