**FIELD SERVICE BULLETIN**

FSB Number: LVCCFSB2004-22  
Author: Tony Bryan  
Date: March 4<sup>th</sup>, 2004  
Total No. of Pages: 3  
Subject: **GSM Triplets Rev. A PCB - ESD Improvement**  
Model Affected: GSM V300, V303, V400 (SUGxxxxAA)  
GSM V500, V525 (SUGxxxxAA or SUGxxxxBA)  
Level of Repair: 2

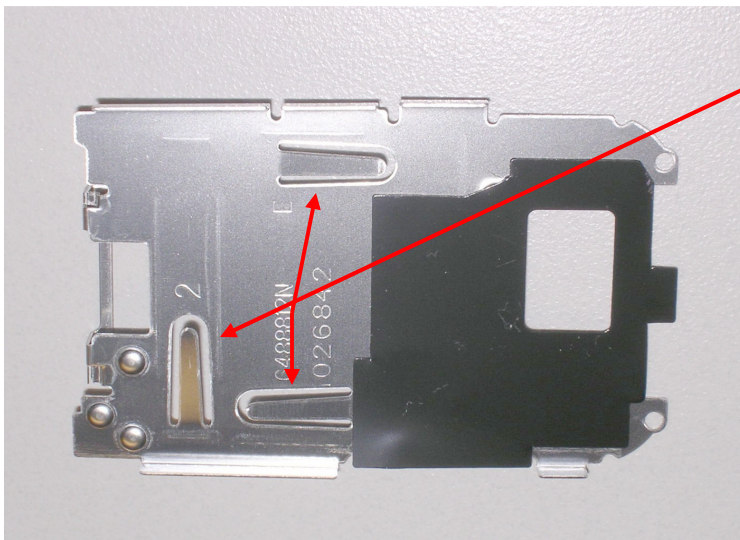
Diagram 1.0 New (0188940N02) Rev. E SIM Chassis Design

Service is aware of a field issue, identified during the 1<sup>st</sup> 200 NPI Analysis on the affected models listed above. Some units, returned with a customer complaint of "Invalid Battery", were found to exhibit a lower than normal resistance on the OWB Line to the Neptune IC. Analysis revealed the root cause of this failure to be damage to the Neptune IC induced by ESD. Product Development identified, prior to launch, that all Triplets Rev. A PCB's had a high susceptibility ESD related failure due to insufficient grounding of the SIM Chassis. A short-term corrective action was implemented, on all shipping product, adding a conductive 1.5mm pad to the back of the SIM Chassis to effectively ground the chassis. Unfortunately, after time in the field, the conductive pad can compress to the point where it no longer makes contact with the PCB Shielding thus leaving the phone susceptible to ESD related failure.

**Special Note:**  
New Design with Three Metal Fingers to GND Chassis

A re-design of the metal SIM Chassis (0188940N01) has been implemented in production as of 1/26/2004. The new (0188940N02) Rev. E design includes three metal fingers that extend into the housing and make contact with the PCB Shielding adequately grounding the SIM Chassis. For additional ESD Protection, a diode was added to the Rev. D PCB release.

Diagram 1.0 below shows a sample of the (0188940N02) Rev. E SIM Chassis with the improved design.

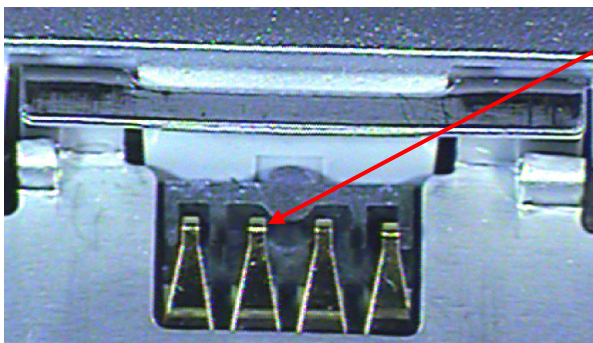
Diagram 3.0 Battery Contacts

1. Power up the unit through the CE Connector with the battery removed
2. Probe the voltage on the OWB Line at M1700 (pin 3). The Voltage should be 2.7 VDC and will measure significantly less (approx 0.7 VDC) on failures with a damaged Neptune IC. See Diagram 2.0 below.

**OWB Line:**  
M1700 Pin 3 = 2.7VDC

- a. If the voltage on the OWB line is correct, then the fault is not related to this issue and normal troubleshooting techniques should be applied to the battery and the unit to determine the failed part.
3. Once a damaged Neptune IC has been confirmed the failed board should be swapped.
