## FIELD SERVICE BULLETIN

FSB Number: LVCCFSB2004-62  
Author: Tony Bryan  
Date: March 24<sup>th</sup>, 2004 (rwo Aus-NZ update June 2, 2004)  
Total No. of Pages: 4  
Subject: **GSM Triplets – Keypad Activation with Flip Closed**  
Model Affected: GSM V300, V303, V400, V500, V525, V600  
Level of Repair: 2

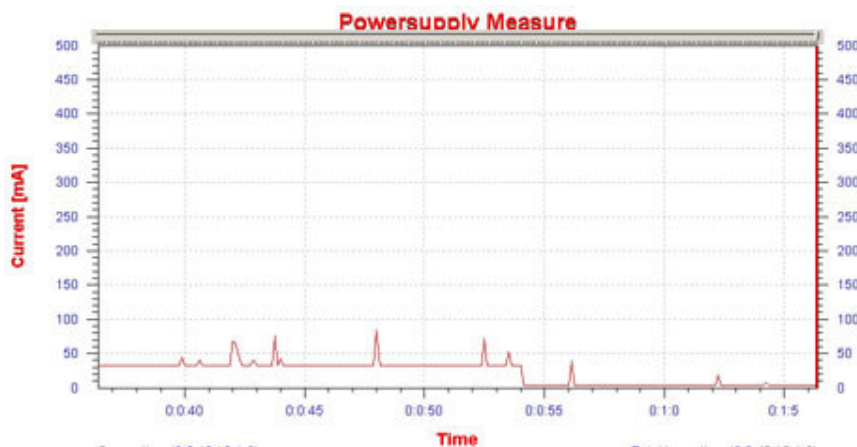
1. Verify the customer complaint is related to this issue by following the procedure below:
  - a. Power-up the unit using a battery eliminator hooked to a power supply, able to measure current, with voltage set to 4.0 VDC and current limited to 1.0 Amp. **Note 1:** Do not use connect any cable to the CE Connector, as this will not allow the phone to enter sleepmode.
  - b. Close the flip and apply a slight pressure to the area directly below the CLI Display, using your thumb, to simulating the use of a holster.
  - c. Allow the unit to enter sleepmode while measuring the current. The sleepmode current should read less then 1mA on a good unit and will read approximately 30mA on a failure. See diagram 1.0(a) and 1.0(b) below for comparison of “Good” versus “Bad” current measurements.

Diagram 1.0(a) – Good Sleep Mode Current

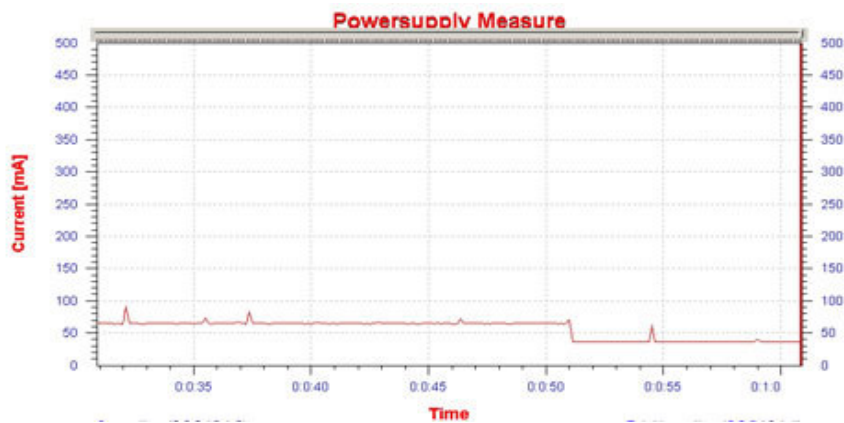
Service is aware of an issue, highlighted by the field, where buttons on the main keypad are being activated by the flip, when closed. This issue was initially seen on V500/V525 customer return units with customer complaints of “Short Battery Life” or “No Side-Key Function”. After further investigation it was determined some of the (3888844N01) Shin-Etsu keypads used on V500/V525, as well as V303 and V400, had an issue with the height of the “Menu” key being out of spec. The variation in height of this key, combined with some variance that is present in the position of the main display lens, would cause the “Menu” key to be activated when the flip was closed. With this key activated, the phone will not completely go into sleepmode causing a 30mA current draw in sleepmode and resulting in short battery life.

Diagram 1.0(b) – Bad Sleepmode Current

2. If the customer complaint is related to this issue then, per the normal Service Procedure, reflash the unit with the latest approved software for your region equal or later than Triplets\_G\_0B.09.38R.
  - a. If the customer complaint is not related to this issue then, follow normal troubleshooting techniques per the customer complaint.
3. Completely retest the customer's unit and battery to verify the repair has been completed successfully and the phone no longer exhibits any current related failure symptoms.
  - a. If the phone still exhibits some failure symptoms after reflash then, follow normal troubleshooting techniques per the customer complaint.

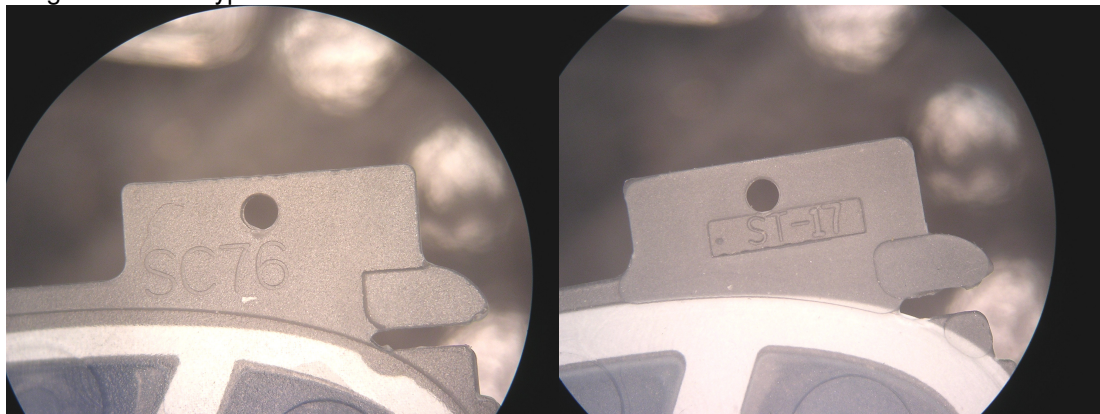
Diagram 3.0 – Keypad Vendor Identification

SC = Sinco

ST = Shin-Etsu

1. Verify if the units were built with Shin-Etsu keypads. See diagram 3.0 below.
2. Replace the keypad, using a Sinco Keypad if possible, and retest.
