FIELD SERVICE BULLETIN

FSB Number: LVCCFSB2003-99 (Rev. A)
Author: Tony Bryan
Date: October 17, 2003
Total No. of Pages: 4
Subject: **Triplets Display Flex Connector**
Model Affected: V300, V303, V400, V500, V525
Level of Repair: 2

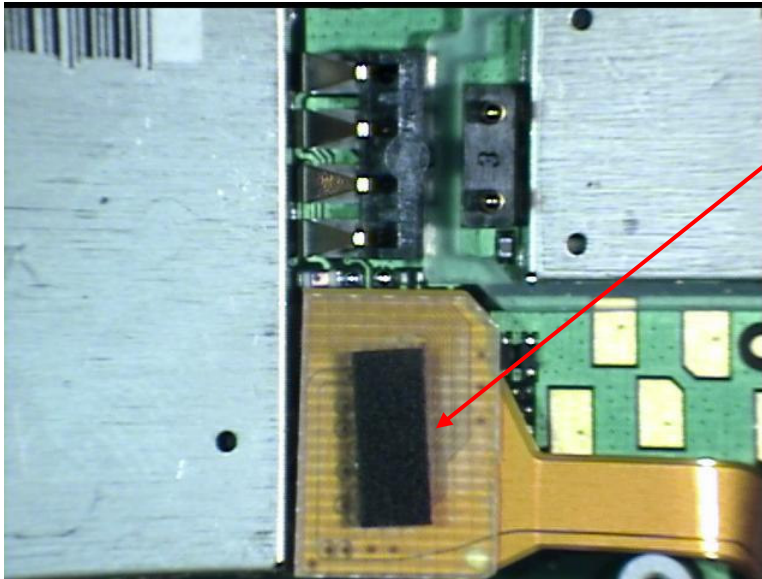
Diagram 1.0 Poron Pad Placement

Service is aware of an issue with the Display Flex Connector on GSM Triplets Products. Various electrical failures, seen in ALT Testing after Drop Test, have been linked to a connectivity issue between the Display Assembly and the PCB at the J1300 connector. Failures are seen when the Display Flex becomes partially or completely separated from the J1300 connector.

Special Note:
Poron Pad should be placed centered across the top of the Display Flex at the connector

Manufacturing implemented the placement of a Poron Pad (7589188N01) directly on top and centered on the Display Flex at the connector. The added Poron Pad increases the pressure applied to the connector when assembled and reduces the chances of the Display Flex separating from the J1300 connector in the field. Diagram 1.0 below shows placement of the Poron Pad.

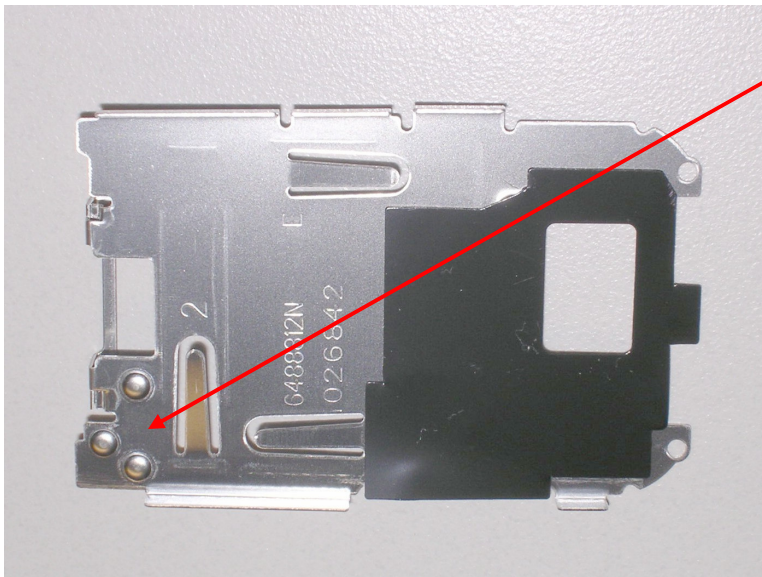
Diagram 2.0 New Rev. E SIM Chassis Design

Special Note:
New Design with Three Dented Areas to apply pressure to connector

A re-design of the original metal SIM Chassis (0188940N01) has been implemented in production as of 1/26/2004. The new (0188940N02) Rev. E design includes three dented areas that extend further into the housing to add the appropriate amount of pressure to the connector to eliminate this type of failure. Placement of the Poron Pad is not compatible with the new (0188940N02) Rev. E SIM Chassis.

Diagram 2.0 below shows a sample of the new (0188940N02) Rev. E SIM Chassis with the improved design.
