FIELD SERVICE BULLETIN

FSB Number: LVCCFSB2004-120
Author: Tony Bryan
Date: July 16, 2004
Total No. of Pages: 4
Subject: **GSM Triplets - Flip Detect Switch**
Model Affected: GSM V300, V303, V400, V500, V525, V600
Level of Repair: 2

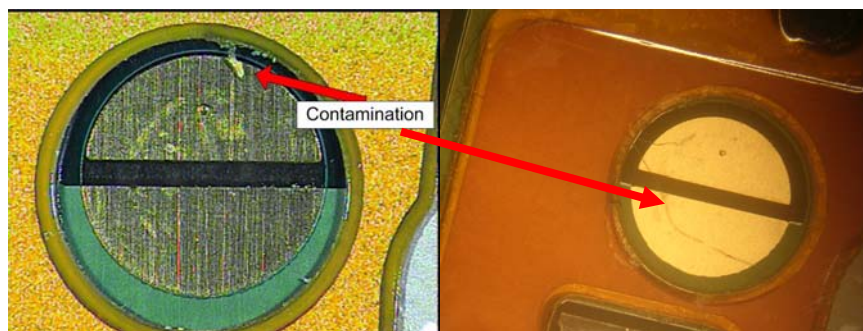
Foreign Material: The main source of the foreign material was the side-key flex, where some excess material would extend over the cutout for the flip switch contacts (S550). See diagram 1 below.

Diagram 1.0 - Contamination from Side-Key Flex

Foreign Material: Supplier Process Improvements including the use of side-key flex with a non-fiber based peelable paper. Factory Process Improvements including increased inspection under magnification for foreign material.

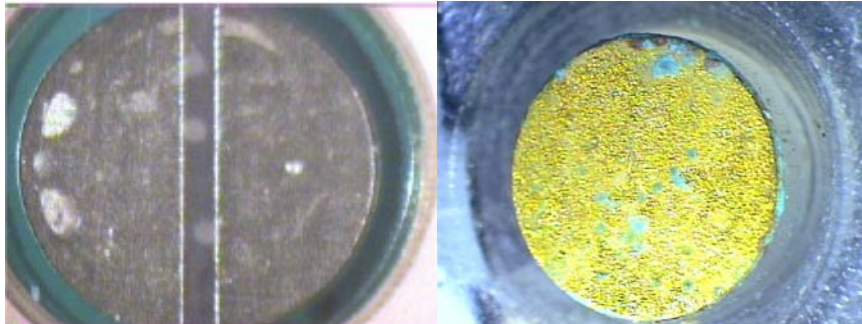
Corrosion: The main source of the corrosion was isolated to the 3888844N01 keypad supplied by Sinco. The gold pucks sourced by Sinco were sub-standard in quality and had a high susceptibility to corrosion when exposed to environmental conditions in the field. See diagram 2 below. In addition, the Sinco keypads had an additional air port which directed air inward towards the contact increasing the opportunity for field failure. The 3888844N01 keypad is used on V303, V400, V500 and V525.

Diagram 2.0 - Corrosion caused by environments (3888844N01 Sinco Keypad)

Corrosion: The 3888844N01 Sinco keypad was redesigned to remove the extra air vent, which was leading to a higher susceptibility to foreign material, completed 12/31/2003. Sinco began sourcing higher quality gold pucks from Shin-Etsu on February 22, 2004. Sinco obtained and crossed over to new supplier, with improved quality, for the gold pucks as of March 31, 2004. Motorola changed the specification for the keypad where an aggressive salt spray requirement was added.

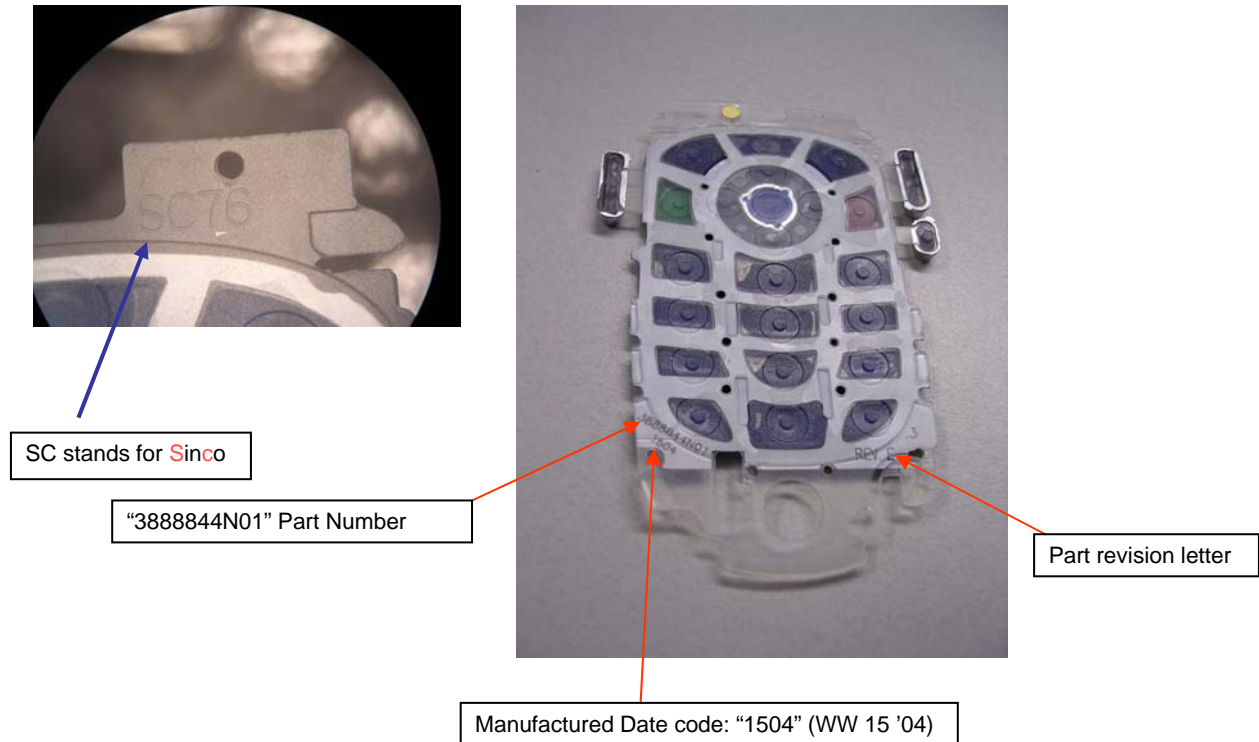
V500 Keypad from SINCO

Note: When servicing any GSM Triplet customer return, Service should inspect and replace **all** 3888844N01 Sinco keypads, built prior to WW12 2004, to prevent future reliability issues due to corrosion.

Service Inventories of the 3888844N01 keypads should be purged to remove Sinco keypads, built prior to WW12 2004.
