**FIELD SERVICE BULLETIN**

FSB Number: LVCCFSB2004-50 (Rev A)  
Author: Rajesh Verma/Tony Bryan  
Date: March 12, 2004                      rwo\_Aus-NZupdate\_June2,2004  
Total No. of Pages: 4  
Subject: **GSM Triplets - Neptune IC (Power Down in Sleep Mode)**  
Model Affected: GSM V300, V303, V400, V500, V525, V600  
Level of Repair: 3

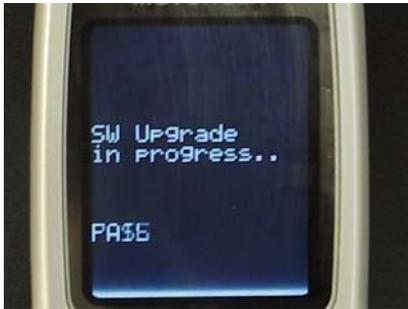
8. Double Click on the “Motorola P2K” icon shown in the Device section of the window to put the unit into flash mode.
9. Click on “Flash” to start the test sequence. Test averages 20 seconds to complete.
10. When test is completed, the phone’s display will indicate either PASS or FAIL. See examples below.

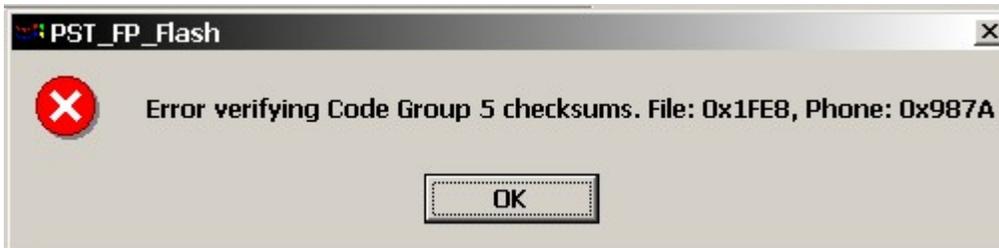
**Note 1:** This test may not be compatible with some older software versions due to the ROM boot loader. If this is the case you will get the following Error Message when attempting to run the Automated Screening Procedure.

If the Automated Screen is not compatible due to boot loader or test result is inconclusive, then perform the Manual Screening Procedure detailed below
