FIELD SERVICE BULLETIN

FSB Number: LVCCFSB2004-6
Author: Tony Bryan
Date: January 20th, 2004
Total No. of Pages: 4
Subject: **GSM Triplets – Integrated Camera Module**
Model Affected: V300, V400, V500, V525
Level of Repair: 3

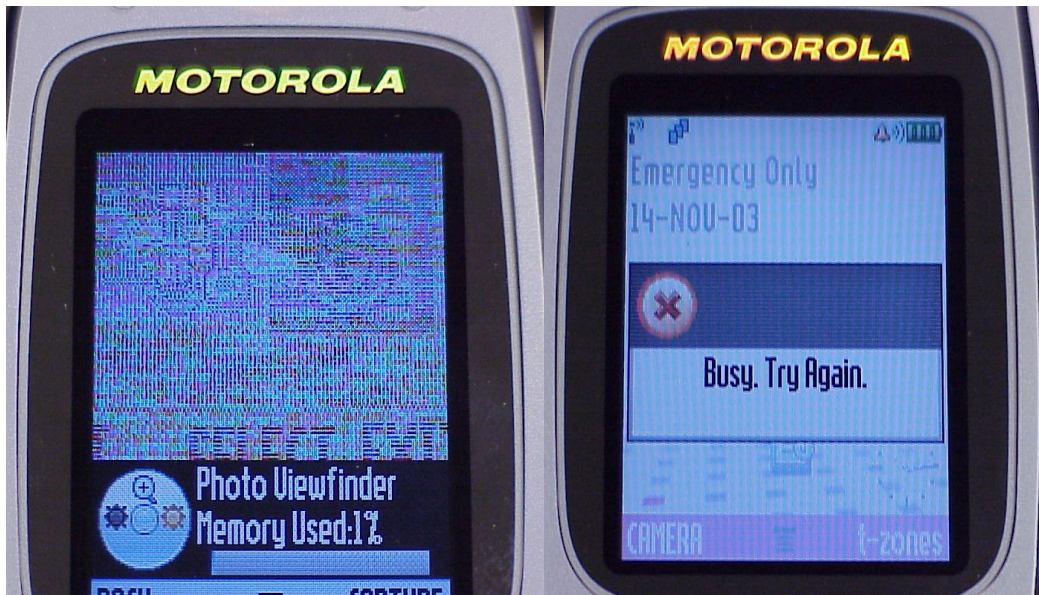
Service is aware of an issue identified during the 1st 200 NPI Analysis on V300, V400 and V500/V525. Some units, returned with a customer complaint of “Camera–No Operation” or “Error Display-Shows Busy”, were found to have cracked solder joints on the integrated camera module between the imager and flex. The images below show examples of the failure symptoms, visible to the user when attempting to activate the camera, that are a result of these broken solder connections.

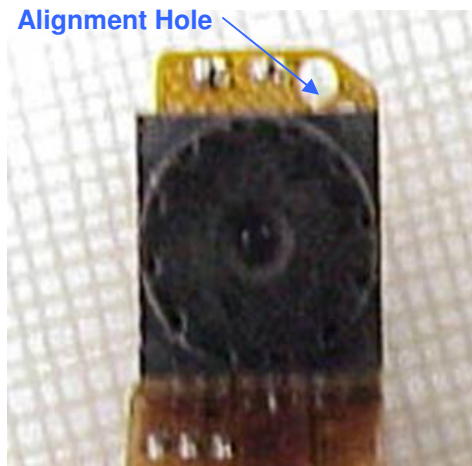
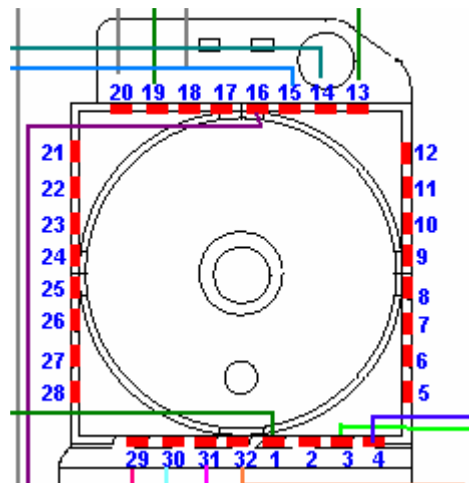
The root cause of the defect is stress to the solder joints of the imager, at both the bend and alignments sides, during the assembly of the camera module into the flip. Pins 13, 14, and 15 are the most susceptible to opens. See images below.

There have been several corrective actions taken by both the supplier and in the factory to increase the robustness of the camera and reduce the amount of stress applied to the camera during the assembly process.

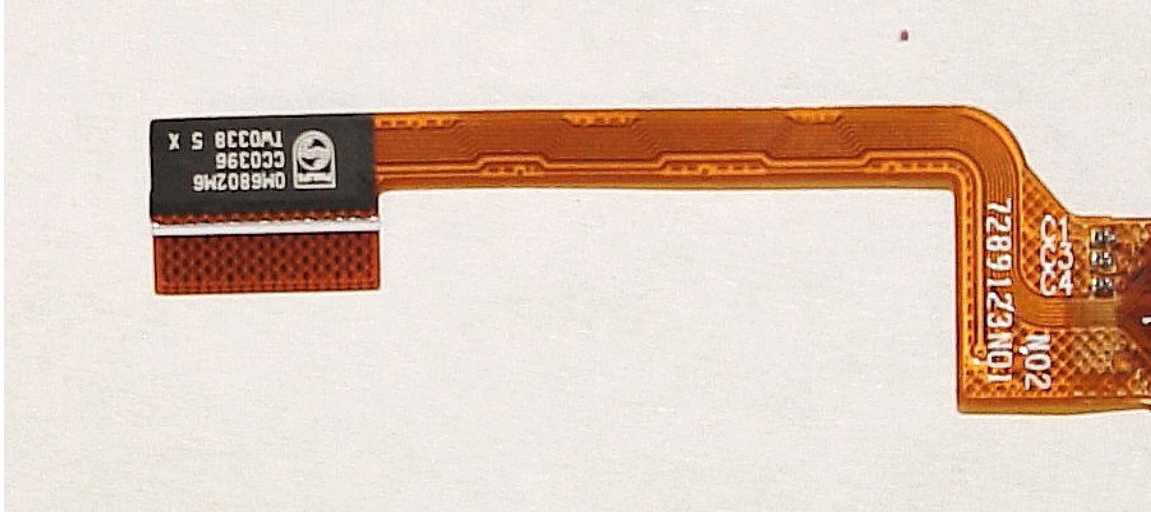
PHILLIPS 8489420N02 FLEX

This issue affects the 7289123N01, N02, N06, and N07 Phillips Camera Modules that were built with the original Phillips 8489420N02 Flex.

Quarantine all existing stock of 7289123N01, N02, N06, and N07 Phillips Camera Modules. Affected modules should be sorted, using the images shown above, to identify modules built with the original Phillips 8489420N02 Flex. All modules confirmed to have been built with the Phillips 8489420N02 Flex should be removed from inventory.

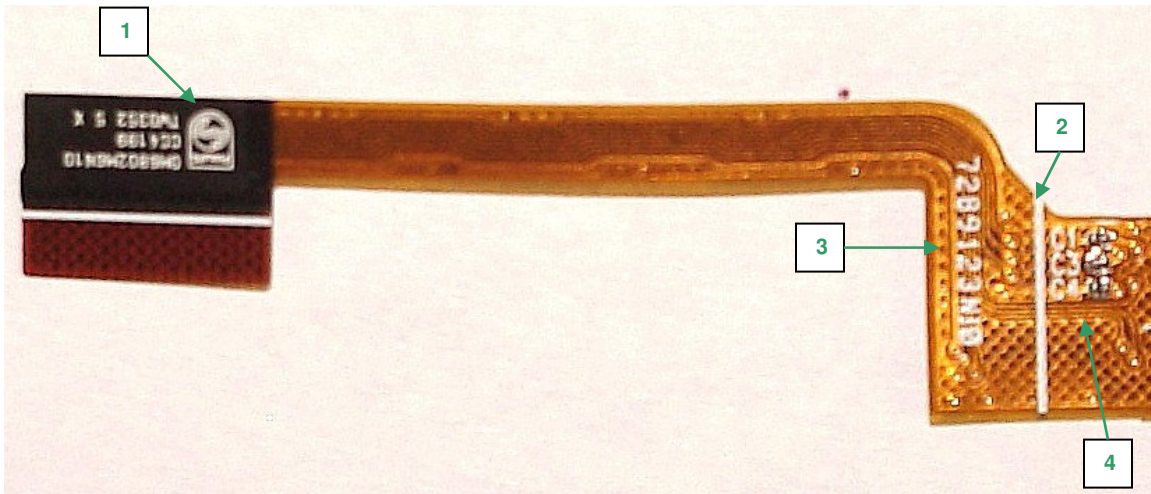
PHILLIPS 8489420N03 FLEX

1. Phillips has changed the design of the flex from the original 8489420N02 Part to a new 8489420N03 Part with some of the surface layer traces re-routed to the bottom layer to increase the overall flexibility of the flex and reduce the amount of stress applied to the solder connections during the assembly process.
2. UV Glue will be added, by the factory, to the alignment side of the imager on all remaining Phillips Cameras built with the original N02 Flex. The UV Glue will add additional support to the affected solder connections.
3. Phillips will optimize the plating and hot bar processes to improve the overall robustness of their design.
4. Steps will be taken to optimize the assembly process of the Camera Module in the Flip Assembly to limit stress put on the imager's solder connections.

1. Phillips Marking at connector
2. White line above imager part number and below components.
3. Part number printed on the flex will read 7289123N10 or 8489420N03
4. Smaller number of traces visible on surface layer

1. Perform testing to confirm the customer’s complaint is related to the issue described above.
 - a. If the unit is not related to this issue, then proceed with normal troubleshooting techniques as per the customer complaint.
2. Disassemble the unit and flip assembly to replace the camera module, with a Phillips camera built with the improved 8489420N03 flex. See Images Above.
