**FIELD SERVICE BULLETIN**

FSB Number: LVCCFSB2005-13  
Author: Tony Bryan  
Date: February 8, 2005  
Total No. of Pages: 3  
Subject: GSM V500 (Rev J1 PCB) –Incorrectly Phased in HZ Factory  
Phone Models: GSM V500 SUG3052HA and SUG3054HA  
Level of Repair: 3

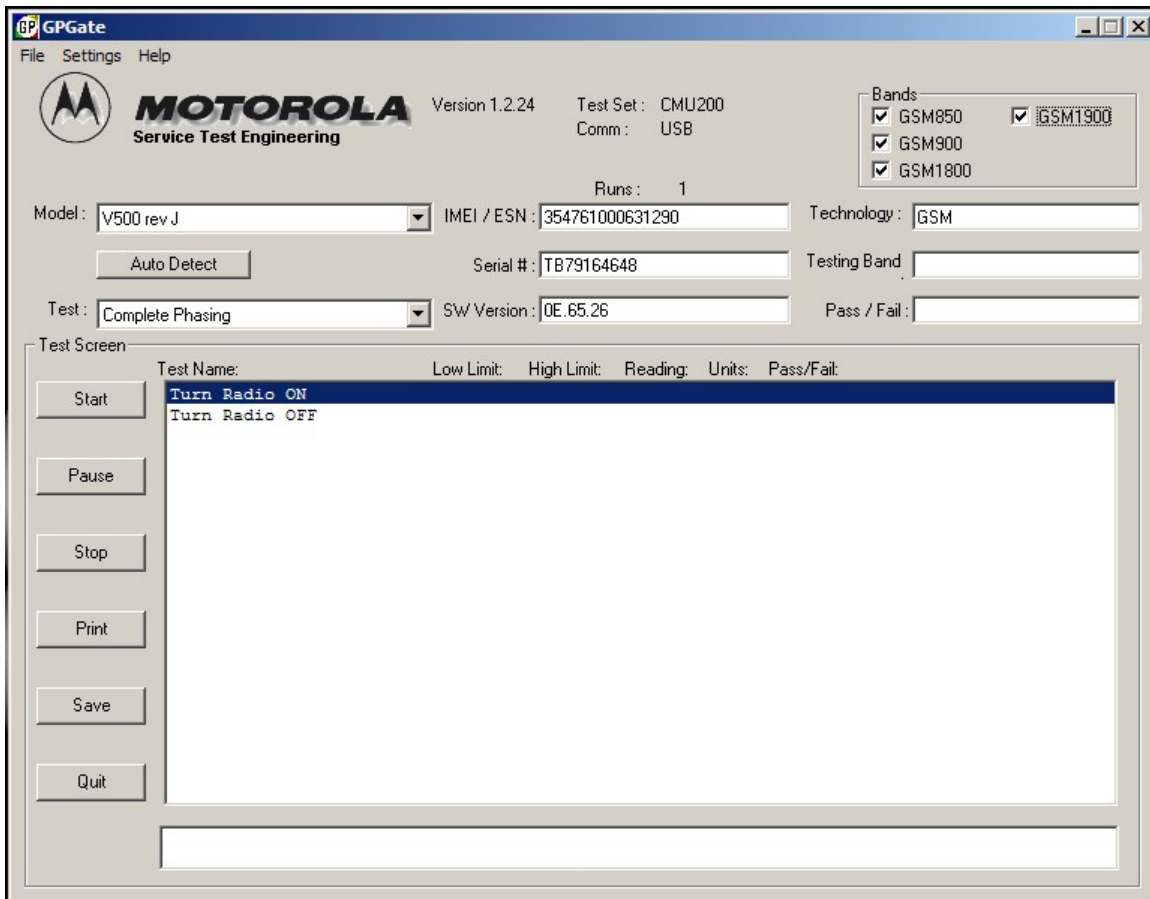
When servicing affected models of GSM V500 customer returns, that were manufactured in HangZhou China with letter G on the serial number and date code from RT\* (Week 44 Thursday) through Tm\* (Week 46 Monday), regardless of customer complaint, then:

5. Unit should then be marked with a green dot on the upper left corner of the factory label pictured above.
6. Follow normal testing and troubleshooting techniques to repair the unit per the customer complaint.
