**FIELD SERVICE BULLETIN**

FSB Number: LVCCFSB2005-52  
Author: Tony Bryan  
Date: March 21, 2005  
Total No. of Pages: 3  
Subject: GSM Intermittent Alert – Pogo-Pin Contact Force  
Phone Models: GSM V547, V551, V555, E550/V535, V545/V550, V300,  
V303, V400, V505, V500/V525  
Level of Repair: 2

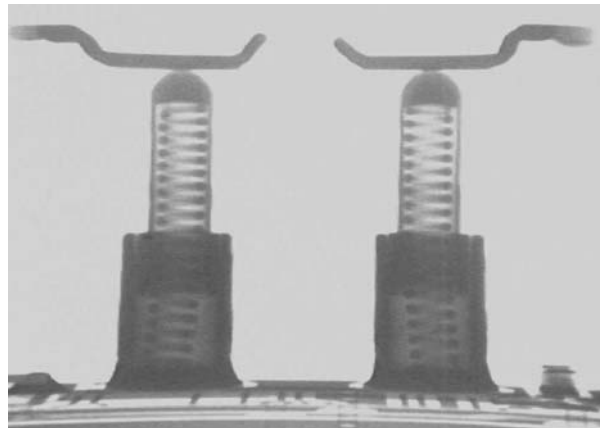
Service is aware of an issue, identified in the NPI Analysis of the GSM San2rini and Triplets Refresh products. Some units, returned with customer complaints of “Alert– Ringtone No” and other related complaints, were found to be caused by poor mechanical connection between the alert pogo-pins and the contacts of the polyphonic speaker. This failure mode is extremely intermittent and can be recovered and induced by flexing the rear housing in the area of the alert. The root cause has been determined to be the lack of adequate spring force between the pogo pins and the alert contacts, at the actual measured working height of the pin. Pogo pin force vs. deflection measurements show that the tested units have at least 1 pin that has low contact force.

A re-design of the 3988194N01 pogo-pins was completed to increase the specification for contact force at the nominal pin working height by 30g (+/-10g).

New Pogo-Pin Part Number: 3988427Z01

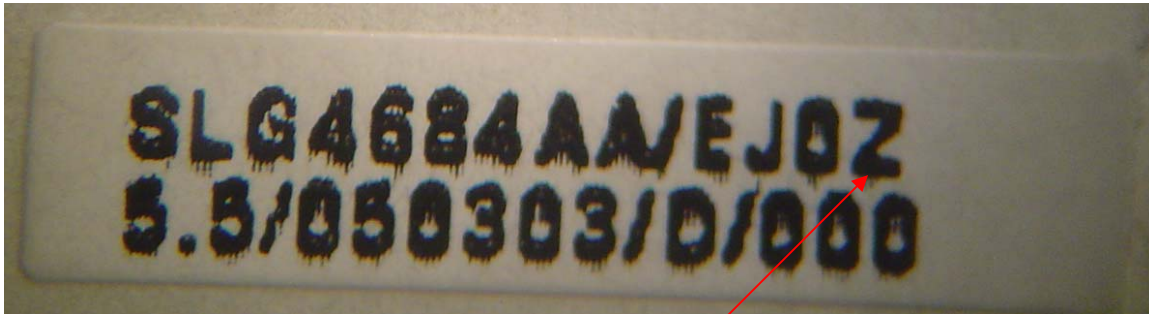
The factory cross-over to the new 3988427Z01 pogo-pin design was started, for the affected products listed above, on 3/14/2005. To assist in identification during the cross-over, the factories will add a marking to the current PCBA Label to indicate which pogo-pin was placed. See image below.

For all the PCBA soldered with new pogo pin 3988427Z01, a letter "Z" must be added on the label at the end of line 1,

1. Disassemble the housing and remove the PCBA.
2. Inspect the Factory PCBA Label to determine which pogo-pin has been placed. See image above.
  - a. If the Factory PCBA Label indicates the new 3988427Z01 pogo-pin has already been placed, then proceed with normal troubleshooting techniques per the customer complaint.
3. Replace the 3988194N01 pogo-pin (J1260) with the new 3988427Z01 pogo-pin design.
4. Reassemble the unit and completely retest to ensure unit has been properly repaired.
  - a. If the unit still exhibits failure symptoms, then proceed with normal troubleshooting techniques per the customer complaint.
