FIELD SERVICE BULLETIN

FSB Number: LVCCFSB2005-7
Author: Tony Bryan
Date: January 10, 2005
Total No. of Pages: 3
Subject: Ramless TMR Display (7287946Y01) – White Main Display
Phone Models: GSM Triplets: V400, V500, V505, V525, and V400p
GSM Triplets Refresh: V550, V545
GSM San2rini: V547, V551
Level of Repair: 3

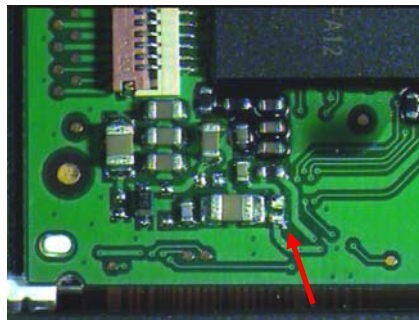
Service is aware of an issue, identified in recent pre-launch ALT Drop Testing of the Samsung Ramless TMR Display (7287946Y01). This issue was also confirmed on some field return units with customer complaints of “Intermittent White Main Display”. Failure occurs after a drop impact to the side of the flip while phone is in an active state. Under this circumstance it is possible for the tail of the display hinge flex to impact, and damage, a discrete (Zero Ohm) resistor on the display board. This missing resistor will result in a very intermittent white main display failure. See Fig. 1.0 Below.

Fig. 1.0 – Missing (Zero Ohm) Resistor

1. Confirm the customer complaint is related to this issue.
 - a. If the customer complaint is determined not to be related to this issue, then follow normal troubleshooting techniques per the customer complaint.
2. Repair the defect by one of the following methods.
 - a. Replacing the missing resistor utilizing a scrap display, if available.
 - b. Insert a solder short between the two pads where the resistor should be. (See Fig. 3.0 Below)
 - c. Replace the display
3. Reassemble, placing Kapton Tape over affected area, and completely retest to confirm unit is properly repaired.

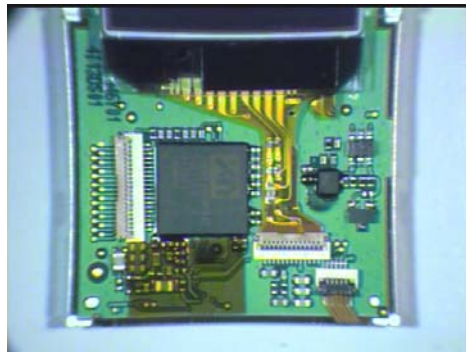
Fig. 2.0 - Kapton Tape (1190142N01) Dimensions: 13.0mm x 8.5mm, 0.08mm thick

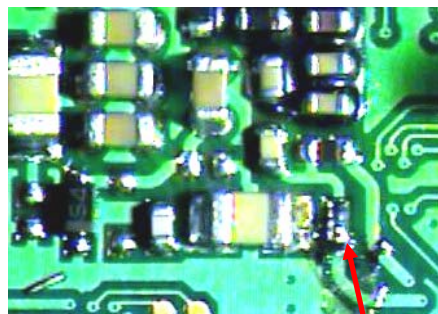
Fig. 3.0 –Solder short across pads
