**Service Bulletin RU_SB024**

Author: Alexander Gaiderov, Technical Support
Date: 2004-02-03
Subject: GSM Triplets – Antenna Issue
Rating: Level 3 Authorized

Products: V300, V500, V525

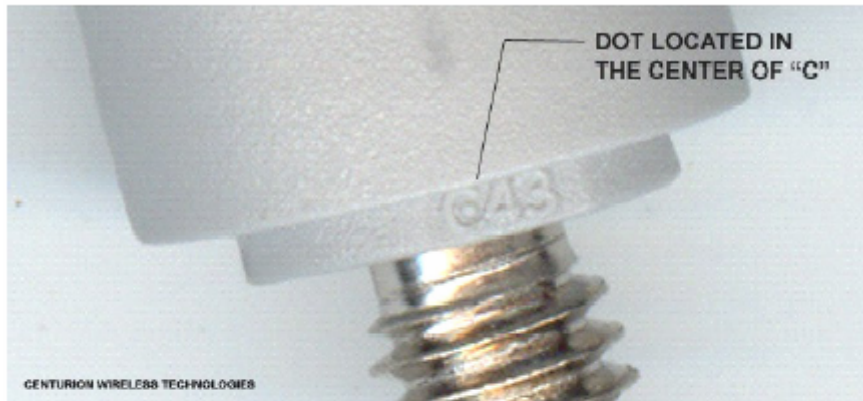
**IDENTIFICATION METHOD FOR ALL V300 & V500
ANTENNAS MANUFACTURED STARTING NOVEMBER 20th.**

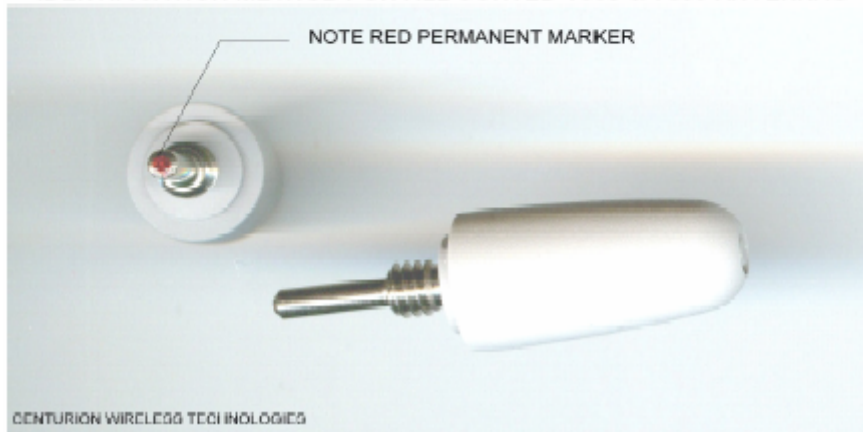
Figure 1.0 – Identification of New and Screened Parts

Solution: Automated fixtures have been implemented by Centurion to replace manual bending of the tang. A screening process, which includes a screening fixture to over-torque antenna, has been defined and implemented by the Quality team at Centurion in place to both fix production and identify means for sorting existing in house material. Centurion has replaced inventories with antennas processed after Nov.20th when all process improvements and screening was in place. New parts, built after Nov.20th, are uniquely marked with a "Dot" inside the "C" at base of plastic. Screened parts will be marked with a "Red Dot" at the metal tip. See Figure 1.0 below.

IDENTIFICATION METHOD FOR ALL SORTED V300 & V500 ANTENNAS

Please quarantine all existing stock of the 8588912N01 V300 and 8589122N01 V500/V525 antenna and replace with new parts built after November 20, 2003.

See Figure 1.0 for identification markings on new parts.
