**Author:** Henrik Sondell, Technical Support  
**Date:** 2004-03-09  
**Subject:** GSM Triplets Rev. A PCB - ESD Improvement  
**Rating:** Level 1&2 Authorized

**Products:** V300 (SUGxxxxAA)  
V500, V525, (SUGxxxxAA or SUGxxxxBA)

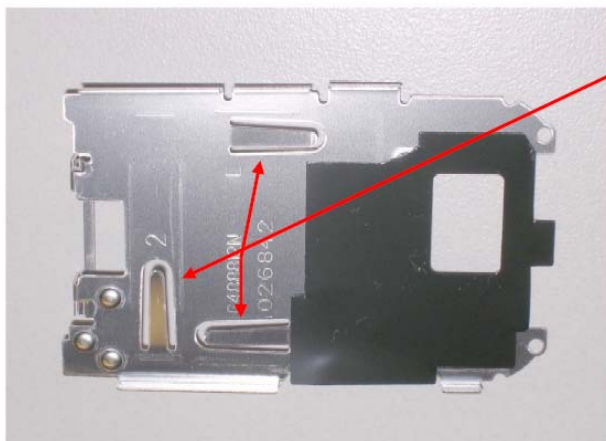
**Diagram 1.0**

**Problem:** Service is aware of a field issue, identified during the 1st 200 NPI Analysis on the affected models listed above. Some units, returned with a customer complaint of "Invalid Battery", were found to exhibit a lower than normal resistance on the OWB Line to the Neptune IC. Analysis revealed the root cause of this failure to be damage to the Neptune IC induced by ESD. Product Development identified, prior to launch, that all Triplets Rev. A PCB's had a high susceptibility ESD related failure due to insufficient grounding of the SIM Chassis. A short-term corrective action was implemented, on all shipping product, adding a conductive 1.5mm pad to the back of the SIM Chassis to effectively ground the chassis. Unfortunately, after time in the field, the conductive pad can compress to the point where it no longer makes contact with the PCB Shielding thus leaving the phone susceptible to ESD related failure.

**Special Note:**  
New Design with Three Metal Fingers to GND Chassis

Diagram 1.0 New (0188940N02) Rev. E SIM Chassis Design

**Solution:** A re-design of the metal SIM Chassis (0188940N01) has been implemented in production as of 1/26/2004. The new (0188940N02) Rev. E design includes three metal fingers that extend into the housing and make contact with the PCB Shielding adequately grounding the SIM Chassis. For additional ESD Protection, a diode was added to the Rev. D PCB release.  
**Note: Also contained in the new Rev. E design is an improvement for connectivity of the Flip Assembly to PCB connector. See Service Bulletin NB\_SB006.**  
Diagram 1.0 below shows a sample of the (0188940N02) Rev. E SIM Chassis with the improved design.

1. Disassemble the unit
2. Remove the existing Poron Pad from the Flip Assembly Connector  
See *NB\_SB006*.
3. Replace the existing metal SIM Chassis with the improved Rev. E Design

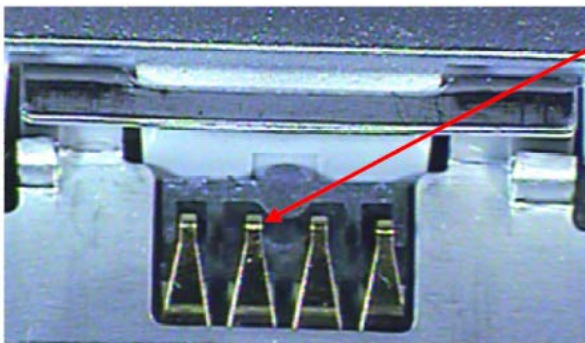
**Diagram 2.0**

1. Power up the unit through the CE Connector with the battery removed
  2. Probe the voltage on the OWB Line at M1700 (pin 3). The Voltage should be 2.7 VDC and will measure significantly less (approx 0.7 VDC) on failures with a damaged Neptune IC. See Diagram 2.0 below.

**OWB Line:**  
M1700 Pin 3 = 2.7VDC

- a. If the voltage on the OWB line is correct, then the fault is not related to this issue and normal troubleshooting techniques should be applied to the battery and the unit to determine the failed part.

3. Once a damaged Neptune IC has been confirmed the failed board should be swapped.
