FIELD SERVICE BULLETIN

FSB Number: LVCCFSB2005-36
Author: Tom Johnson
Date: February 25, 2005
Total No. of Pages: 3
Subject: **CDMA V810, E310, V510 Serial Communication**
Models Affected: CDMA V810, E310, V510
Level of Repair: 3, 4

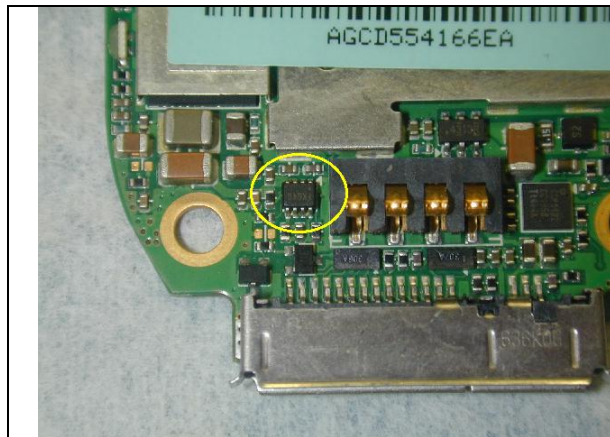
Service is aware of an issue where the CDMA V810, CDMA V510, and CDMA E310 may not be able to communicate to devices via an un-powered serial cable and in addition, some accessories may exhibit no audio conditions. This condition is the result of an incorrect IC Switch placed by the manufacturing facility. Units with this incorrect part will have B+ voltage applied to pin 7 of the CE Bus Connector at all times. Note that the use of a powered serial cable, Junior Board, or USB cable will mask the issue.

Figure 1. E310 PCB. IC303 is highlighted.

1. With the phone powered off and a charged battery installed:
 - a. Measure the DC voltage on Pin 7 of the CE Connector.
 - b. A correct part will indicate 0 DC Volts on Pin 7 of the CE Connector.
 - c. An incorrect part will indicate the battery voltage on Pin 7 of the CE Connector.
 - d. If battery voltage is present on Pin 7 of the CE Connector, Replace IC303 with the correct part number 51-46101-01.
 - e. Figures 1 and 2 indicate the IC303 placement on the respective models.
 - f. Figure 3 shows the correct part marking HXxxx.
 - g. Figure 4 shows the wrong part marking FKxxx.

Ensure IC303, ODM part number 51-46101-01 is available for service.

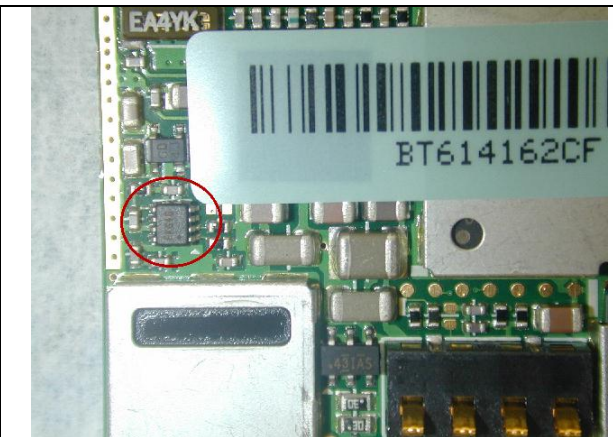
Figure 2. V510 and V810. IC303 is highlighted.

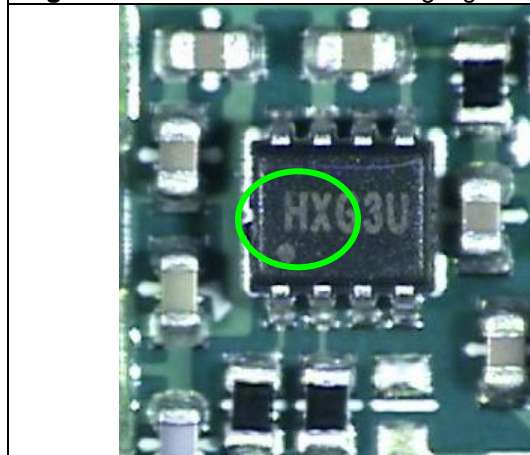
Figure 3. Correct Part with HX Suffix

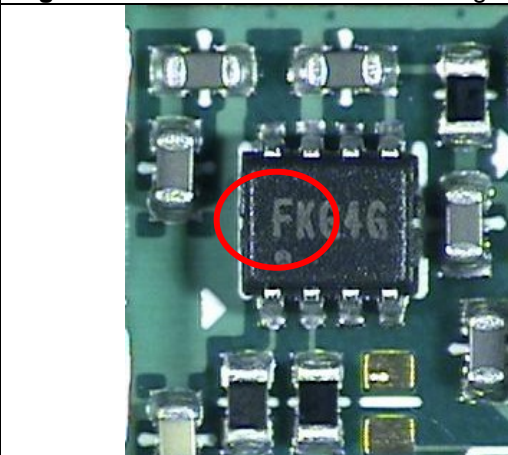
Figure 4. Wrong Part with FK Suffix
