Service Bulletin RU_SB013

Author:	Alexander Gaiderov, Technical Support
Date:	2003-12-29
Subject:	Triplets Display Flex Connector
Rating:	Level 1 & 2 Authorized

Products: V300, V500, V525

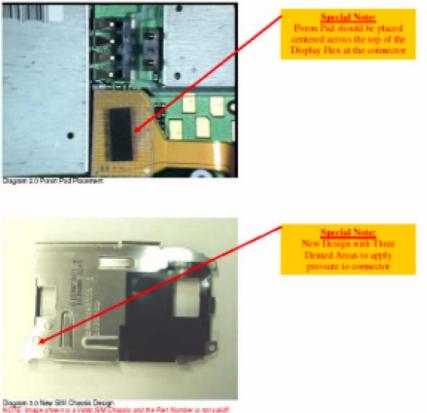
by Hardware Development and will be implemented in manufacturing as soon as material with the new design is available. The new design will include three dented areas that extend further into the housing to add the appropriate amount of pressure to the connector to eliminate this type of failure. Diagram 3.0 below shows a sample of the SIM Chassis with the improved design.

WOTE: Image about is a Vetto SIMiChauda and the Part Number is no

Solution: SHORT-TERM: Manufacturing has implemented the placement of a Poron Pad (7589188N01) directly on top and centered on the Display Flex at the connector. The added Poron Pad increases the pressure applied to the connector when assembled and reduces the chances of the Display Flex separating from the J1300 connector in the field. Please see Diagram 2.0 below for proper placement of the Poron Pad. LONG-TERM: A re-design of the original metal SIM Chassis (0188940N01) has been requested
