## Service Bulletin RU\_SB037

**Author:** Alexander Gaiderov, Technical Support  
**Date:** 2004-03-23  
**Subject:** GSM Triplets – Keypad Activation with Flip Closed  
**Rating:** Level 2 Authorized

**Products:** V300, V400, V500, V525, V600

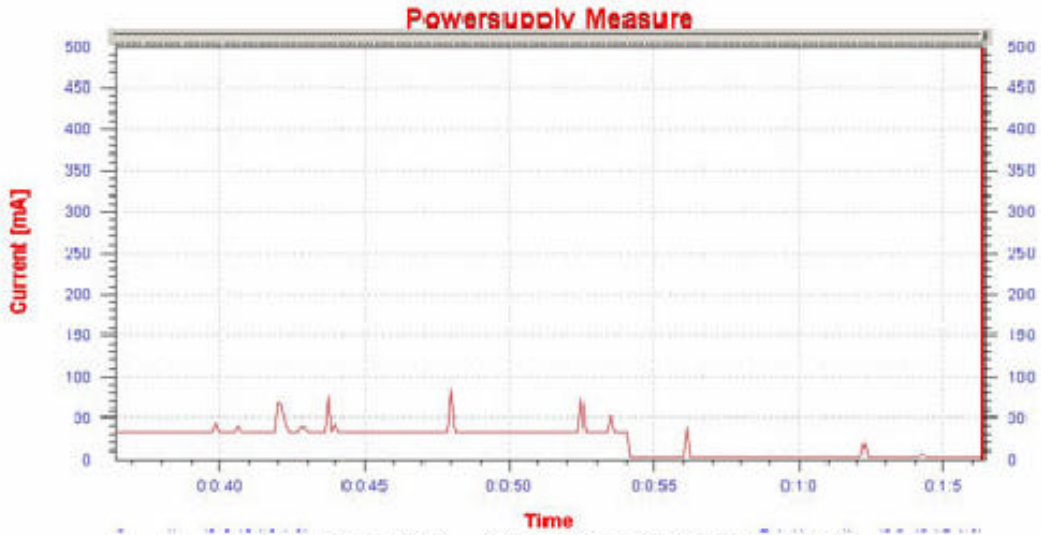
Diagram 1.0(a) – Good Sleep Mode Current

b. Close the flip and apply a slight pressure to the area directly below the CLI Display, using your thumb, to simulating the use of a holster.  
c. Allow the unit to enter sleepmode while measuring the current. The sleepmode current should read less then 1mA on a good unit and will read approximately 30mA on a failure. See diagram 1.0(a) and 1.0(b) below for

comparison of “Good” versus “Bad” current measurements.

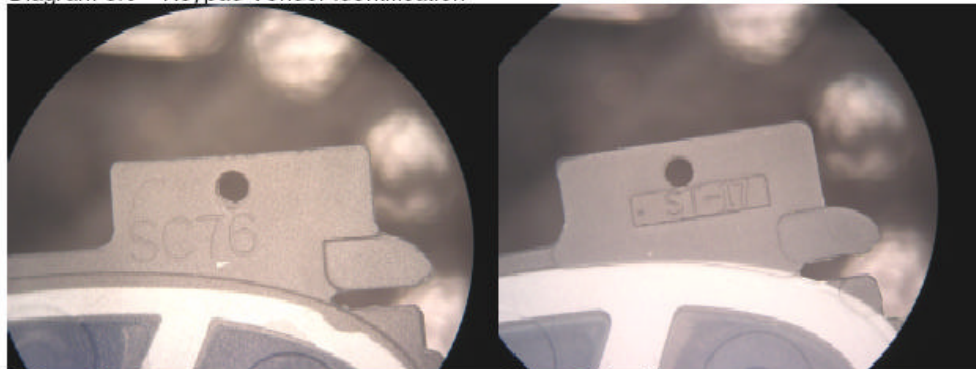
Diagram 3.0 – Keypad Vendor Identification

SC = Sinco

ST = Shin-Etsu

1. Verify if the units were built with Shin-Etsu keypads. See diagram 3.0 below.
2. Replace the keypad, using a Sinco Keypad if possible, and retest.
