FIELD SERVICE BULLETIN

FSB Number: LVCCFSB2004-63
Author: Tony Bryan
Date: March 31st, 2004
Total No. of Pages: 2
Subject: **GSM V600 - CLI Lens**
Model Affected: GSM V600
Level of Repair: 2

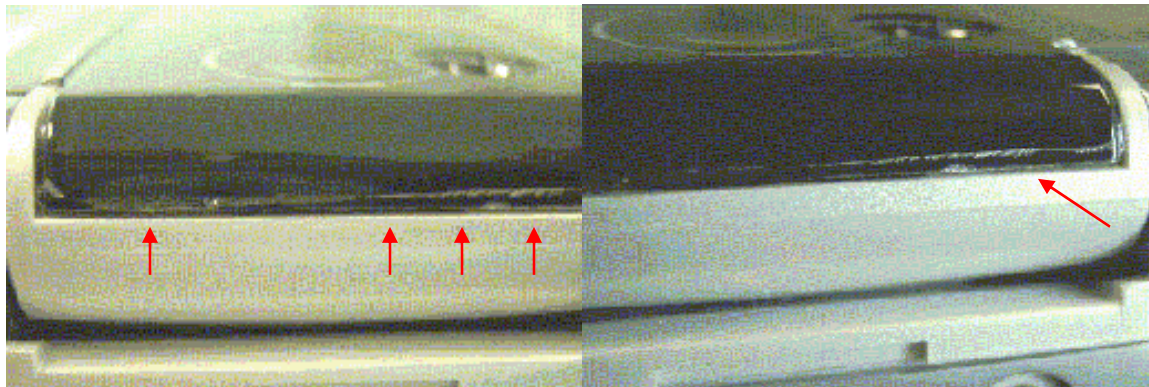
Service is aware of an issue affecting some CLI Lenses (6187309Y01/Y02/Y03) on GSM V600, shipped to EMEA during the months of December 2003 through March 2004. The affected lenses start to show a visible cosmetic defect, micro cracking at the hinge, after periods of use. The cracks originate at the top-left edge of the lens and propagate along the edges thru part mid-plane. See Diagram 1.0 below for an example of this defect. Analysis has revealed the cracking to be caused by molded-in stresses, which manifest after time and stabilize once the stresses have been relieved. The root cause of the molded-in stresses is related to process timing issue at the supplier between the filling of the mold and the IMD Decoration process.

Diagram 1.0 - V600 CLI Lens with micro cracking at hinge

Containment Action (3/8/04): All material aged less than 60 days has been returned to the supplier for annealing process and screening. All material aged more than 60 days has been 100% screened for this defect.

Corrective Action (3/10/04): An annealing process has been implemented at both lens suppliers to relieve molded-in stresses. Annealing process consist of baking the lens in an oven for a time period determined by the cycle-time of the suppliers' molding processes. Engineering is evaluating a material change for the lens to Acrylic.

1. Visually inspect the CLI Lens for the defect detailed in Diagram 1.0 above
2. Replace the CLI Lens if needed. Refer to the V600 CLI Lens Replacement Procedure.
