FIELD SERVICE BULLETIN

FSB Number: LVCCFSB2005-227
Author: Tony Bryan
Date: August 01, 2005
Total No. of Pages: 3
Subject: GSM V600/V600R – Lazy Flip
Phone Models: GSM V600, V600i, V620
Level of Repair: 2

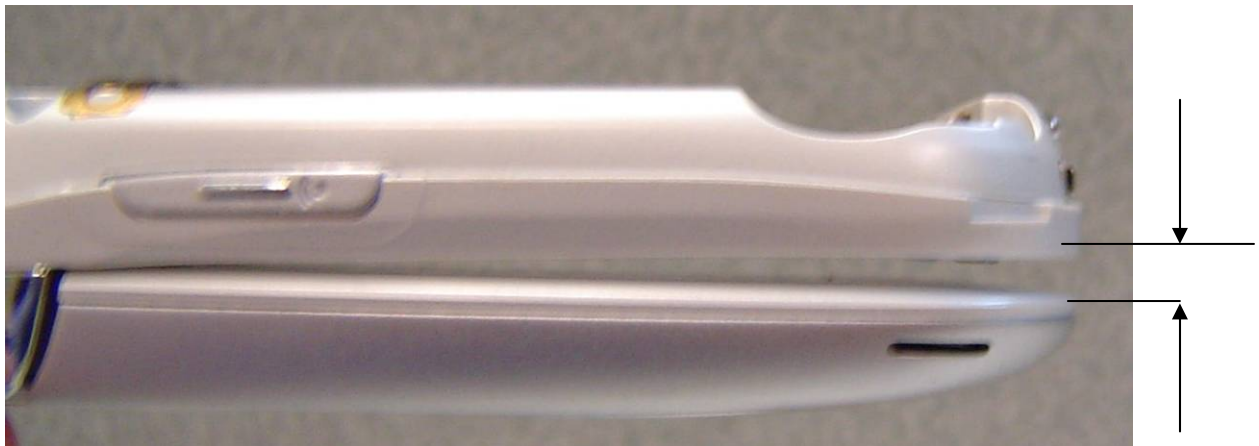
Service is aware of an issue, identified during field return analysis of the GSM V600/V600R product, where pressure applied to the flip at hyper-extend can result in the ‘Lazy Flip’ failure mode. See image below. The root cause is that the hinge cam, in the flip closed position, is not able to provide sufficient force to keep flip closed tight to the base. This allows the flip to open if phone is turned upside down. Severe cases, when used in an active use-case, may lead to customer returns for display flickering due to over cycling of the flip detect switch.

Fig. 1.0 - Flip falls away from base, creating a gap between the flip and base bumpers

Adjust double D feature in right knuckle (P/N 1588188N01) to optimize hinge cam position.

1. Replace the old 1588188N01 Rev. B knuckle with the new 1588188N02 Rev. C knuckle to prevent this failure mode.

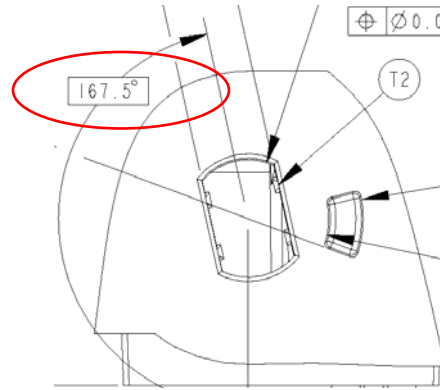
Change to 177.5°

With the new knuckle, there is no gap between bumper and flip housing.

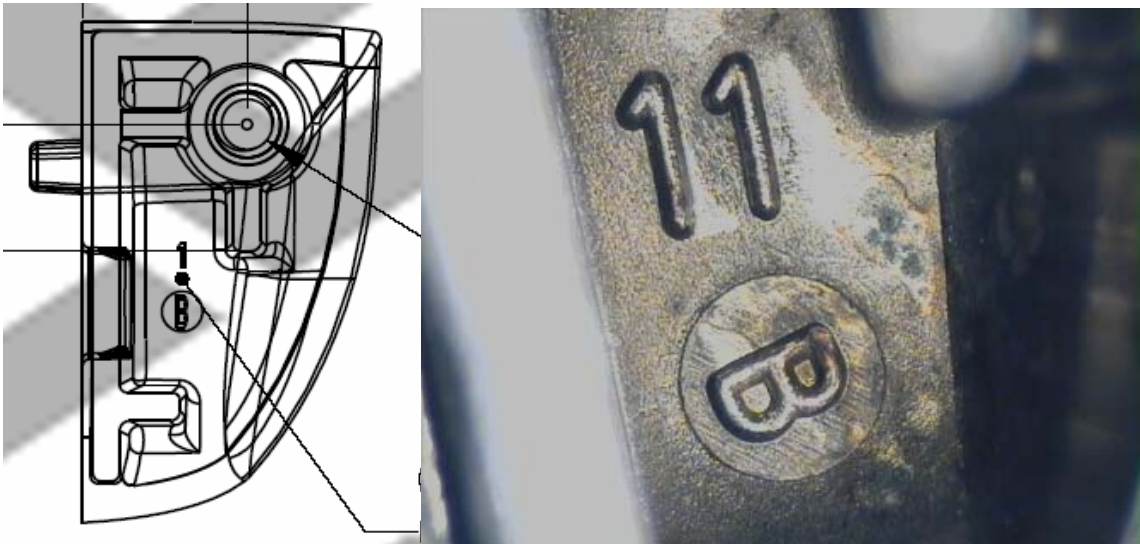
The old knuckle P/N is 1588188**N01**, **Rev B**. You can see the Rev mark on the knuckle as follows.

The new knuckle P/N is 1588188**N02**, **Rev C**. You can see the Rev mark at same location as that of Rev. B.
