Informational FIELD SERVICE BULLETIN

FSB Number: LVCCFSB2005-143 Rev B

Subject: GSM Mid-Tier - Placement of Liquid Detection Labels

Model Affected: V300, V303, V400, V500, V505, V525, V600

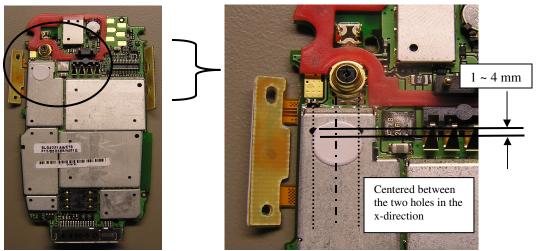
Fig. 2.0 - "Good" Placement

As of April 29th 2005, all factories producing the models (V300, V303, V400, V500, V505, V525, V600E550/V535, V550/V545, V620/V600i, V635) are placing the liquid detection label on the shield in the upper section of the board near the antenna port. See image (Fig. 2.0 – "Good" Placement) below.

Note: The exact position may vary slightly on the shield.

When performing services on any GSM model, listed, that requires the rear housing to be removed allowing access to the water detection label. Remove label that has been placed in SIM card area and place a new label (Part # 5485042F01) on the shield in the indicated location. See images above.
