FIELD SERVICE BULLETIN

FSB Number: LVCCFSB2005-15
Author: Tony Bryan
Date: January 27, 2005
Total No. of Pages: 3
Subject: GSM Triplets Refresh (V600R) – Flip Detect Switch
Phone Models: GSM V620, V600i
Level of Repair: 2

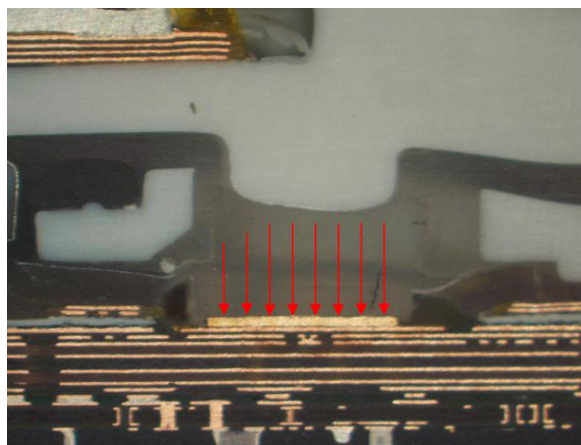
Service is aware of an issue, identified during the NPI Analysis on GSM V620/V600i. Some units, returned with customer complaints related to improper operation of the “Secondary/External Display” were found to have an intermittent problem where the flip detection switch would not activate when the flip was closed. Analysis revealed the issue to be caused by a poor or uneven compression force between the keypad gold puck and the flip switch contacts on the PCB. See Fig. 1.0 below.

Note: V620/V600i hardware included a fix for an issue where the main display lens would be scratched by the keypad. This fix combined a thinner main display lens and added height to the rubber base bumpers. This is a factor which is contributing to this failure mode.

The failure rate for this issue was much higher on units built with ITT keypads versus units built with TeeHwa keypads. Analysis of the keypads found, although no keypads were found to be out of specification, some of the keypads were at the low end of the tolerance and that was the reason for the higher failure rate.

Fig. 1.0 – Cross-Section showing uneven compression force on flip detect switch, concentrates contact area on a small portion (right side) of the PCB contact area.

Short-Term: (1) Factory took immediate action. A shim was added to the functional testing for flip switch operation. The shim holds the flip open an additional 1mm higher than in normal use to screen out units with potentially weak compression on the flip switch. – WW43 '04.
(2) All ITT keypads were purged from the factory as well as TeeHwa keypads that were found to be on the low end of the tolerance for gold puck height. Only TeeHwa keypads, measuring on the high end of the tolerance, are used. – WW48 '04.

Long-Term: (1) Keypad 3888470Yxx Rev. B - Modify keypad plunger to create chamfered surface to allow for more uniform compression. - February '05
(2) Flip Front Housing 0188382N03 Rev. G - Modify flip inside housing flip detect protrusion to account for flip bias due to hinge spring. This will better align the flip detect protrusion with the keypad plunger/gold puck. - April '05
(3) Side-Key Flex 8489088N04 Rev. D - Modify side-key flex to pull back adhesive from around flip detect switch opening to reduce opportunity from foreign material to collect around the PCB contacts. – March '05

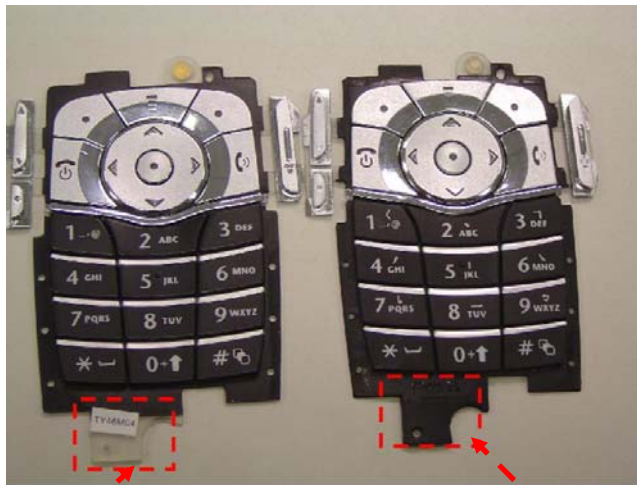
Clear for TeeHwa

Black for ITT

Good after WW48 '04
