**FIELD SERVICE BULLETIN**

FSB Number: LVCCFSB2005-43  
Author: Tony Bryan  
Date: February 28, 2005  
Total No. of Pages: 2  
Subject: GSM Triplets Refresh – Thumbnail Image Quality  
Phone Models: GSM E550, V535, V545, V550, V600i, V620  
Level of Repair: 1

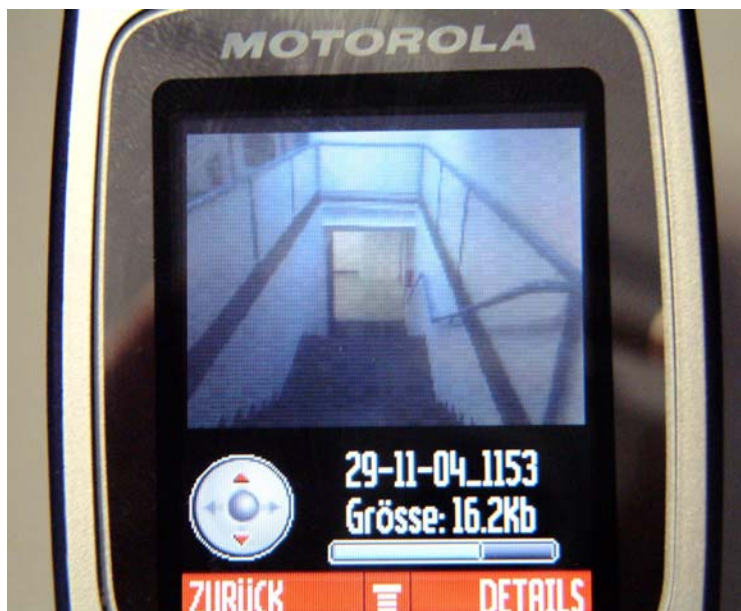
Service is aware of a customer perception issue, highlighted by the field and identified in the NPI Analysis, of the GSM Triplets Refresh product. Some units, returned with customer complaints of “Camera – Poor Quality”, were analyzed to have no failure. However, it was noted that captured images that are stored in phone memory have a pattern of gray squares “water spot effect” superimposed on the thumbnail image. These gray squares are not seen on the actual image, when set as wallpaper, or when viewed by a PC or any other phone. The squares are a result of the dithering applied on the images in order to improve the quality of a color gradient image. This effect is most noticeable when the captured image is a plain (uniform color) image. Removal of dithering would worsen the quality of images displayed on the screen. Since this is a rare occurrence, no change will be made to the existing imaging software.

Fig 1.0 – Thumbnail Image with gray dot “Water Spot Effect”

1. Inform the customer that is not a defect and is normal operation of the product's imaging software.
