FIELD SERVICE BULLETIN

FSB Number: LVCCFSB2005-139
Author: Tony Bryan
Date: May 12, 2005
Total No. of Pages: 3
Subject: Skyworks Eagle IC – High Current Failure
Model Affected: GSM V300, V303, V400, V400p, V600, V220, E398, C650,
C550, V180, C380, E550/V535, V620/V600i, V3
Level of Repair: 3

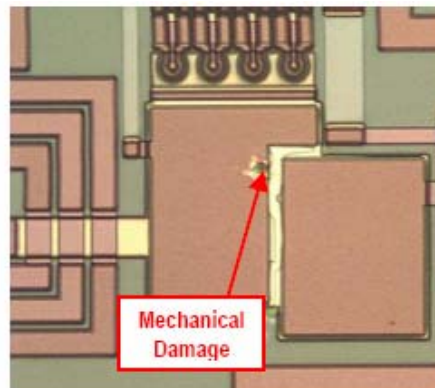
Pic.1

Service is aware of an issue identified during the 1st 200 NPI analysis on several GSM products that use the Skyworks PA P/N 5189818N01. Some units, returned with customer complaints of “Can’t Power on” or “Battery short life”, were found to have a higher than normal current draw. This issue is caused by abnormal high current consumption of Skyworks PA P/N 5189818N01 due to a mechanical scratch across the die surface. Such damage would lead to a short to ground on the die surface after phone assembly and field operation.

Skyworks has instituted several corrective actions to reduce the occurrence of mechanical damage failure mode. The actions include:

- 1) Added Cleaning After GaAs Die Scribe and Break Process
- 2) More Frequent Cleaning of the Pick up Tip (After Every Lot), Replacement of Pick up Tip (After Every 17,000 Placements).
- 3) Heightened Wafer Inspection (100X Microscopic Inspection of Panels After Die Attach – for Lot Set-up) Added to Improve Overall Product Quality at all Assembly Sites. – WW52 '04

4) Additional electrical tests were added to the Rev. F High Current Density Test (HCDDT) including a leakage test performed at 4.6VDC to screen out some potentially weaker components. – WW09 '05

All Corrective Actions are in place in part date codes after WW09 '2005.
New date code is 0509
