Informational FIELD SERVICE BULLETIN

FSB Number: LVCCFSB2005-137 (Rev A)
Author: Tony Bryan
Date: May 19, 2005
Total No. of Pages: 3
Subject: **GSM V635 Fiji – Software Upgrade from 48.2xx**
Model Affected: V635
Level of Repair: 2

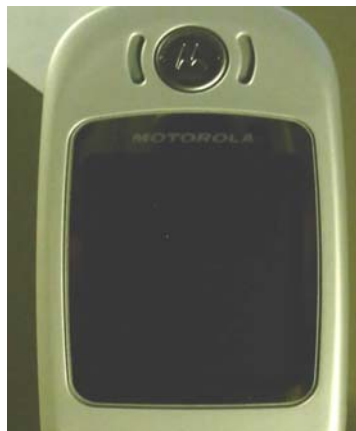
Problem 2: When upgrading the GSM V635 Fiji software, the phone does not show the Boot Loader version, SW version, or OK to Program information. The screen is completely black, as shown in Figure 1 below. Instead of the normal display that is shown in Figure 2 and Figure 3 below.

Figure 1: FIJI – V635 is going through the software upgrade process without displaying the information on the phone screen

This problem will happen in all the phones manufactured with GNPO-8 factory file, which includes boot loader version 8.20.

With this black screen, the phone software **can still be upgraded successfully**. Just watch the information during the SW upgrading displayed on either RSD Lite, or PST, it will show all the steps until the unit has successfully finished the upgrade process.

This software problem has been corrected in boot loader 8.21, which is integrated into GNPO-B factory file.

In field service centers, this problem can be ignored. When using RSD Lite or PST to upgrade the software, just watch the RSD or PST tool screen, it will show all the upgrading steps until the upgrading procedure is complete.

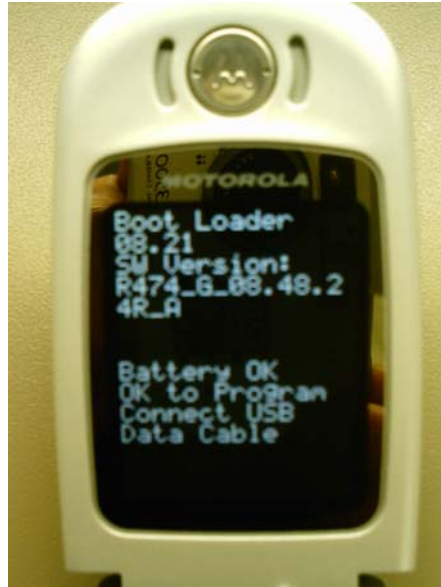
Figure 2: FIJI - V635 is ready to be flashed

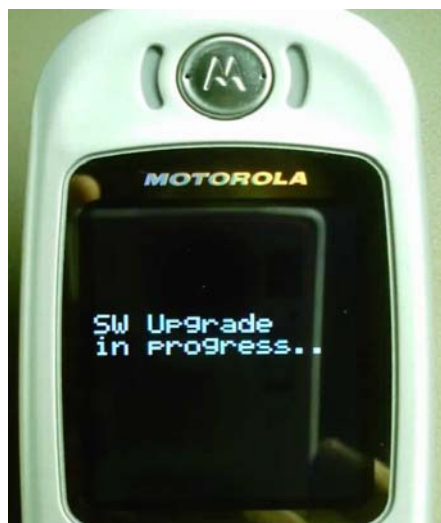
Figure 3: FIJI - V635 is going through the software upgrade process
