GSM V80_ Joystick Rubber Torn Issue

Our Reference: SI46_10_2004

Product/System: V80

FIELD SERVICE INFORMATION

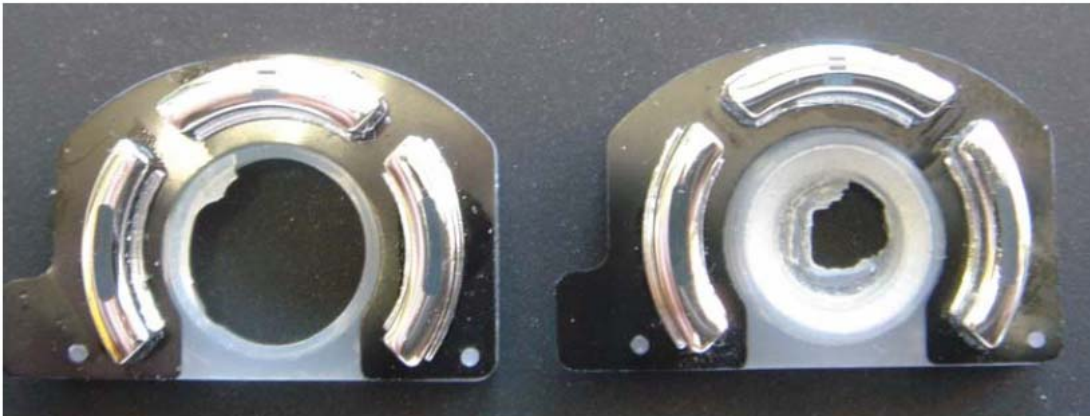
Silicone Rubber Torn (From old 16 Cavity tool)

Joystick Cluster Failure Mode

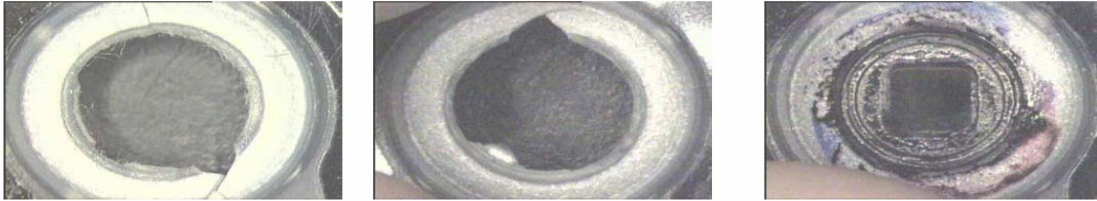
Received Field Return Samples (2 unit)

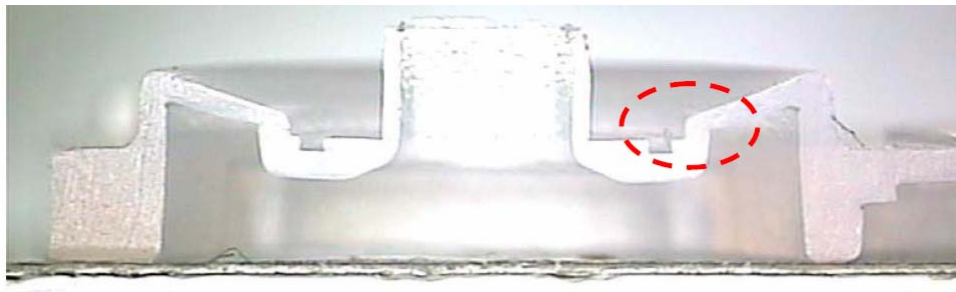
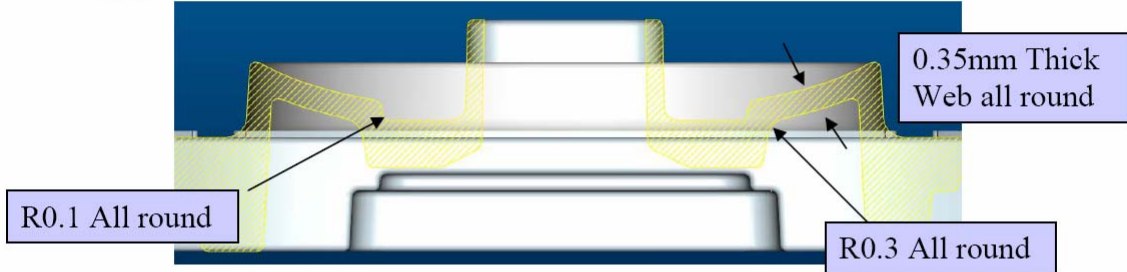
- Sharp edges without radius ~ radius in database are not added at actual part
- Rubber thickness uneven, thinning at edges
- Sharp corner at glue channel ~ 2 Field return torn at channel edge

- Add Radius at all sharp corner
- Remove glue channel
- Characterize the pull test performance for each cavity. Set requirement for minimum pull force for future build

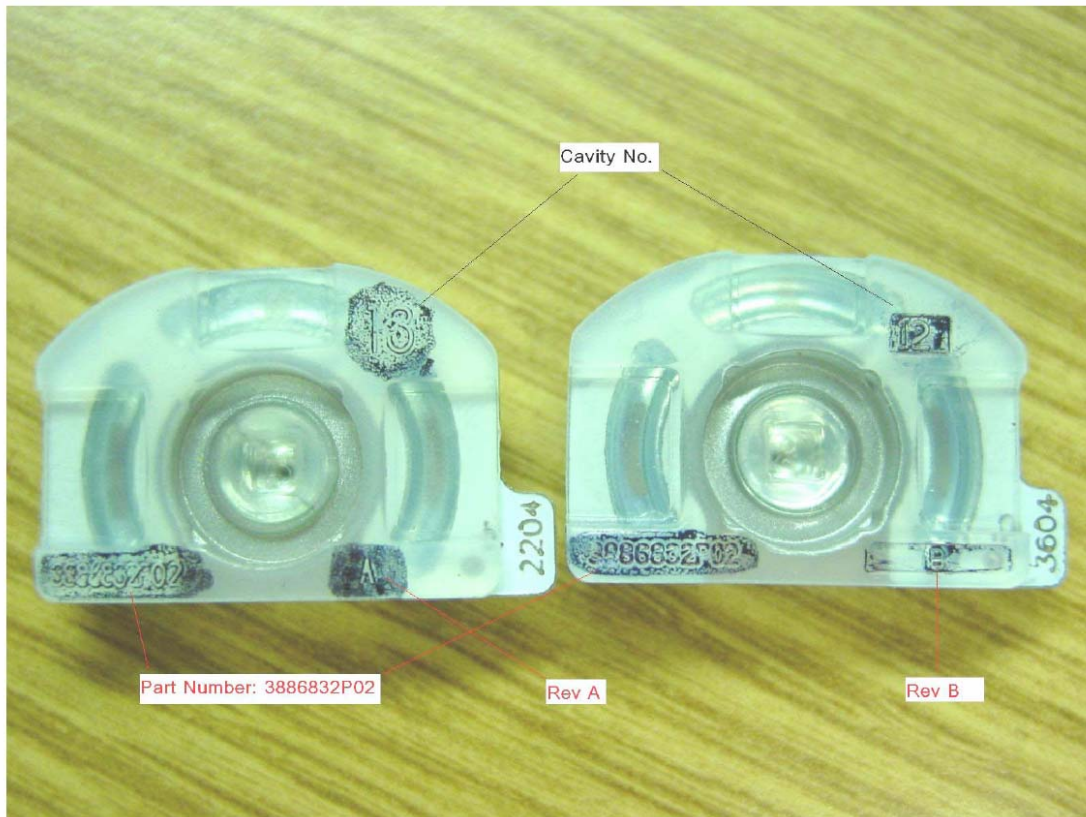
Design Center has issued new Rev B joystick come from new 16 extra cavity tooling. The part was qualified on Sep. 1st 2004. Below picture is the comparison between old joystick Rev A and new joystick Rev B.

If the joystick is determined to be faulty, replace the joystick with Rev B written on the joystick rubber surface you may see the capital letter "B". All mass production cross over to Rev B. Rev A should not be used anymore.
