FIELD SERVICE BULLETIN

FSB Number: LVCCFSB2004-249
Author: Ross Karlen
Date: December 10, 2004
Total No. of Pages: 5
Subject: **3G V980 – No / Intermittent CLI Display**
Model Affected: 3G V980's
Level of Repair: 3

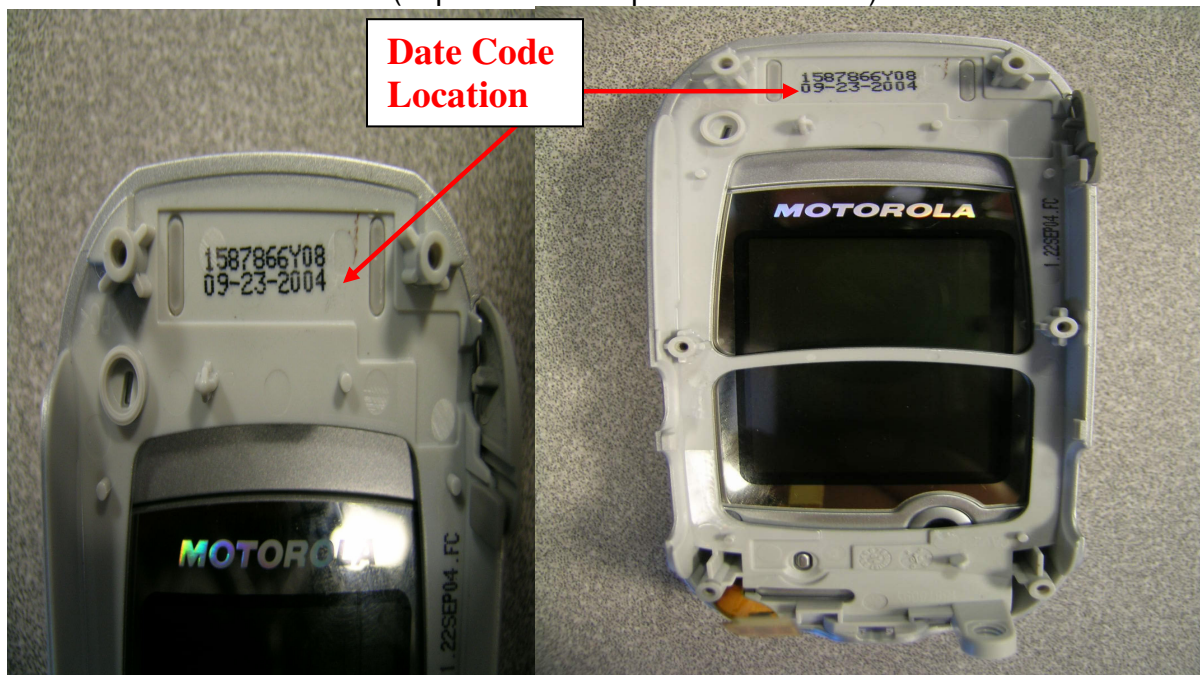
Service is aware of an issue, highlighted by Development. Some units were returned with a customer complaint of “No CLI Display or Intermittent CLI Display” during OOB inspection. Analysis revealed the CLI Flex component shorting to the PCBA copper etched date code to cause CLI failures.

NOTE: Affected date code (Flip assemblies prior to 11-15-04)

Affected: Units shipped prior to 12-15-04 have suspect flips manufactured prior to 11-15-04 flip assemblies.

Short Term Solution: Follow the following procedure of adding Kapton Tape on the PCBA.

Use Kapton tape as insulator
Dimension of tape: approx 19 mm x 5.5 mm
Location: over the current P/N (see slide 5)
Color of tape: Optional

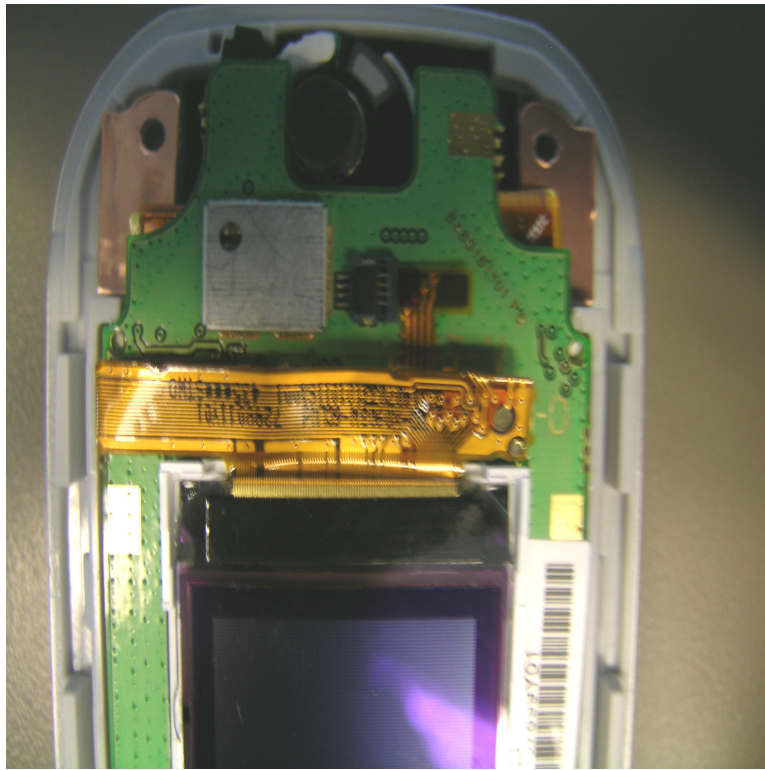
Step 1: CLI board as assembled (For Disassembly of Flip, view Level 2 Service Manual posted on the WEB)

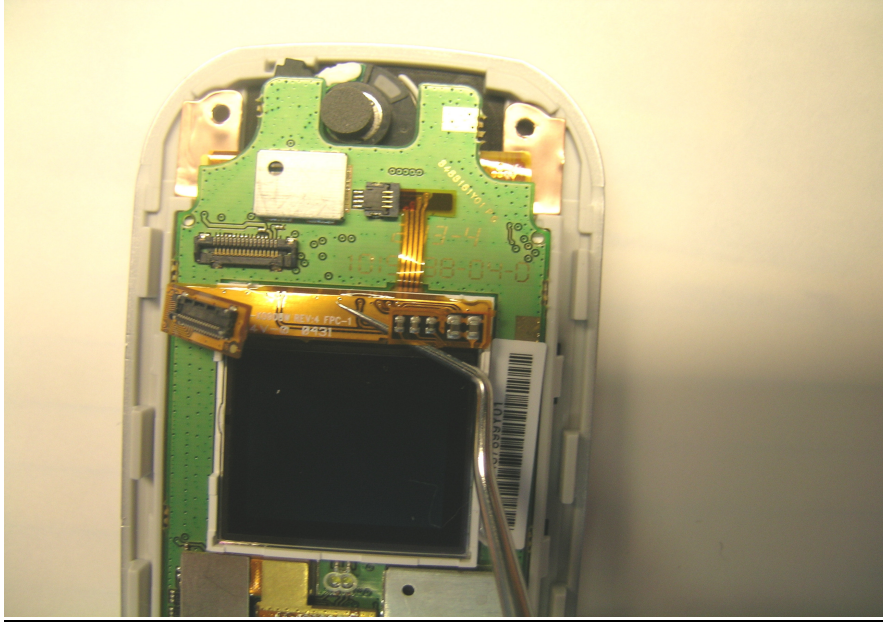
Step 2: Fold CLI flex assembly carefully as shown

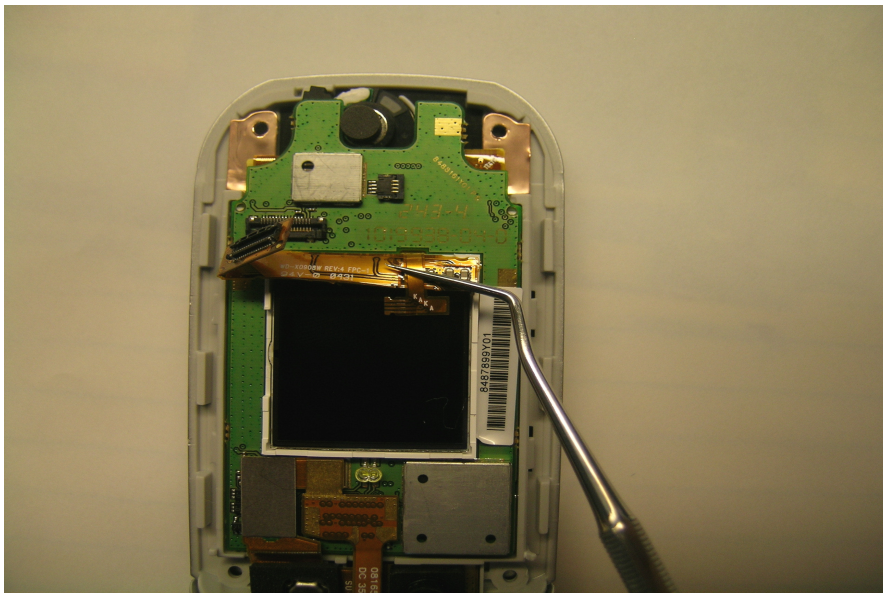
Step 3: Disassemble CIF flex from CIF connector

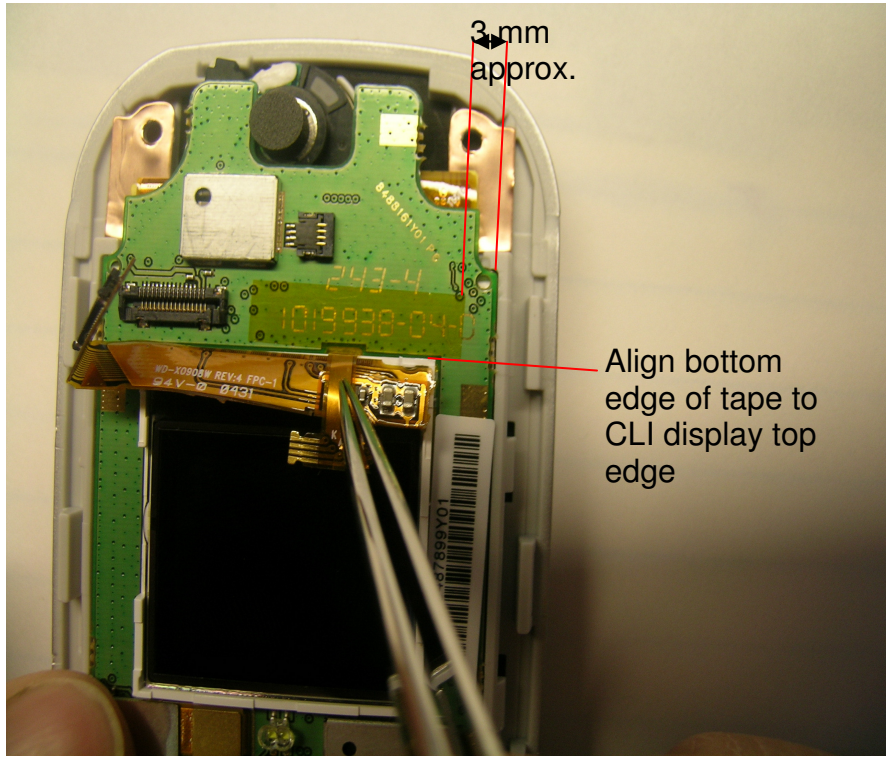
Step 4: Place the Kapton tape as shown

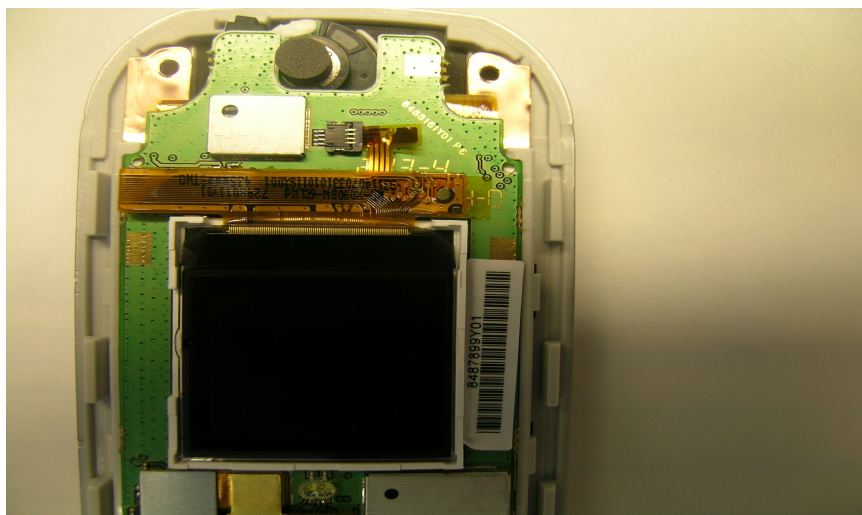
Step 5: Re assemble CLI flex and CIF flex---> DONE!

During Reassembly of flip, Flip screws should have $1.5 \pm .01$ in-lbs of torque applied.
