## FIELD SERVICE BULLETIN

FSB Number: LVCCFSB2004-249  
Author: Ross Karlen  
Date: December 10, 2004  
Total No. of Pages: 5  
Subject: **3G V980 – No / Intermittent CLI Display**  
Model Affected: 3G V980's  
Level of Repair: 3

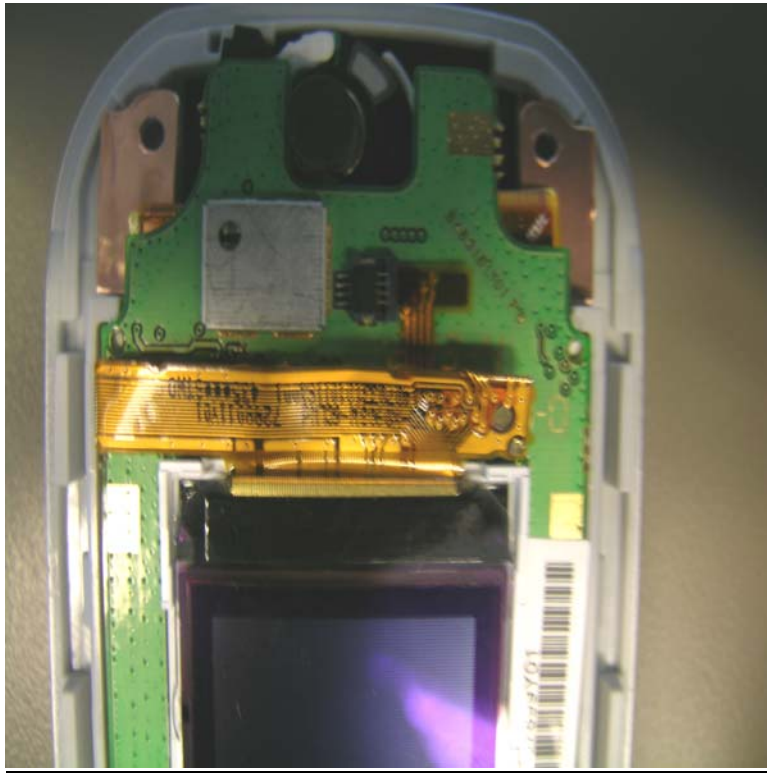
**Step 1: CLI board as assembled (For Disassembly of Flip, view Level 2 Service Manual posted on the WEB)**

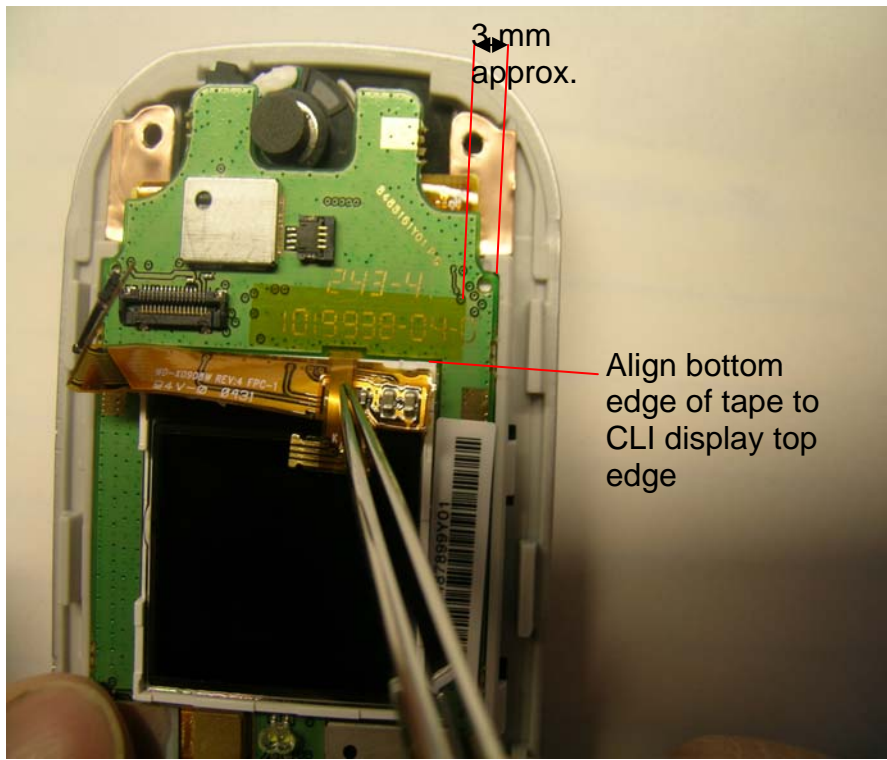
Service is aware of an issue, highlighted by Development. Some units were returned with a customer complaint of “No CLI Display or Intermittent CLI Display” during OOB inspection. Analysis revealed the CLI Flex component shorting to the PCBA copper etched date code to cause CLI failures.

Use Kapton tape as insulator  
Dimension of tape: approx 19 mm x 5.5 mm  
Location: over the current P/N (see slide 5)  
Color of tape: Optional

**Step 4: Place the Kapton tape as shown**
