## FIELD SERVICE BULLETIN

FSB Number: LVCCFSB2005-96  
Author: Ross Karlen  
Date: April 4, 2005  
Total No. of Pages: 3  
Subject: **3G A1000, V980, E1000, C980, C975 – Low output power GSM**  
Phone Models: 3G A1000, V980, E1000, C980, C975  
Level of Repair: 3

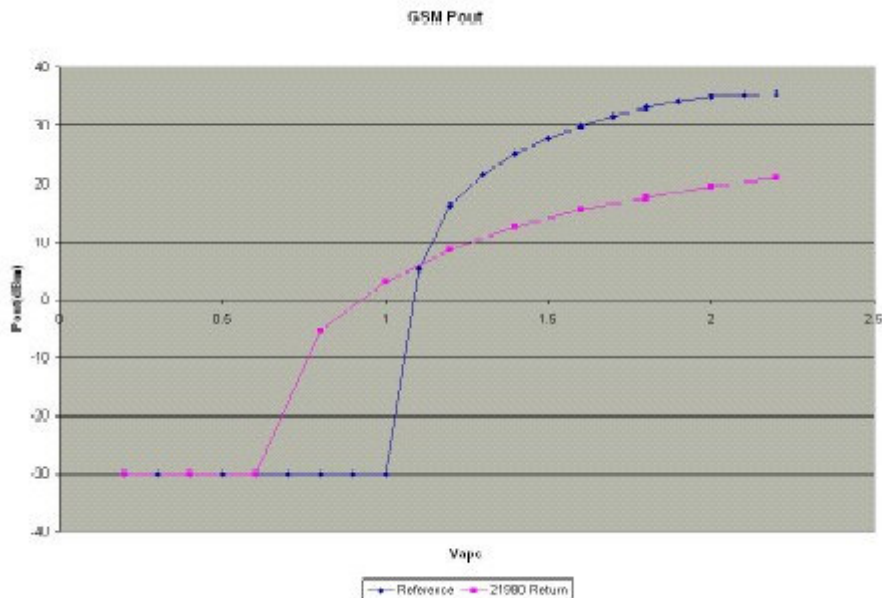
FIG 1.

Service is aware of a concern identified during the 1<sup>st</sup> 200 NPI analysis on A1000. Some units were returned with a customer complaint of “Turn On/Off power down in call” or “Voice Call – Poor Reception”. Analysis revealed low output power in the GSM 900 band. The concern is the power coupler (capacitor) in the Skyworks PA (5188220Y02) losing resistance, which will result in the power being shunted off. Shown Fig. 1

Blue: Reference Pout  
Pink: PA with shunted power.

1. Verify unit exhibits low RF Output Power in GSM 900 Band.
  - a. If failure symptoms do not match above, follow normal troubleshooting techniques to determine the issue.
2. Replace the PA with a 5188220Y02 part with a lot code 0452 or later. See image above.
3. Perform required re-phasing and completely retest the unit to confirm successful repair of the failure.
  - a. If failure symptoms persist, follow normal troubleshooting techniques to determine the issue.

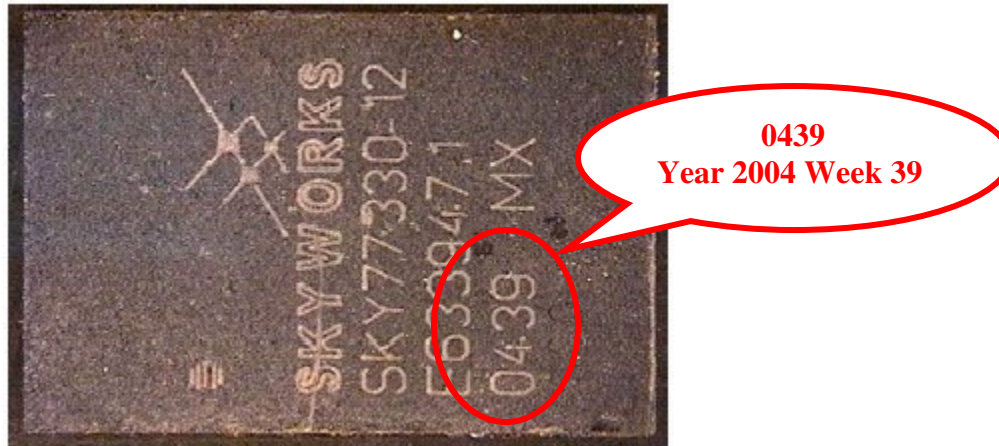
Skyworks implemented a screen to capture failures. (2004 Week 52)  
Units produced after 0452 have been screened. See Fig 2 below to identify date code.

FIG. 2 (Date code on picture shown 0439 – Year 2004 Week 39)  
Screen implemented 0452 (Year 2004 Week 52)
