CSB-1013-2
 Country : UK
 Date : 2/2/2007
 APC : ALL
 Repair Level : 2

Title C168/C168i/W220 - GSM - No Vibrate
 Model Effected C168,C168i,W220

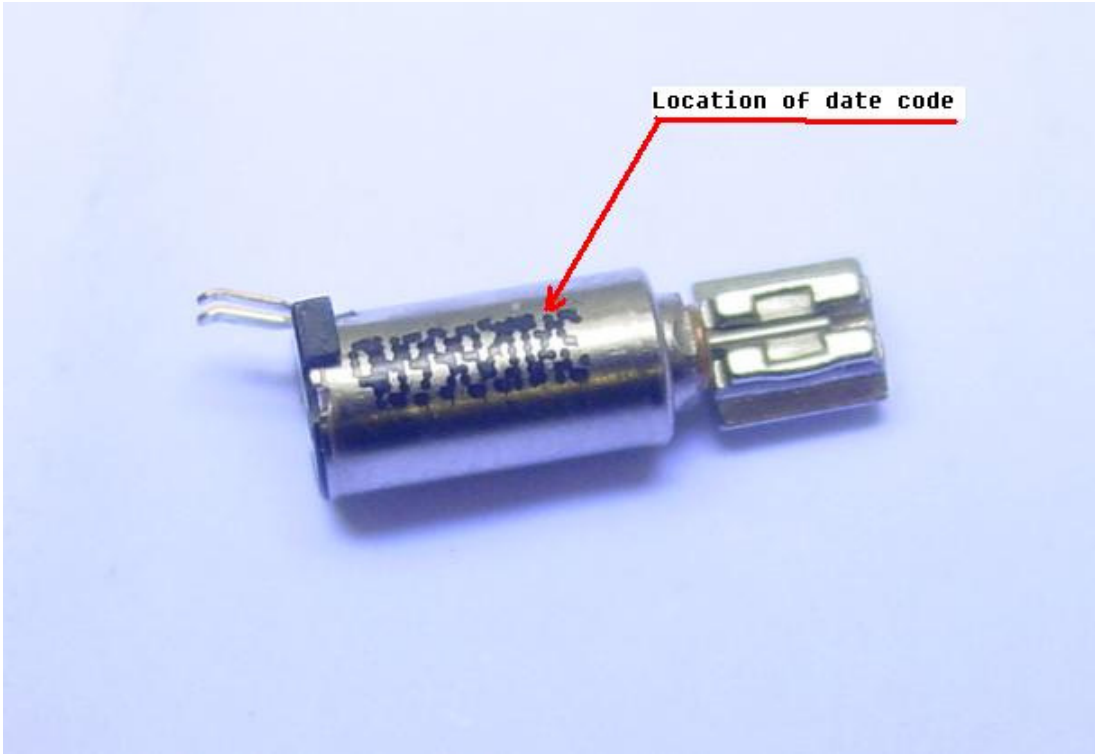
An issue was found in the C168/W220 MOL analysis process. The customer complained: "No vibrate". The root cause is vibrator can not work normal. The analysis revealed the Armature Deformed of vibrator. Vendor Panasonic is analyzing the cause of Armature Deformed.

Deformed Armature

Armature deformation is due to the tape around the armature shrinkage. Action is to change the new tape from Jan 03, 2007. New vibrator date code is Jan/03'07 and with the mark of "Ba". For example, 3XU0317Ba.

When C168/C168i/W220 handsets returned to service center with the customer complaint of 'No vibrate', Please replace a new vibrator with the new data code.
