CSB-1068-1
 Country : UK
 Date : 11/1/2006
 APC : F77
 Repair Level : 1

Title W220 - GSM - W220 SIM card no recognized
 Model Effected W220

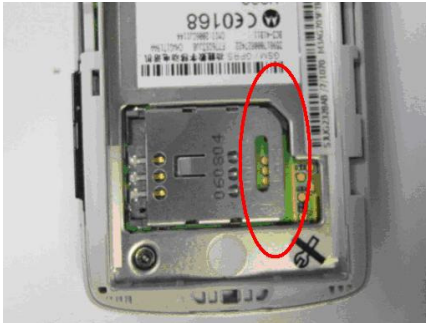
During the 1st NPI analysis on the W220, some units were returned with a complaint of 'Insert SIM card. The phone can not recognize the SIM card. After confirmed with the user, the root cause is that the SIM card latch doesn't be locked completed

Uncompleted locked SIM card Latch

Remind the customer must lock the SIM card latch in the right location.

When W220 (Sicily) handsets are returned to a Service Center with the Customer Complaint of 'Insert SIM card', please communicate with the user if he didn't lock the SIM card Latch completed.

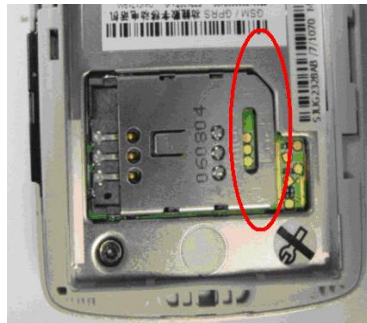
Completed locked SIM card Latch

When a customer contacts the Motorola Call Center, with the complaints of 'Insert SIM card' on W220 (Sicily), Communicate with the customer to check if their SIM card latch is locked completed as the picture.
