CELLULAR SERVICE Bulletin

CSB-1310-3
 Country : UK
 Date : 4/27/2007
 APC : ALL
 Repair Level : 3

Title W220 - GSM - SIM card - Card holder broken issue
 Model Effected Sicily

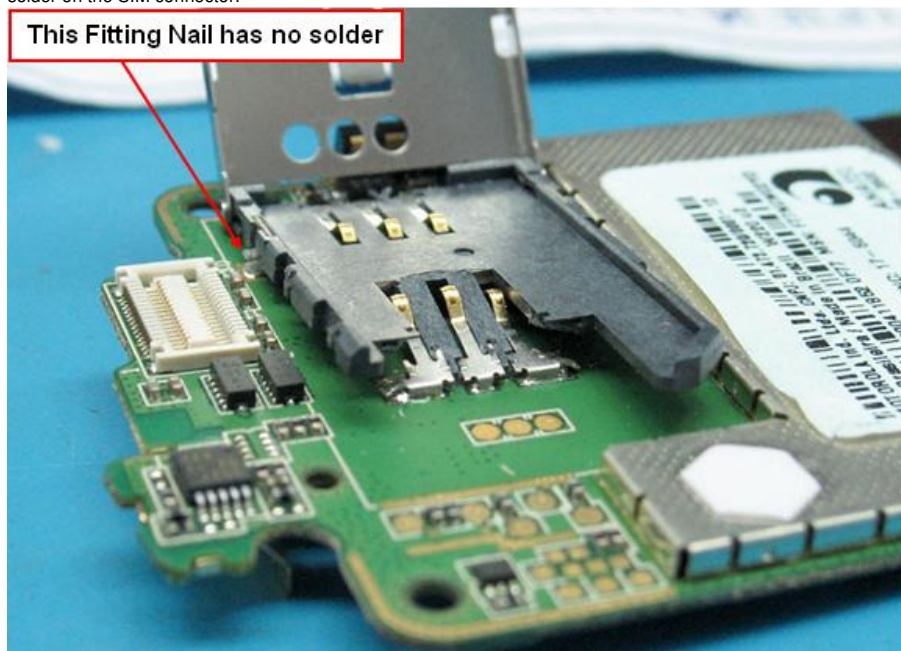
Picture 1

The root cause analysis identified that there is interference between the housing and the shell inner corner of SIM connector causing no solder on the SIM connector.

- 1- Please check if the failure symptom is according to the picture 1 above;
- 2- If yes, replace the original SIM connector with a new one.
- 3- If not, please proceed to normal troubleshooting techniques.

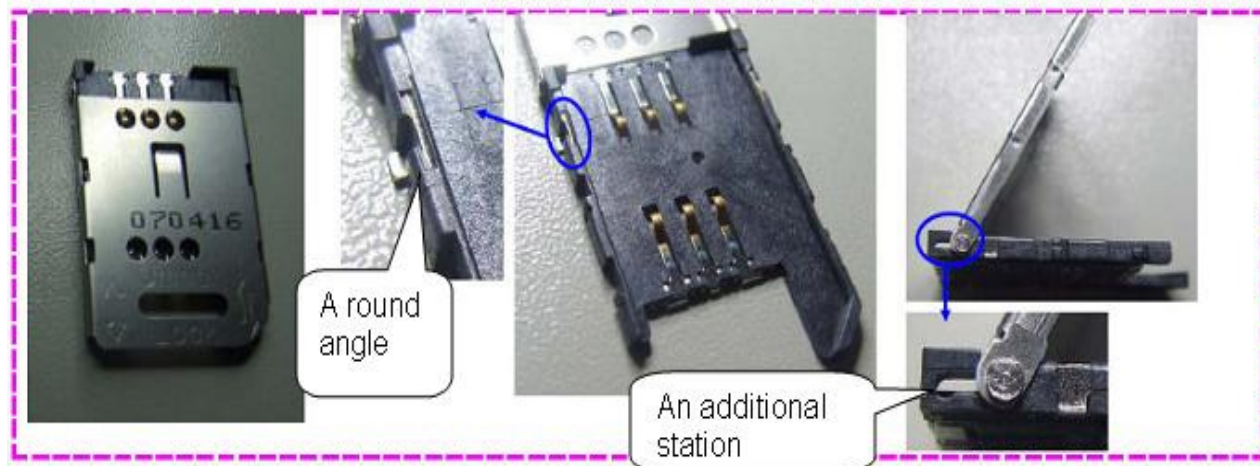
New Housing

SIM connector PN MESC47002B was redesigned to modify the angle of housing to R 0.40mm according to the picture below.

The corrective action was implemented on SIM socket date code after 070416.
