FIELD SERVICE BULLETIN

FSB Number BJCCFSB2009 - 33
Author hong fang
Date Friday, February 27, 2009
Subject **GSM - Moto W388 - Check SIM card**
Model Affected W388
Level Of Repairs 3

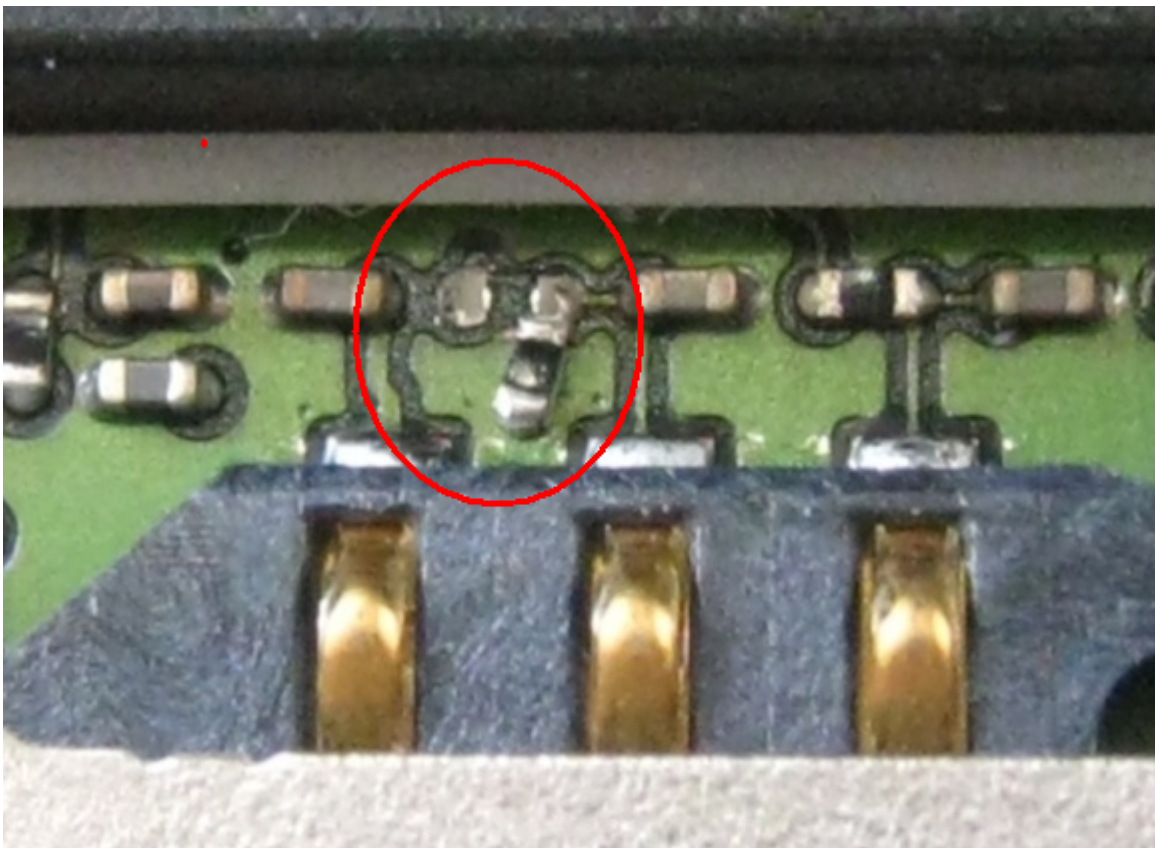
Service is aware of an issue during W388 NPI process. The complaint is 'Check SIM card'. the handset can't detect SIM card when SIM card was inserted.

The root cause is some components related to SIM read/write damaged during SIM card removed by any tools (tweezer etc).

Because this issue is caused by user, so the solution is to recommend user not to use any tools to remove SIM card.

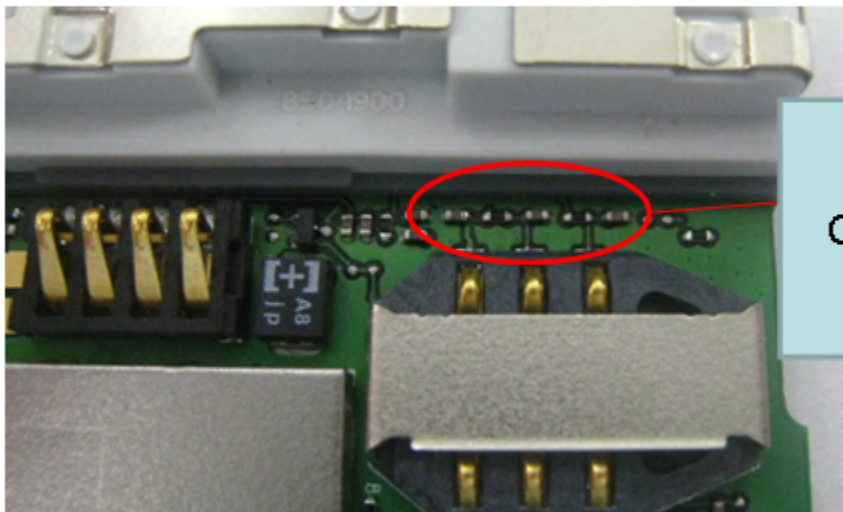
- Normal location

The components' name:
C707, R715, C705, R714,
C704

Please check the components below if the location is correct, soldering is good.

If having some problem, please replace corresponding component.
