STANDARD FIELD SERVICE BULLETIN

FSB Number	CHRAEFSB2014-89
Author	Anthony Bryan
Date	08/11/2014
Subject	Camera Flash LED
Model Affected	Moto G (XT937C, XT939G, XT1028, XT1031, XT1032, XT1033) and Moto G 4G (XT1039, XT1040, XT1042, XT1045)
Level Of Repairs	Level 2

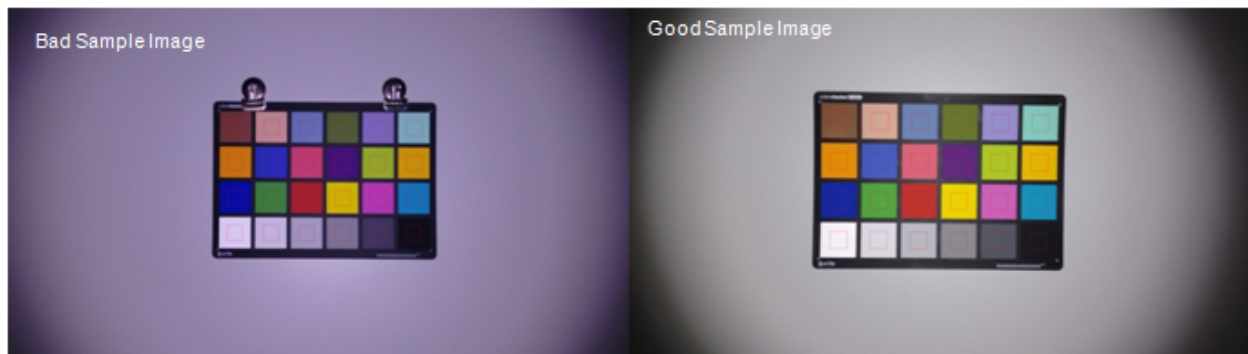
Figure 1 - Example Photos

Motorola is aware of a potential field return issue on the Moto G and Moto G 4G products related Camera Flash performance. It was identified that some of the Flash LED's received by a particular supplier were not meeting Motorola standards for white balance. Affected devices may not achieve the same level of quality when capturing photos in low light conditions where the Flash LED is triggered. Photos captured in low light condition with the the affected Flash LED's may appear dark, washed out, or have a bluish tint. See the Example Photos shown below in Figure 1.

1. Regardless of whether or not complaint can be confirmed through functional testing, replace the Rear Housing Assembly (Service P/N: 010176880xx).
2. Following normal service procedures, completely reassemble and retest the device to ensure proper repair.

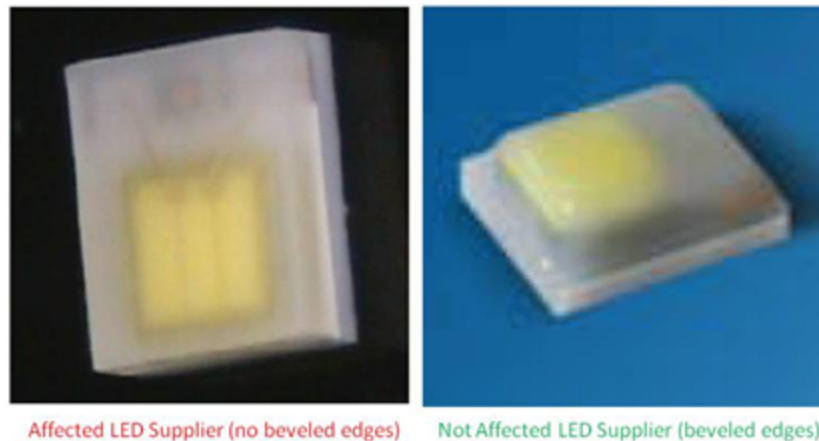
Figure 2 - Flash LED Suppliers

The affected Flash LED supplier (part image shown below) has implemented corrective actions into their process and are currently shipping only material that fully meets Motorola standards as of August 7th, 2014. Supplier will screen on-hand material built prior to August 7th, 2014 and apply a "Flash OK" marking to screened good material.

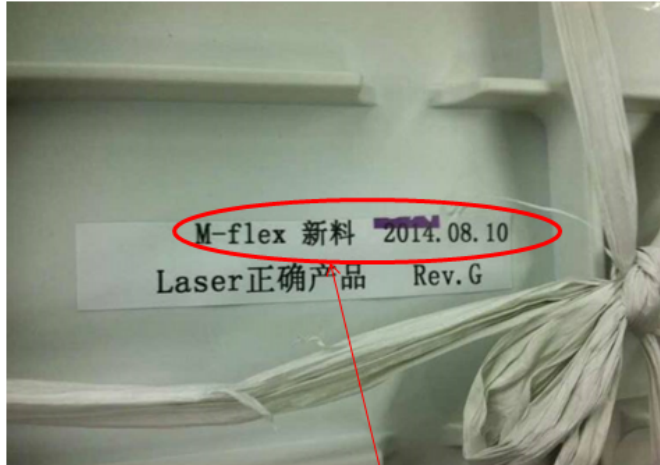
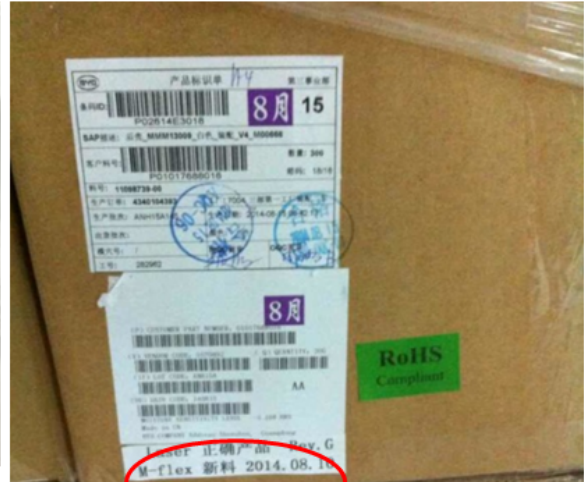
Figure 3 - Affected Supplier Screen "M-FLEX 新料" Marking (image to be added)

Marked "M-flex 新料+ Mflex date code" on trays and outside of box.

Any Rear Housing Assembly (Service P/N: 010176880xx) material found to be affected should be returned to the supplier.

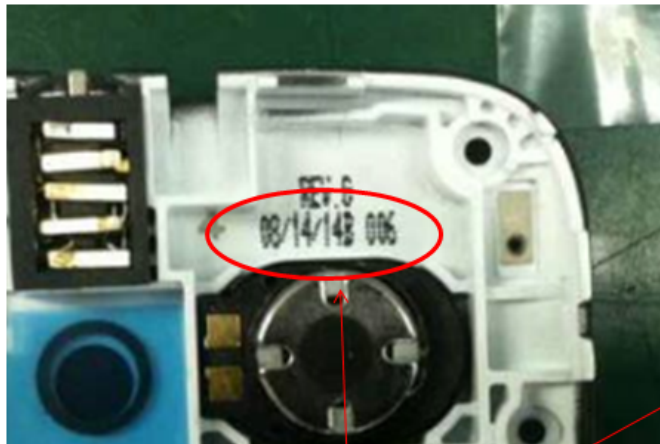
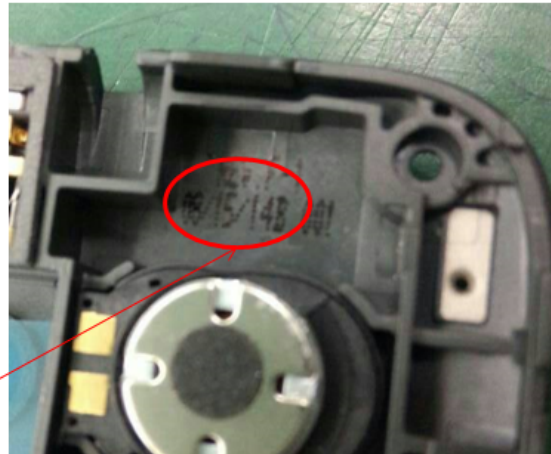
RH assy date code: the first batch for new Mflex material
08/14/14B (MM/DD/YY Shift)
