STANDARD FIELD SERVICE BULLETIN

FSB Number	BJRAEFSB2014-118
Author	Bill Li
Date	11/25/2014
Subject	Moto G (2nd Generation) - Moto G 2nd generation Touch Panel glue exposure and lift
Model Affected	XT1068, XT1069
Level Of Repairs	Level 2

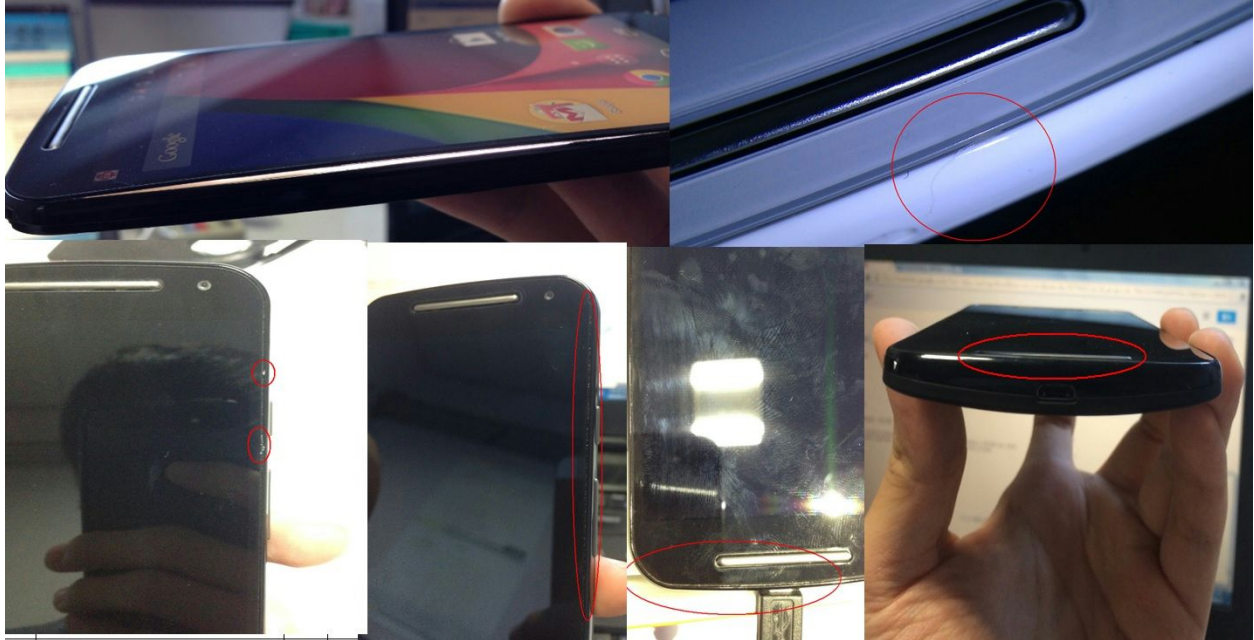
- Touch Panel Gap
- Touch Panel Glue Overflow
- Touch Panel Lift
- Touch Panel Glue Exposure

Engineering analysis root caused this issue to a manufacturing process issue when assembled the touch panel.

- Touch Panel Gap
 - Touch Panel Glue Overflow
 - Touch Panel Lift
 - Touch Panel Glue Exposure
1. Following Service Manual, carefully disassemble the phone .
 2. Replace touch panel chassis assembly with good known part. Part number: 20DBU0W0005 -- CHASSIS ASSEMBLY, TOP COVER, BLACK Part number: 20DBU0W0006 -- CHASSIS ASSEMBLY, TOP COVER, WHITE
 3. Per Service Manual, reassemble the phone.
 4. Completely retest the device per standard Service procedure to ensure proper operation
