STANDARD FIELD SERVICE BULLETIN

FSB Number	CHRAEFSB2015-24
Author	Rajesh Verma
Date	05/18/2015
Subject	SIM No Detect, SD Card No Detect / No Operation, Front Camera Flash No Function, Vibrator No Function
Model Affected	XT1063, XT1064, XT1068, XT1069, XT1072, XT1077, XT1078, XT1079
Level Of Repairs	Level 2

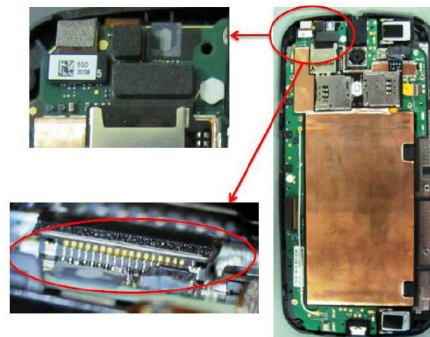
Photo 1

Engineering analysis identified this issue was related to a Daughter board assembly FPC (flex panel connector) disconnecting after drop test. This issue was identified on part number MEDBU14001C.

- Use only supplier A part number MEDBU14005B (Flex cable color is copper).
- If supplier A parts are not in stock then use supplier B part number MEDBU14001C till supplier A part number MEDBU14005B are available (supplier A parts availability end of June, 2015)

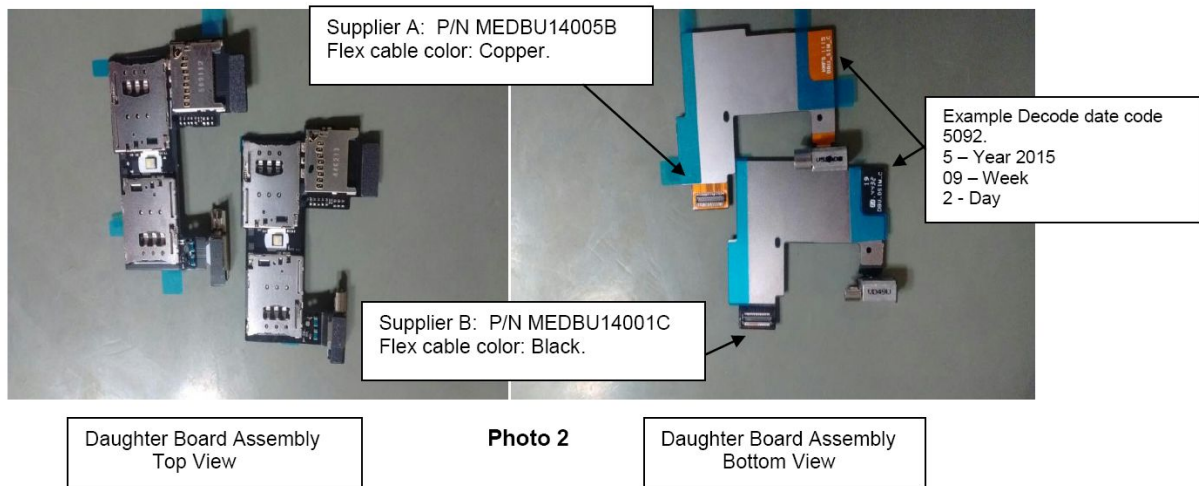
Note: See below photo 2 to identify supplier A and Supplier B parts and date code from supplier B parts.

Supplier A (Part Number MEDBU14005B) are good to use and going forward order only Supplier A parts.

When Part Number MEDBU14005B are available, Quarantine current inventory of Supplier B part number MEDBU14001C. This bulletin will be revised for Supplier Part B usage, after corrective actions and date codes are available.
