STANDARD FIELD SERVICE BULLETIN

FSB Number	CHRAEFSB2014-101
Author	Rajesh Verma
Date	09/22/2014
Subject	Moto X (2nd Generation) - No Turn On/No Charge - Battery Deep Discharge (PMIC Latch)
Model Affected	XT1092, XT1093, XT1096, XT1097
Level Of Repairs	Level 2

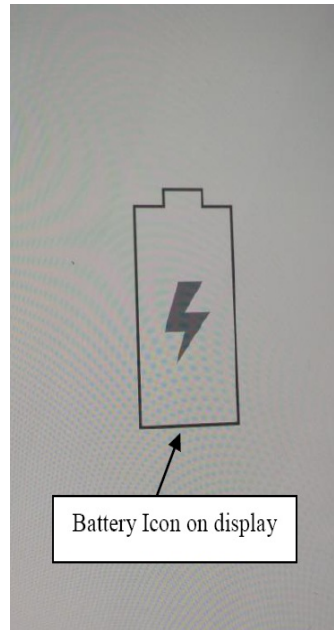
1. Instruct the user to re-connect the device and look for sign of life from the device (0% Battery Icon on display - see below photo).
 - a. If yes, then device is charging as expected. Please go to Step 3.
 - b. If no, while charger is attached to the device then press and hold the power button for 10 seconds (Note: Call-Center Agent should record the time). If display shows 0% Battery Icon then,
2. Educate user that their device was locked up for some reason and should be charging now.
3. Instruct user that it may take some time before the display shows battery icon with charge percentage.
4. Allow device to charge to at least 10% before attempting to power-up.
