STANDARD FIELD SERVICE BULLETIN

FSB Number	CHRAEFSB2014-110
Author	Rajesh Verma
Date	11/03/2014
Subject	Moto X (2nd Generation) - Paint Peeling / Bubbles/ Ink Delamination
Model Affected	XT1092, XT1093, XT1094, XT1095, XT1096, XT1097
Level Of Repairs	Level 2

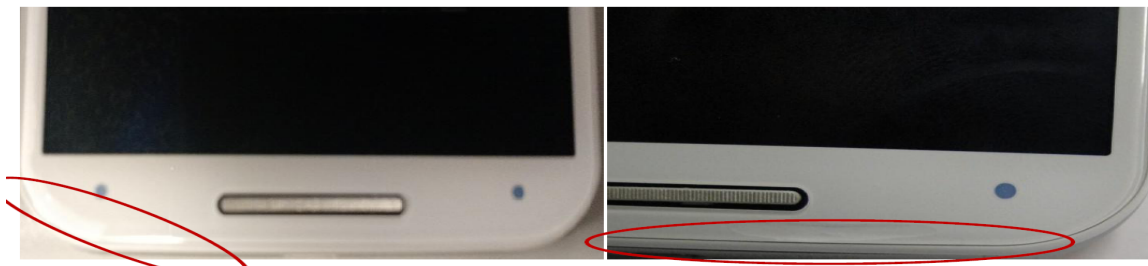
Engineering analysis root cause this issue to a supplier process issue related to ink delamination. See below photos as an examples of paint peeling off /bubbles/Ink delamination.

1. Inspect front endo (front chassis assembly) for above listed complaints, if confirmed then:
2. Per Service Manual, carefully disassemble the device to gain access to the front endo
3. Replace the front endo (front chassis assembly) with a good known new part
4. Per Service Manual, carefully reassemble the device.
5. Completely retest the device per standard Service procedure to ensure proper operation.
