STANDARD FIELD SERVICE BULLETIN

FSB Number	CHRAEFSB2014-111
Author	Rajesh Verma
Date	11/03/2014
Subject	Moto X (2nd Generation) - Wood / Leather Inlay Lifted
Model Affected	XT1092, XT1093, XT1094, XT1095, XT1096, XT1097
Level Of Repairs	Level 2

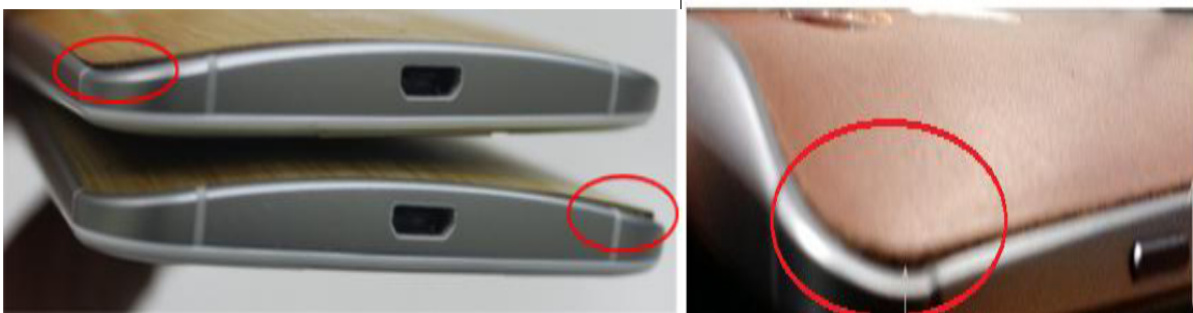
Figure 1

Motorola is aware of a potential issue identified on Moto X (2nd Generation) where customer may complain that any Wood or Leather inlay (rear cover) color is lifted at the corners or on the sides. See below Figures 1.

- Rolling Press and Corner press has been implemented to improve wetting.
- All Wood inlay parts inventories at supplier and manufacturing locations have been 100% inspected for warped parts per specification.
- All suspected Endos suspected for pocket not deep enough have been quarantined.
- Cleaning process has been added prior to inlay assembly.

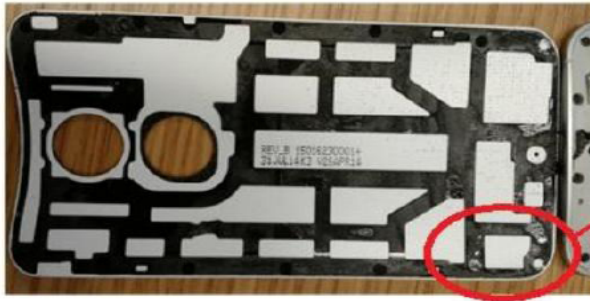
- Adhesive not fully wetted in the corners (see below Figure 2).
- Wood inlay warped and flatness was out of spec (see below Figure 3).
- Wood inlay curvature does not match Endo.
- Endo pocket depth not deep enough.
- Contamination around Endo perimeter.

Figure 2
Adhesive not wetted

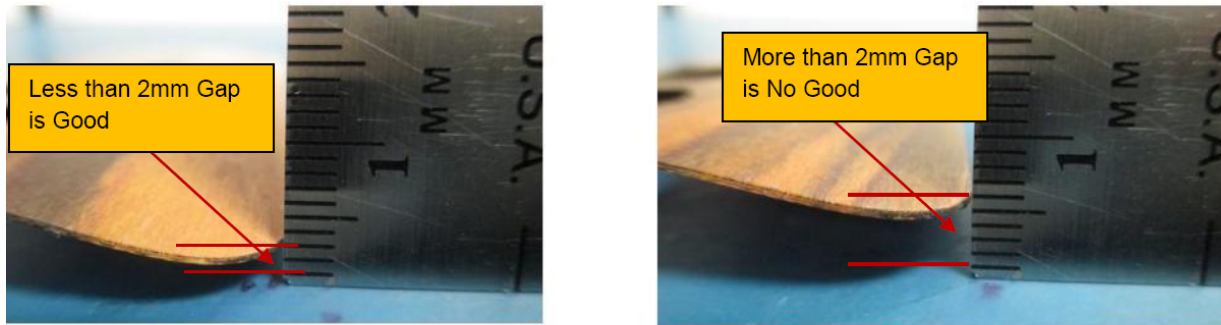
Figure: 5

1. Inspect Wood/Leather inlay for any lift at the corners and on the sides, if confirmed then,
2. Measure the Wood/leather inlay lift per spec specified in the service manual. If lift is excessive/out of spec then;
3. Per Service Manual, disassemble the inlay.
4. Inspect new Wood inlay part for flatness as shown in Figure 5 below.
5. Replace the inlay with a good known new part.

Note 1: Use fixture p/n 4-00-V8-10000 to make sure adhesive get adhere in the corners/sides properly.

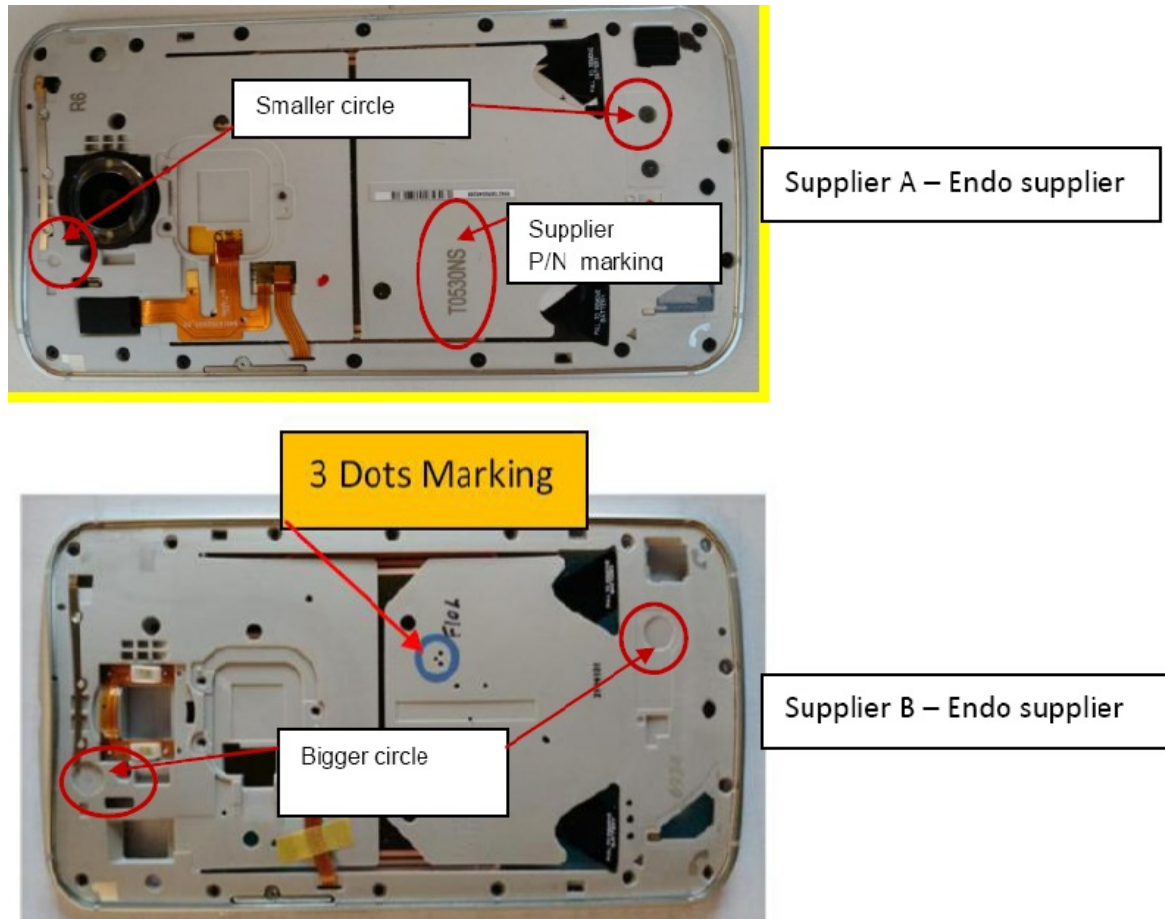
Figure: 4

- a) Supplier A, good parts have “smaller circle” and part number marked (see Figure 4).
- b) Supplier B, good parts have “bigger circle” and “3 dots” marked.

- Stock Endo p/n # 010179390XX & 0101182620XX (ASSEMBLY,SUB,INNER REAR HOUSING).
 - **Note 4:** Screen existing inventory of Endos p/n # 010179390XX & 0101182620XX as shown below in Figure 4.
 - Supplier A, parts have “smaller circles” and “p/n marked” (see below Figure 4) - All parts are good from this supplier and no screening is require.
 - Supplier B, parts have “bigger circles” and “3 Dots marked” (see below Figure 4). If no “3 Dots marked then parts are not good to use.
- Stock Wood Inlay p/n 0101796900X
 - **Note 5:** Existing inventory of Wood Inlay p/n 0101796900X should be screened for warp and out of spec flatness. See Figure 3 above.
